From: Eric Duncan
To: Anne Boland; Bill Bateman; Bruce Boger; Charles Weil; Cynthia Pederson; David Hills; Deborah Jackson; Eric Duncan; Gary Shear; Geoffrey Grant; Geoffrey Wright; Gregory Cwalina; James Caldwell; James Davis; James Heller; James Wiggins; Jared Heck; Jay Collins; Jim Dyer; John Grobe; John Jandovitz; John Rutkowski; John Tsao; Joseph Petrosino; Mark Satorius; Matthew Mitchell; Melvin Holmberg; Michael Weber; Michele Evans; Patrick Hiland; Richard Smith; Russell Gibbs; Scott Langan; Steven West; Terence Chan; Thomas Wengert; Tom Bilik; Victor Hall; William Cullen
Date: Wed, Mar 21, 2007 6:36 AM
Subject: Additional Document for Davis-Besse Call

10. The Unique Nature of the Davis-Besse Nozzle 3 Crack and the RPV Head Wastage Cavity

10.1 Wastage Cavities at Nozzles 3 and 2

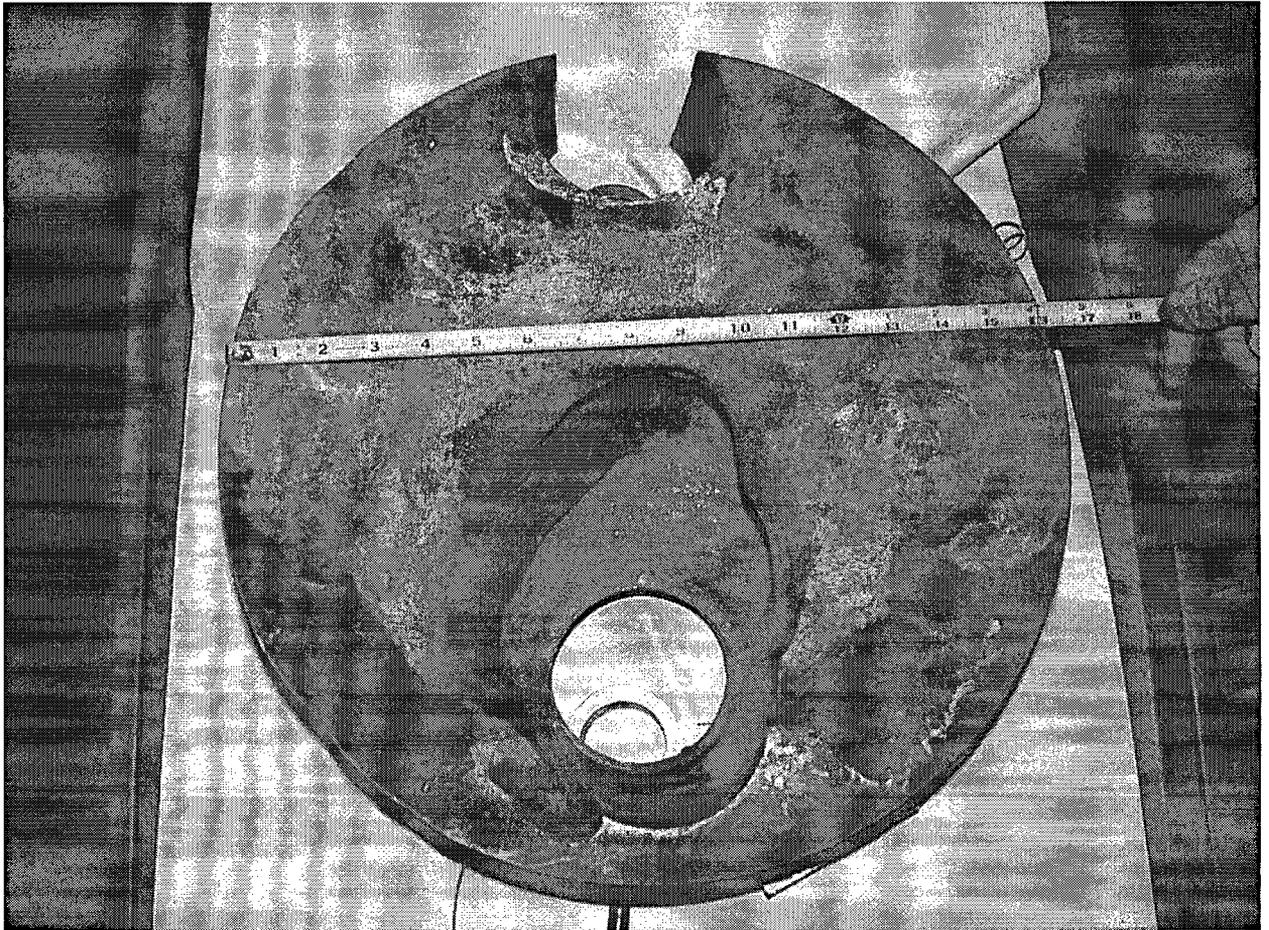
Figure 10.1 Top view of wastage cavity.

- The cavity extends down to the upper surface of the stainless steel cladding, exposing both the cladding and the J-groove weld.
- The cavity extends approximately 8 inches towards nozzle 11, is a maximum of approximately 4 inches in lateral dimension, and extends back to approximately the 90° and 270° points on the nozzle bore.
- The total volume of alloy steel removed was approximately 195 cubic inches.

- The cavity is centered on the large axial/radial crack in the J-groove weld at CRDM Nozzle 3 at the 10° location.
- The axial Crack 1 in Nozzle 3, which extended 1.23 inch above the top of the J-groove weld, is also approximately centered on the wastage cavity.

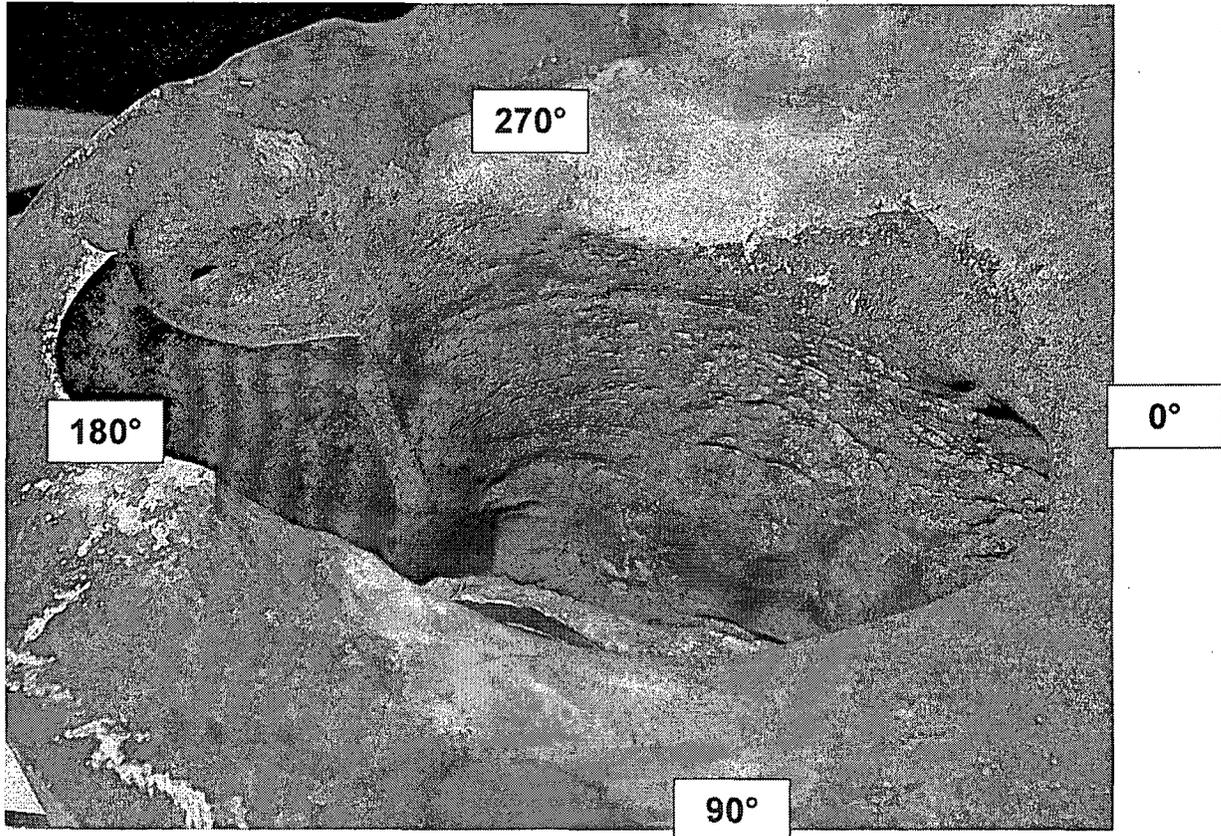
Figure 10.2 View of cavity looking toward 270°

- The cavity morphology is indicative of a combination of processes, including mechanical removal by impingement of high velocity fluid, flow assisted corrosion, and boric acid corrosion.

- The corrosion process is clearly more dominant in the upper region of the cavity. There is clear evidence of mechanical removal and/or flow-assisted corrosion in the lower region, where the wastage cavity is clearly undercut. This lower undercut region is indicative of a more rapid metal removal process than at the mid-elevation point of the cavity.

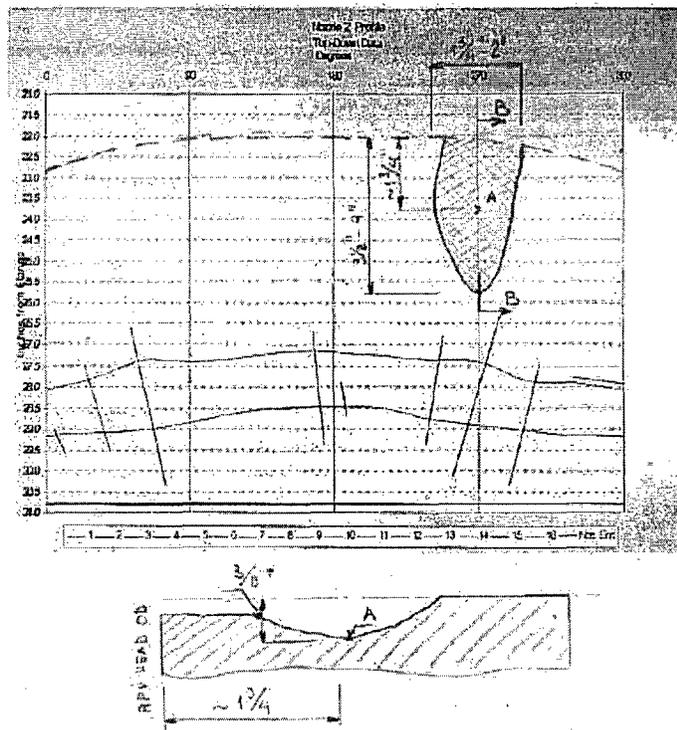
Figure 10-6 Wastage Cavity at CRDM Nozzle 2

- The wastage cavity was located above three of the through wall axial cracks in Nozzle 2, in the upper half of the nozzle bore, centered on the 270° location.
- The wastage area was located 180° away from the two longest axial cracks in Nozzle 2, which were either side of the 90° location.

- Enlargement of the annulus clearance at the upper surface of the RPV head was observed at approximately the 90° location.
- None of the axial cracks extended up into the wastage cavity.
- The wastage area extended approximately 3 ½ to 4 inches down from the upper surface of the RPV head and was 50° (1 ¾ inches) in circumferential extent.
- The maximum penetration of the cavity into the RPV head was approximately 3/8 inch in the radial direction away from the nozzle OD, and this maximum point was approximately 1 ¾ inches below the upper surface of the RPV head. This indicates that whatever processes of mechanical removal, corrosion, or flow-assisted corrosion were active; the cavity was growing at its maximum rate sub-surface.

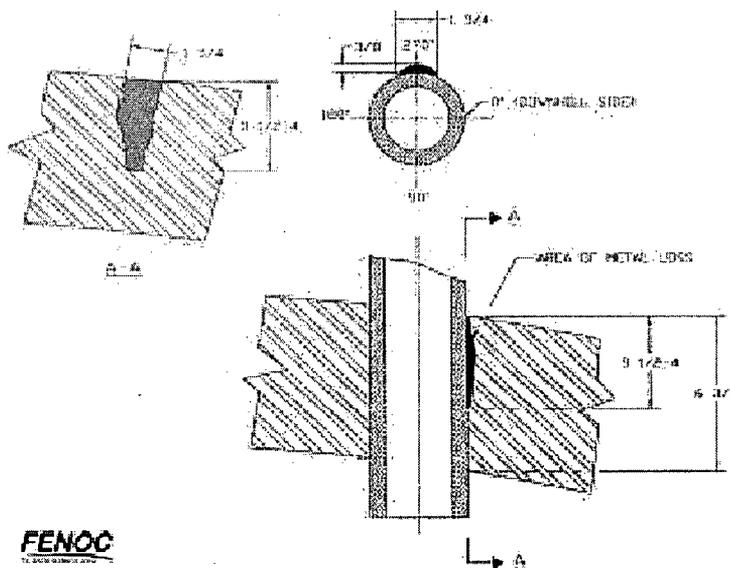
Figure 10-7 Wastage Cavity at CRDM Nozzle 2

Nozzle 2 Corrosion Profile

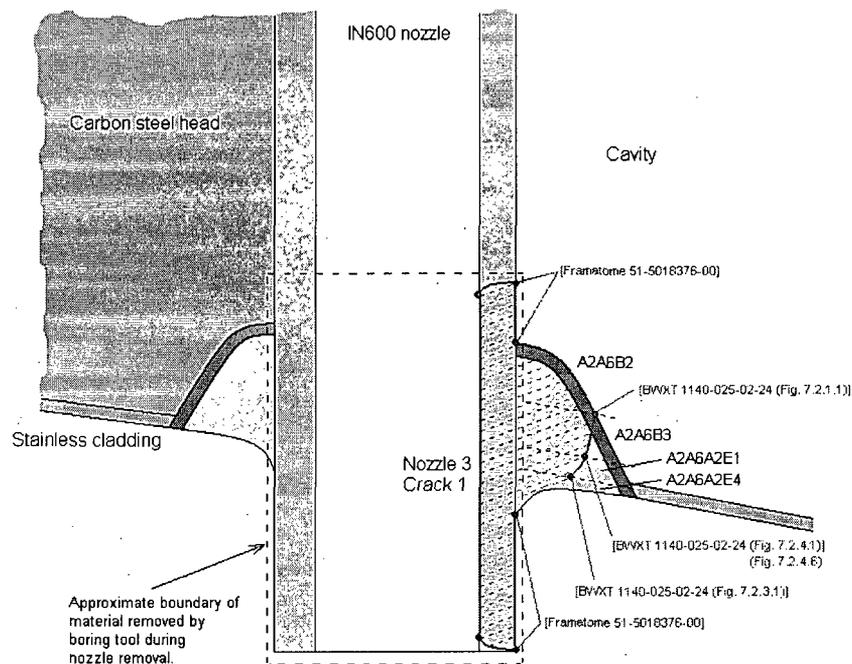
However, careful metallurgical examination of the portion of the J-groove weld that remained after the RPV head section containing the cavity was removed from the RPV head, together with the UT data, allowed us to build up a composite picture of the large nozzle and weld crack at CRDM Nozzle 3 that is shown in Figure 10.8 (See Section 8.4.2).

Figure 10.8 Schematic of final size and shape of Crack 1 in Davis-Besse CRDM Nozzle 3 (from Section 8, Figure 8-10)

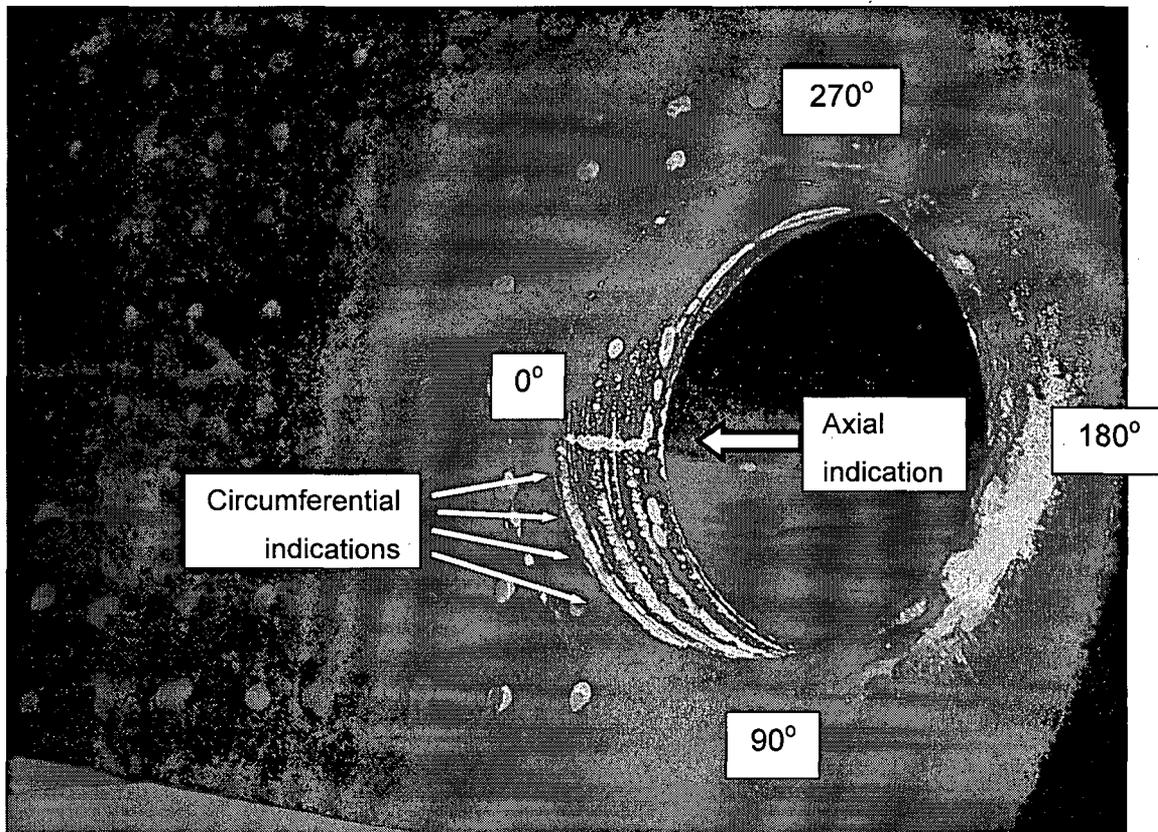
- A large axial through-wall crack (Crack 1) at the 3° location at the top of the J-groove weld extended from almost the bottom of Nozzle 3 to 1.23 inches above the weld on the OD.
- This axial nozzle crack appears to have extended into and almost completely across the J-groove weld at Nozzle 3.
- The metallurgical examination of this weld crack showed that it was quite wide and extended approximately 0.75 inches across the weld in the radial direction at the 10° location (Figures 10.9 through 10.14).
- The weld crack was in line with the upward bulge and crack in the stainless steel cladding at the bottom of the wastage cavity. The bulge in the cladding may have contributed to opening of the weld crack.

Figure 10.9 PT results for nozzle 3 J-groove weld bore and cladding underside. The J-groove weld contained an axial indication near 10° on the bore ID and circumferential indications on the RCS side from ~20° to ~45°.

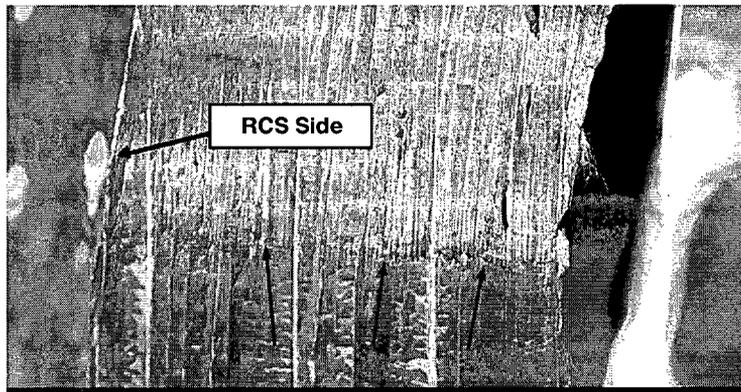
Looking at J-groove weld bore near 10°. ~1.2X

Figure 10.10 Photograph showing the remaining portion of the axial crack near 10° in the CRDM Nozzle 3 J-groove weld. This is the portion remaining after the machining was completed for nozzle repair.

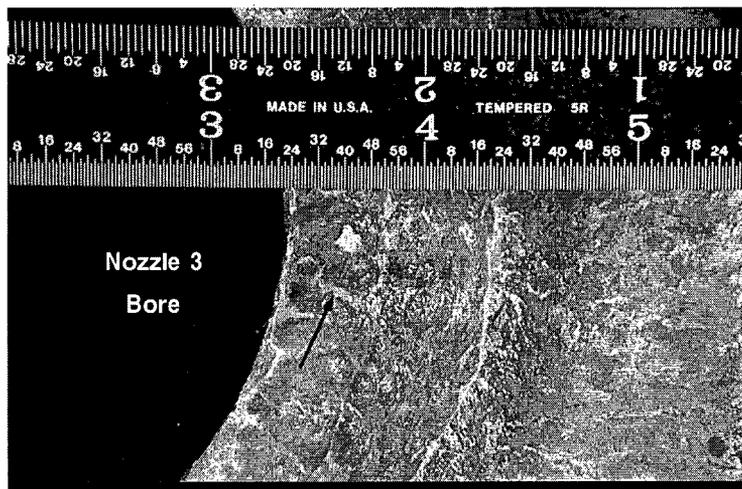
Top view of J-groove weld crack near 10°. ~1.4X

Figure 10.11. Photograph showing axial crack in CRDM nozzle 3 J-groove weld near 10°.

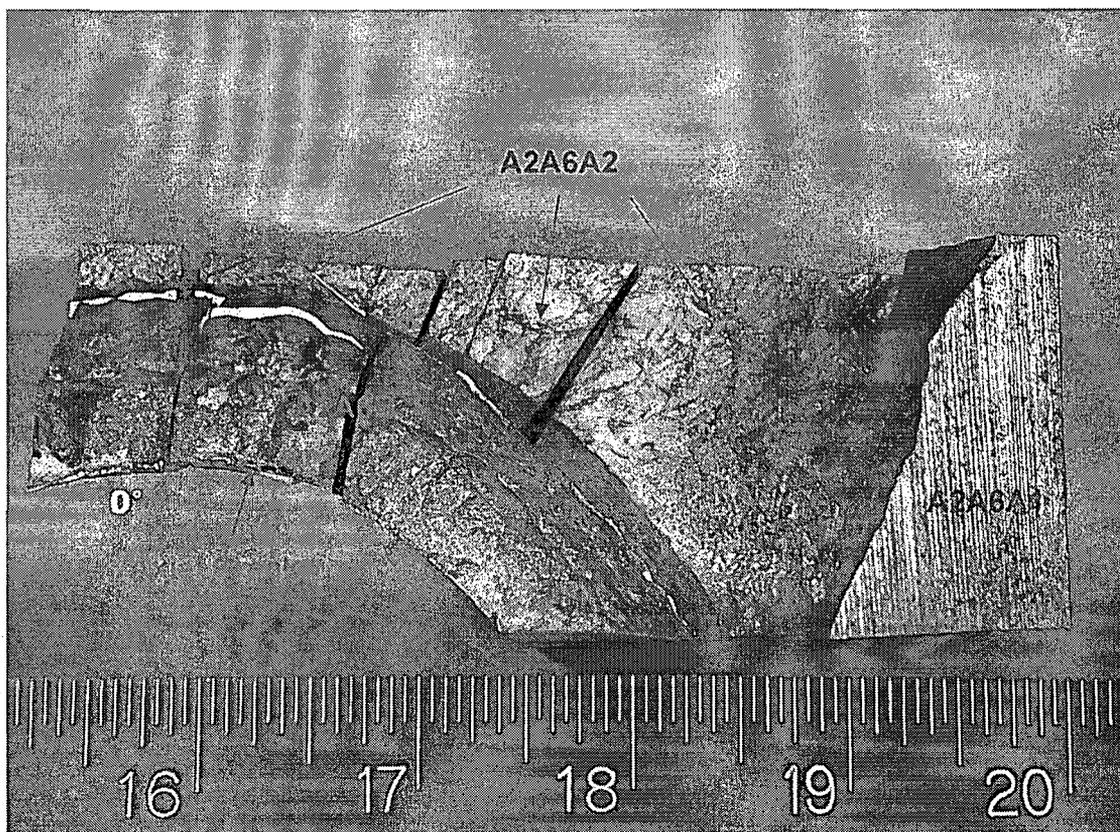
Figure 10.12 Piece A2A6 was first sectioned into Pieces A2A6A and A2A6B. Piece A2A6A was further sectioned into Pieces A2A6A1 and A2A6A2. Both cuts were made on the same plane, parallel to the paper. The first cut line is partially visible; Piece A2A6B is the upper portion of the weld. The second cut line between Pieces A2A6A1 and A2A6A2 is obscured by Piece A2A6A1

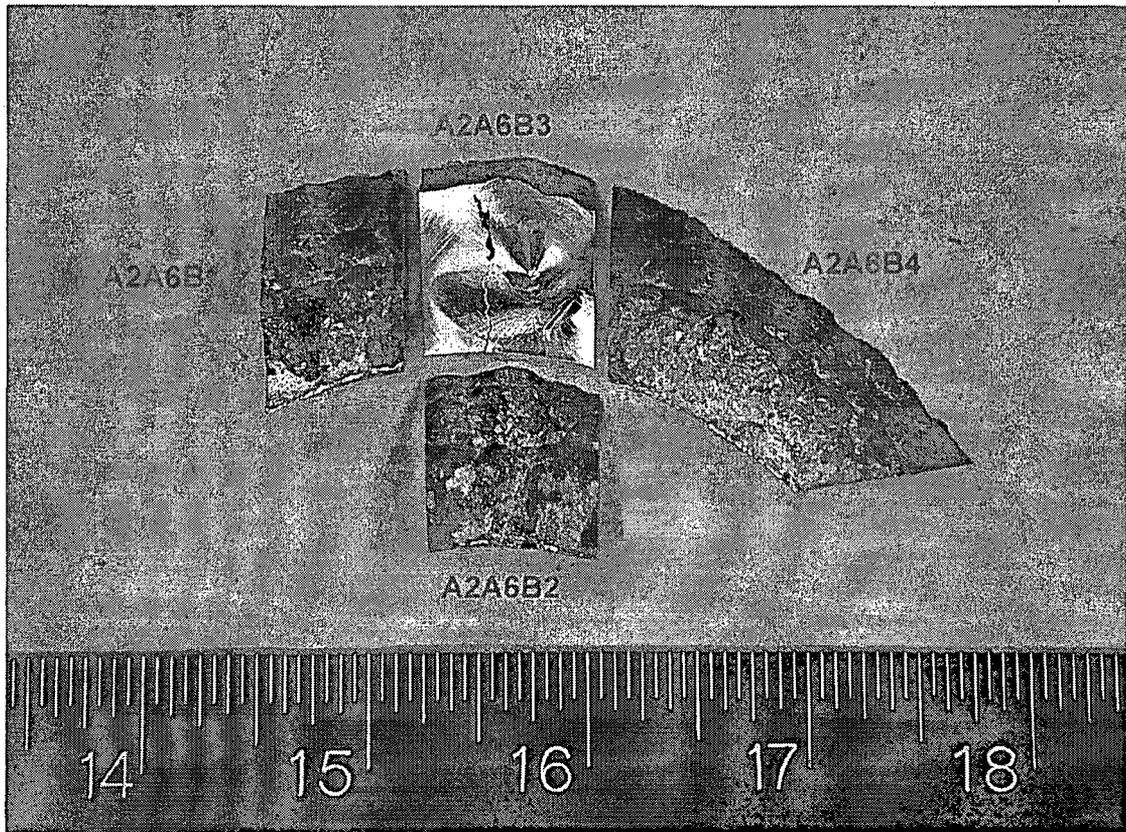
Figure 10.13

Piece A2A6B after sectioning. The bottom surface of A2A6B2 was mounted. The axial crack in A2A6B3 was opened up for SEM.

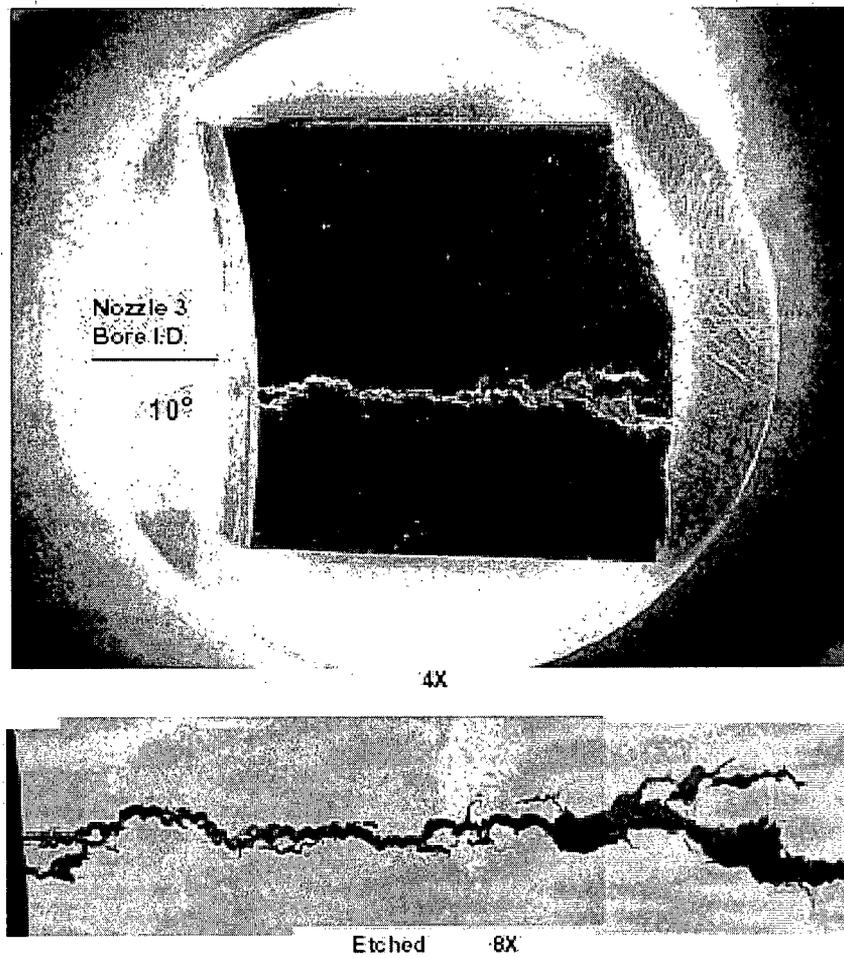
Figure 10.14 Macro photograph of metallographic mount sample A2A6B2 (see Figures 5.4 and 5.5 for the sample orientation). The axial cracking at $\sim 10^\circ$ is through the J-groove weld, in contrast to the cracking near 180° , which was partially through the weld. A slightly higher magnification micrograph is also provided
