From: Eric Duncan
To: Anne Boland; Bill Bateman; Bruce Boger; Charles Weil; Cynthia Pederson; David Hills; Deborah Jackson; Eric Duncan; Gary Shear; Geoffrey Grant; Geoffrey Wright; Gregory Cwalina; James Caldwell; James Davis; James Heller; James Wiggins; Jared Heck; Jay Collins; Jim Dyer; John Grobe; John Jandovitz; John Rutkowski; John Tsao; Joseph Petrosino; Mark Satorius; Matthew Mitchell; Melvin Holmberg; Michael Weber; Michele Evans; Patrick Hiland; Richard Smith; Russell Gibbs; Scott Langan; Steven West; Terence Chan; Thomas Wengert; Tom Bilik; Victor Hall; William Cullen
Date: Wed, Mar 21, 2007 6:36 AM
Subject: Additional Document for Davis-Besse Call

Please find attached one additional section from the Exponent report regarding the wastage of nozzle 3 of the Davis-Besse head that may be helpful to review in advance of tomorrow's call.

10. The Unique Nature of the Davis-Besse Nozzle 3 Crack and the RPV Head Wastage Cavity

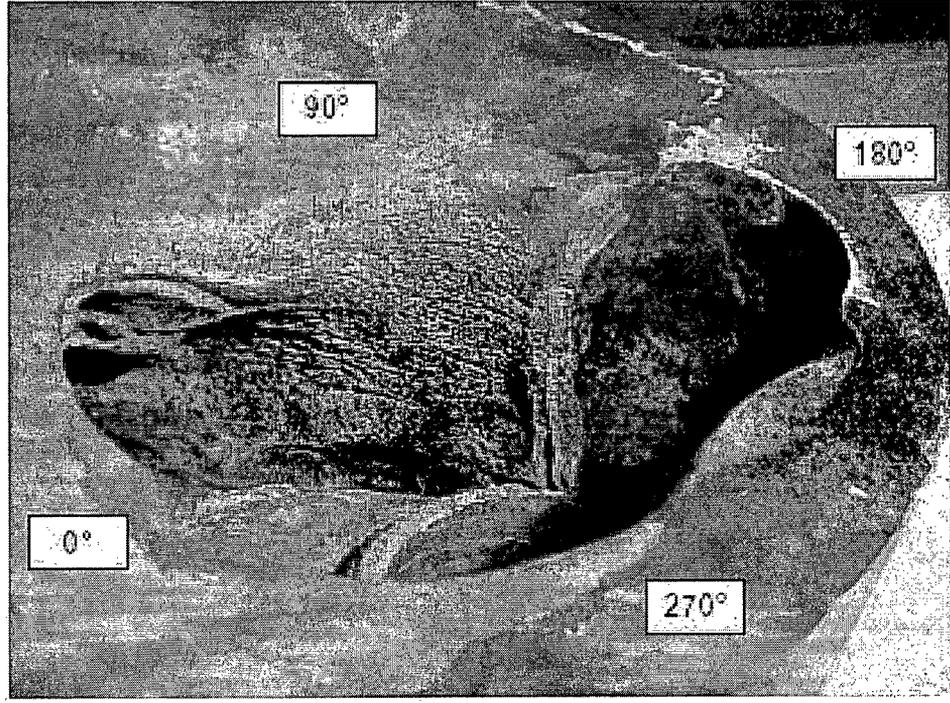
Figure 10.3 View of cavity looking toward 90°

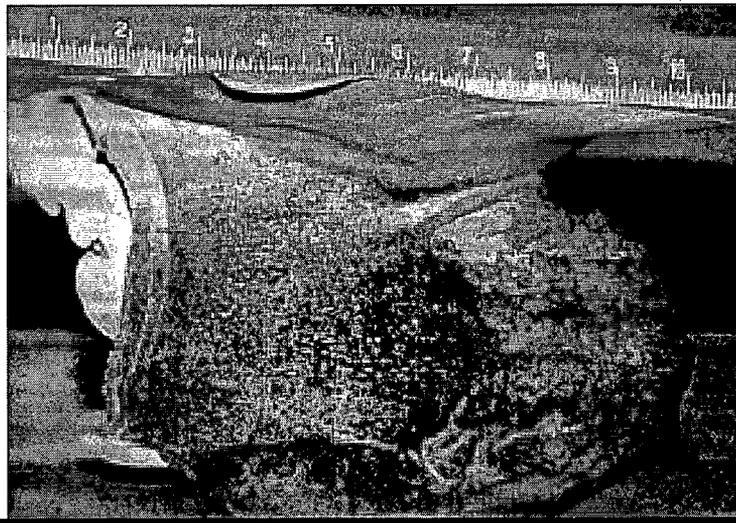
- General corrosion of the upper RPV head surface around the cavity is evident to a depth of 1 to 1.5 inches. This can be seen in the view of the top section of the cavity (Figure 10.4) and more clearly shown in the dental mold impressions (Figure 10.5).

Figure 10.5(a) Photographs of cavity dental mold

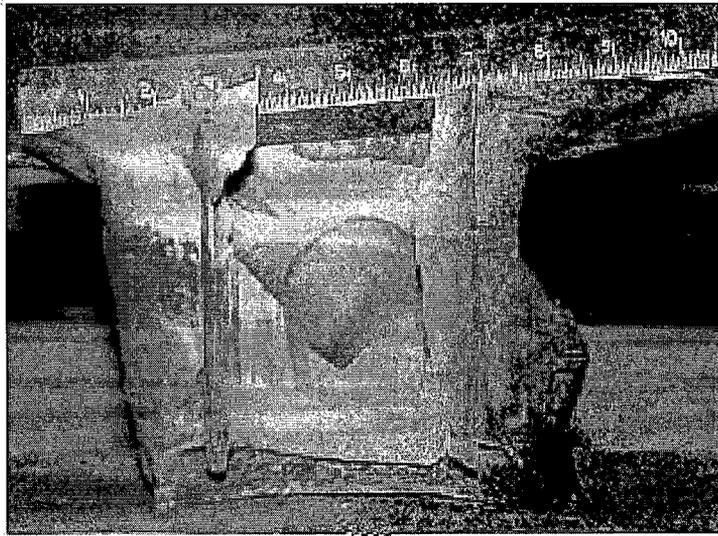
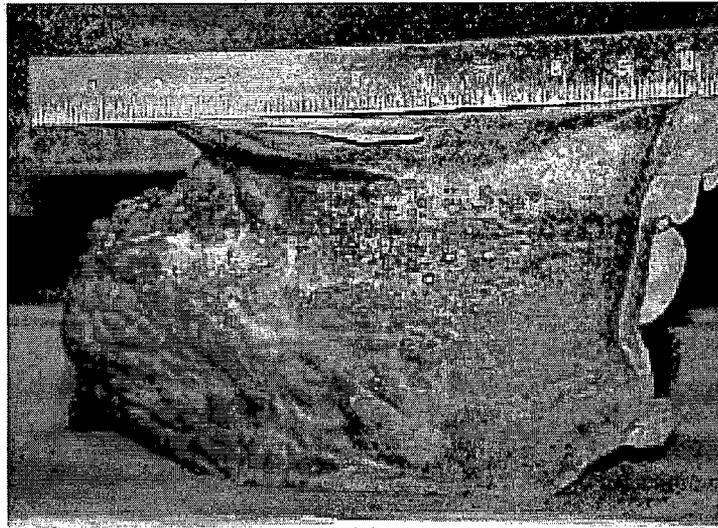
Figure 10.5(b) Photographs of cavity dental mold

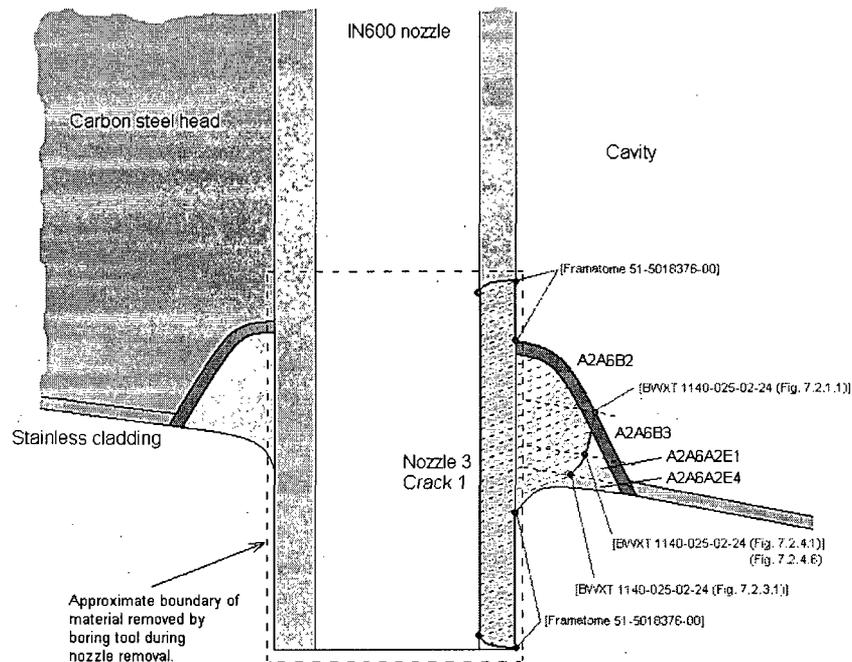
However, careful metallurgical examination of the portion of the J-groove weld that remained after the RPV head section containing the cavity was removed from the RPV head, together with the UT data, allowed us to build up a composite picture of the large nozzle and weld crack at CRDM Nozzle 3 that is shown in Figure 10.8 (See Section 8.4.2).

- A large axial through-wall crack (Crack 1) at the 3° location at the top of the J-groove weld extended from almost the bottom of Nozzle 3 to 1.23 inches above the weld on the OD.
- This axial nozzle crack appears to have extended into and almost completely across the J-groove weld at Nozzle 3.
- The metallurgical examination of this weld crack showed that it was quite wide and extended approximately 0.75 inches across the weld in the radial direction at the 10° location (Figures 10.9 through 10.14).
- The weld crack was in line with the upward bulge and crack in the stainless steel cladding at the bottom of the wastage cavity. The bulge in the cladding may have contributed to opening of the weld crack.

Figure 10.8 Schematic of final size and shape of Crack 1 in Davis-Besse CRDM Nozzle 3 (from Section 8, Figure 8-10)

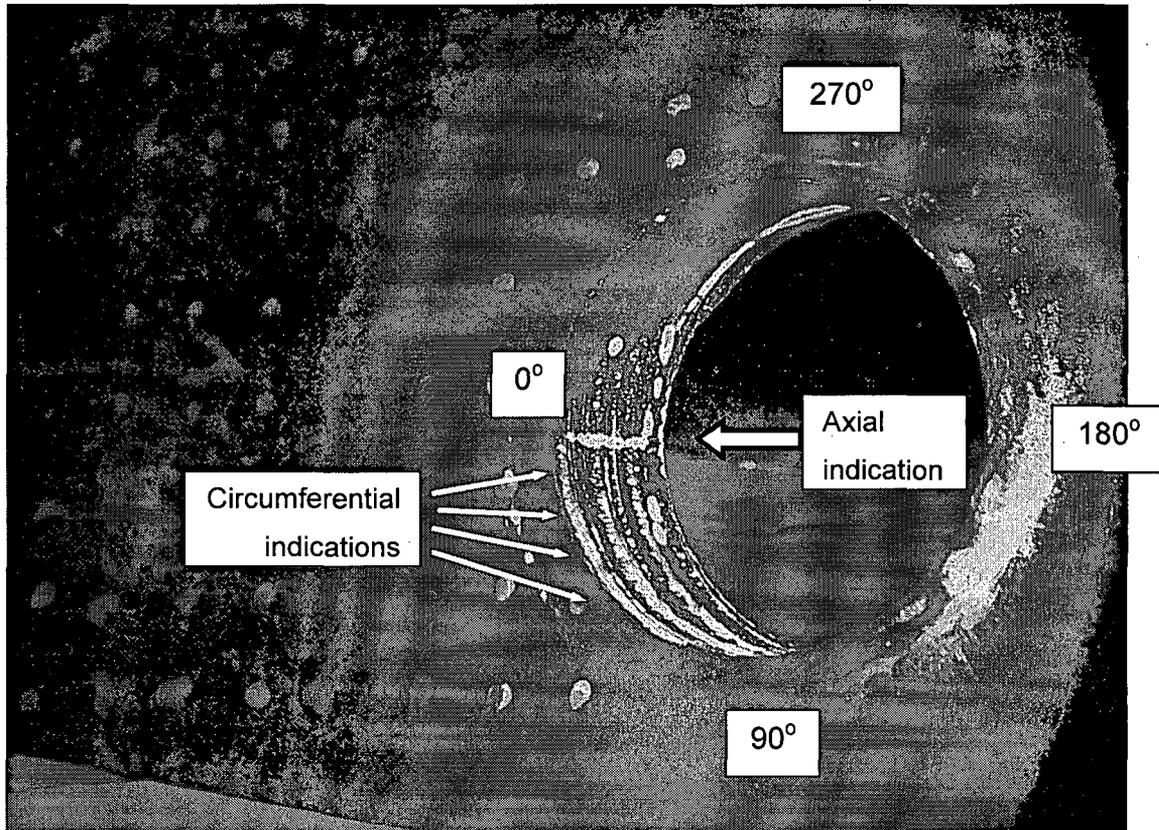
Figure 10.9 PT results for nozzle 3 J-groove weld bore and cladding underside. The J-groove weld contained an axial indication near 10° on the bore ID and circumferential indications on the RCS side from ~20° to ~45°.
