From: Anne Boland *p3*
To: Jared Heck
Date: 07/05/2007 11:29:41 AM
Subject: Fwd: Additional Document for Davis-Besse Call - Subpoena Response

Please find attached one additional section from the Exponent report regarding the wastage of nozzle 3 of the Davis-Besse head that may be helpful to review in advance of tomorrow's call.

10. The Unique Nature of the Davis-Besse Nozzle 3 Crack and the RPV Head Wastage Cavity

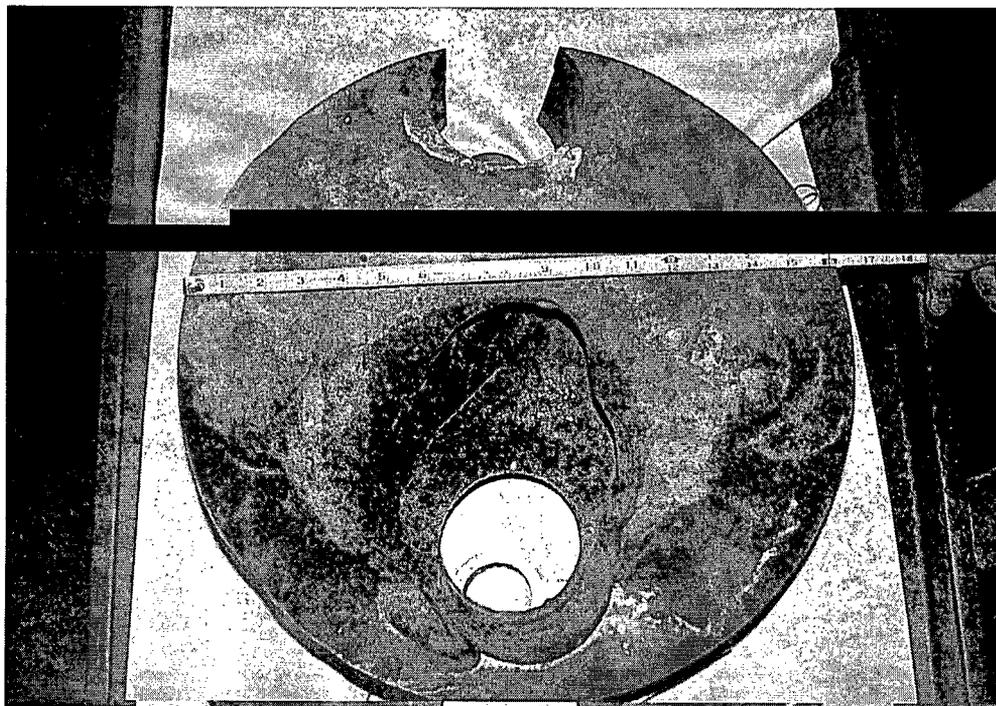
The detailed physical examination of the large wastage cavity at CRDM Nozzle 3 after a portion of the RPV steel containing the cavity was removed from the RPV head and examined in the laboratory¹ shows the following principal characteristics (Figures 10-1 through 10-4):

- The cavity extends down to the upper surface of the stainless steel cladding, exposing both the cladding and the J-groove weld.
- The cavity extends approximately 8 inches towards nozzle 11, is a maximum of approximately 4 inches in lateral dimension, and extends back to approximately the 90° and 270° points on the nozzle bore.
- The total volume of alloy steel removed was approximately 195 cubic inches.

- The cavity is centered on the large axial/radial crack in the J-groove weld at CRDM Nozzle 3 at the 10° location.
- The axial Crack 1 in Nozzle 3, which extended 1.23 inch above the top of the J-groove weld, is also approximately centered on the wastage cavity.

Figure 10.1 Top view of wastage cavity.

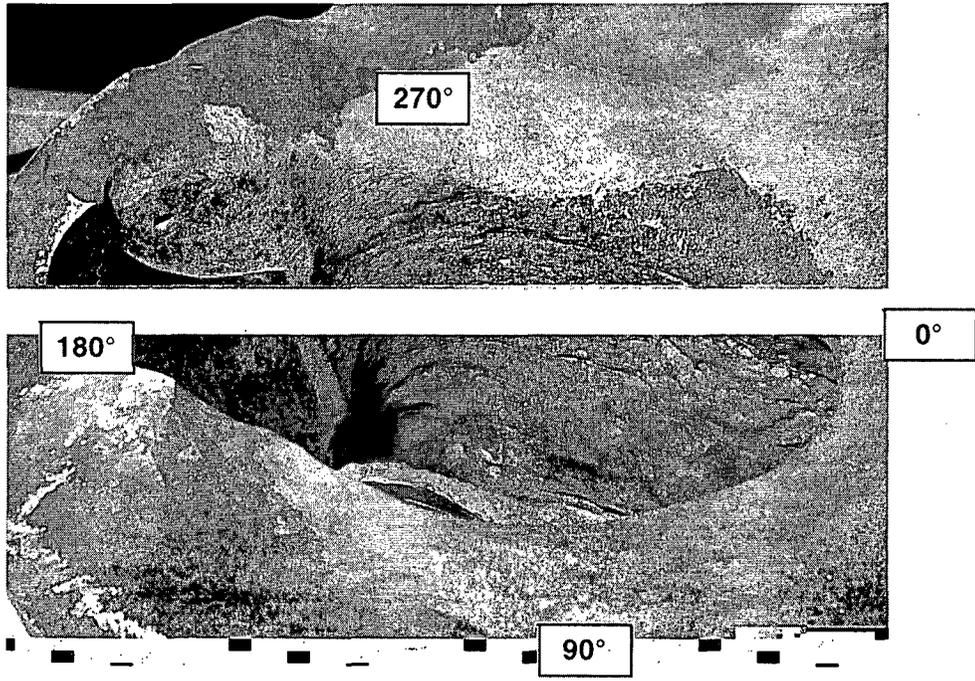
- The cavity morphology is indicative of a combination of processes, including mechanical removal by impingement of high velocity fluid, flow assisted corrosion, and boric acid corrosion.

- The corrosion process is clearly more dominant in the upper region of the cavity. There is clear evidence of mechanical removal and/or flow-assisted corrosion in the lower region, where the wastage cavity is clearly undercut. This lower undercut region is indicative of a more rapid metal removal process than at the mid-elevation point of the cavity.

Figure 10.2 View of cavity looking toward 270°

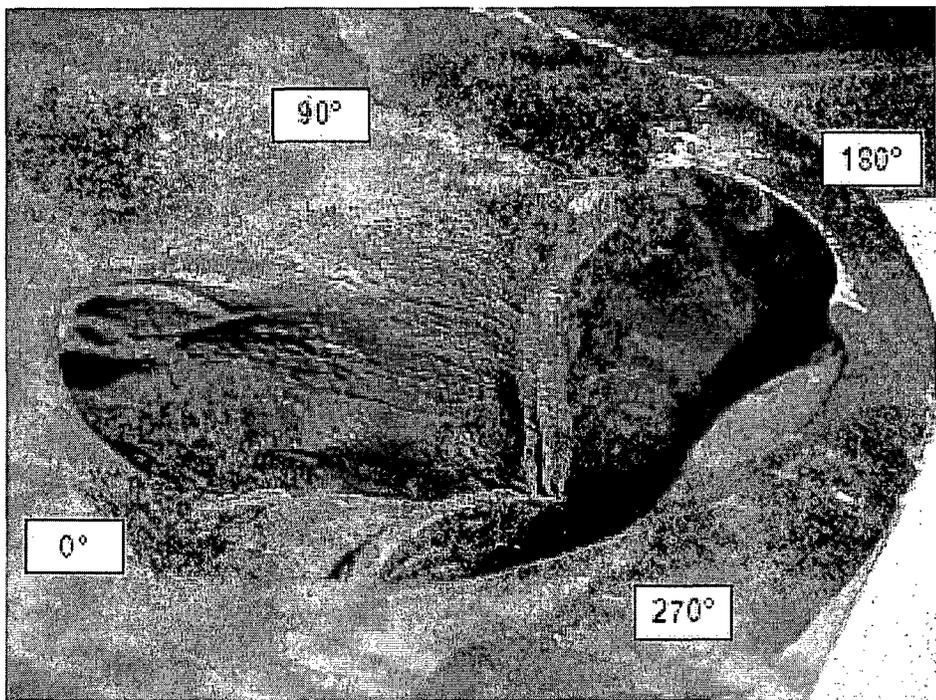
Figure 10.3 View of cavity looking toward 90°

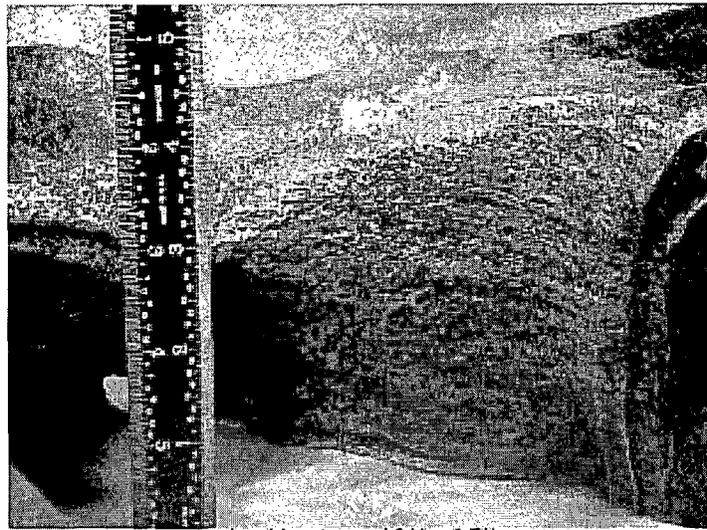
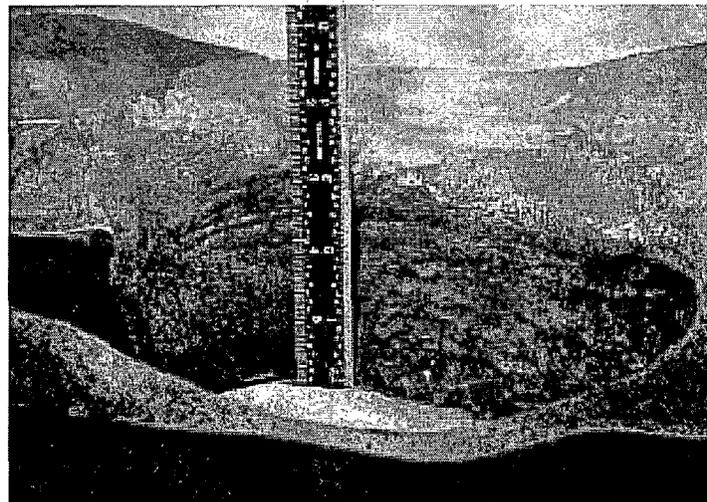
- General corrosion of the upper RPV head surface around the cavity is evident to a depth of 1 to 1.5 inches. This can be seen in the view of the top section of the cavity (Figure 10.4) and more clearly shown in the dental mold impressions (Figure 10.5).

Looking toward 90° ~0.7X

Looking toward 270° ~0.5X

Figure 10.4 Low magnification photographs of cavity sidewalls

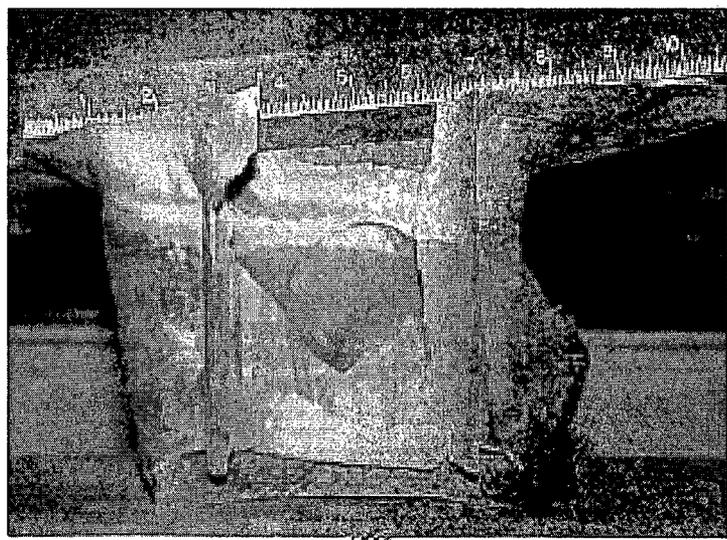
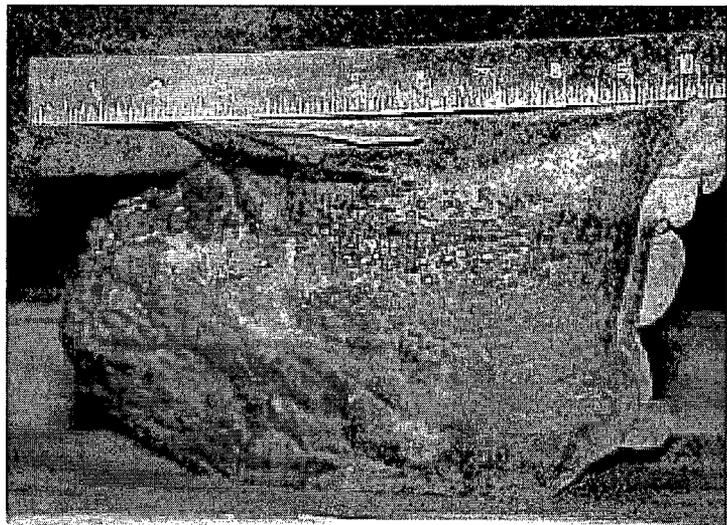
Figure 10.5(a) Photographs of cavity dental mold

Figure 10.5(b) Photographs of cavity dental mold

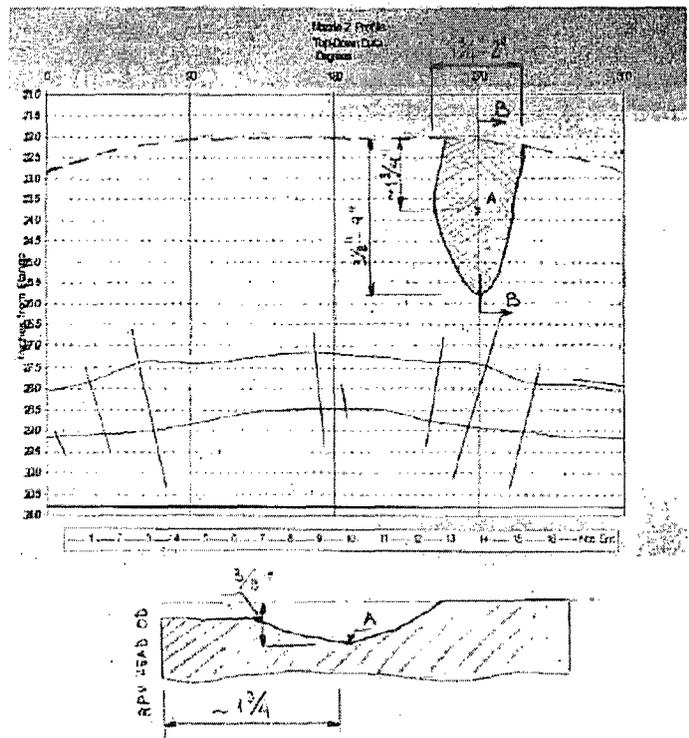
Field examination of the much smaller wastage cavity at CRDM Nozzle 2 by means of a borescope camera revealed the following characteristics (Figures 10-6, 10-7):

- The wastage cavity was located above three of the through wall axial cracks in Nozzle 2, in the upper half of the nozzle bore, centered on the 270° location.
- The wastage area was located 180° away from the two longest axial cracks in Nozzle 2, which were either side of the 90° location.

- Enlargement of the annulus clearance at the upper surface of the RPV head was observed at approximately the 90° location.
- None of the axial cracks extended up into the wastage cavity.
- The wastage area extended approximately 3 ½ to 4 inches down from the upper surface of the RPV head and was 50° (1 ¾ inches) in circumferential extent.
- The maximum penetration of the cavity into the RPV head was approximately 3/8 inch in the radial direction away from the nozzle OD, and this maximum point was approximately 1 ¾ inches below the upper surface of the RPV head. This indicates that whatever processes of mechanical removal, corrosion, or flow-assisted corrosion were active; the cavity was growing at its maximum rate sub-surface.

Figure 10-6 Wastage Cavity at CRDM Nozzle 2

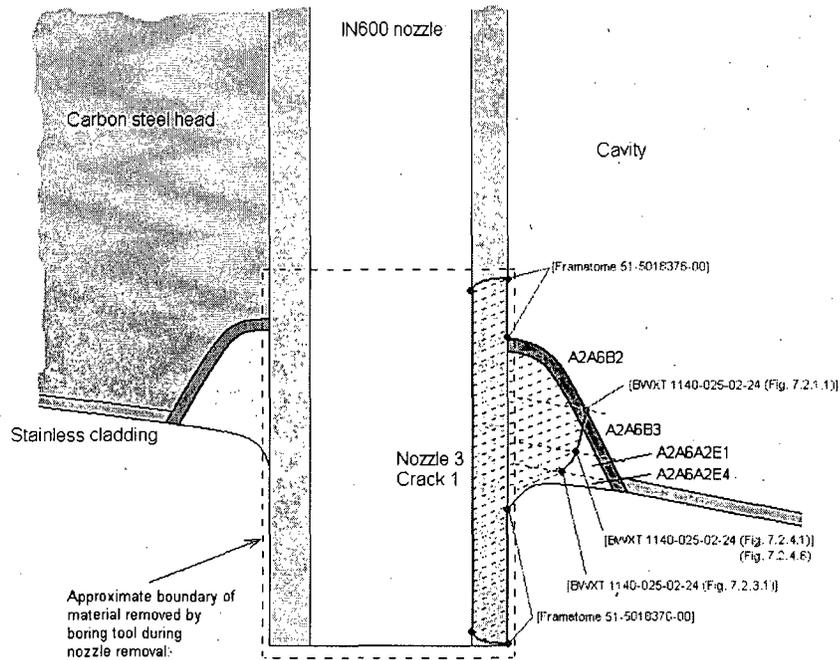
However, careful metallurgical examination of the portion of the J-groove weld that remained after the RPV head section containing the cavity was removed from the RPV head, together with the UT data, allowed us to build up a composite picture of the large nozzle and weld crack at CRDM Nozzle 3 that is shown in Figure 10.8 (See Section 8.4.2).

- A large axial through-wall crack (Crack 1) at the 3° location at the top of the J-groove weld extended from almost the bottom of Nozzle 3 to 1.23 inches above the weld on the OD.
- This axial nozzle crack appears to have extended into and almost completely across the J-groove weld at Nozzle 3.
- The metallurgical examination of this weld crack showed that it was quite wide and extended approximately 0.75 inches across the weld in the radial direction at the 10° location (Figures 10.9 through 10.14).
- The weld crack was in line with the upward bulge and crack in the stainless steel cladding at the bottom of the wastage cavity. The bulge in the cladding may have contributed to opening of the weld crack.

Figure 10.8 Schematic of final size and shape of Crack 1 in Davis-Besse CRDM Nozzle 3 (from Section 8, Figure 8-10)

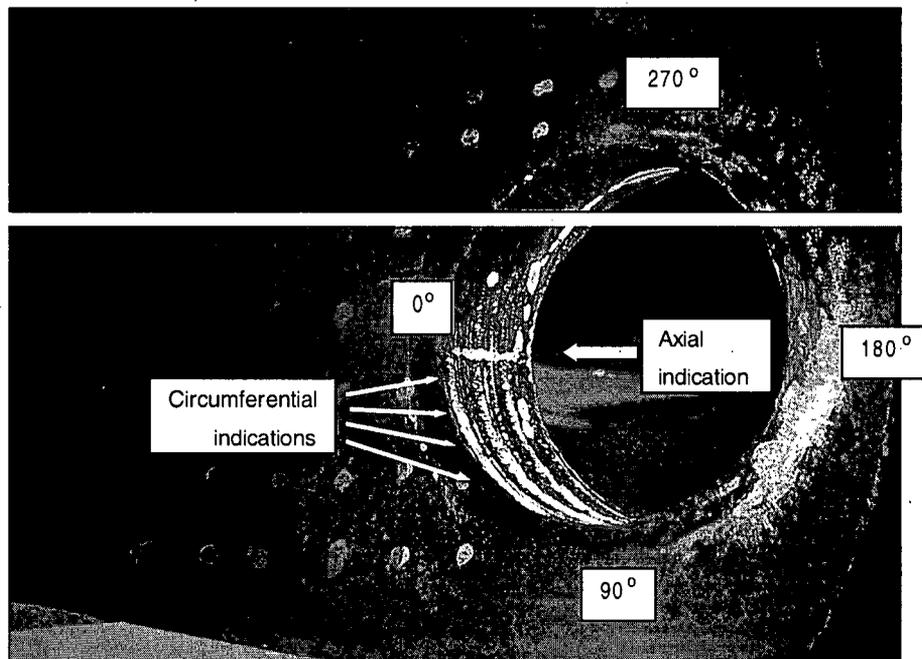
Figure 10.9 PT results for nozzle 3 J-groove weld bore and cladding underside. The J-groove weld contained an axial indication near 10° on the bore ID and circumferential indications on the RCS side from ~20° to ~45°.

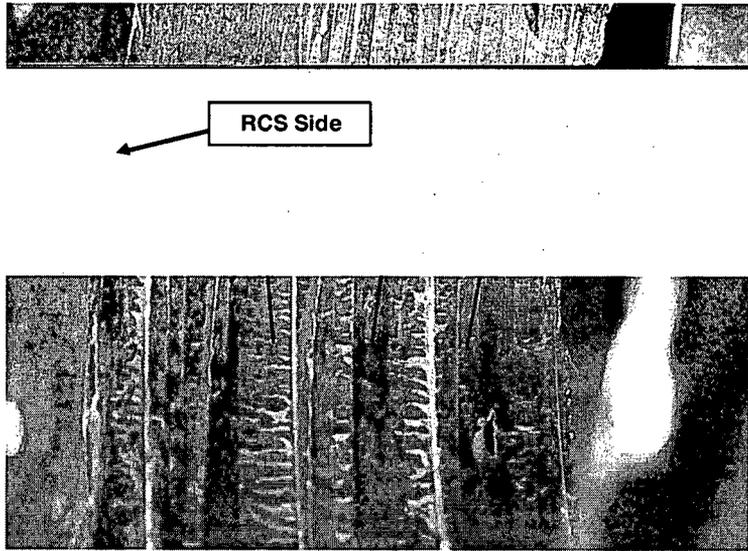
Looking at J-groove weld bore near 10°. ~1.2X

Figure 10.10 Photograph showing the remaining portion of the axial crack near 10° in the CRDM Nozzle 3 J-groove weld. This is the portion remaining after the machining was completed for nozzle repair.

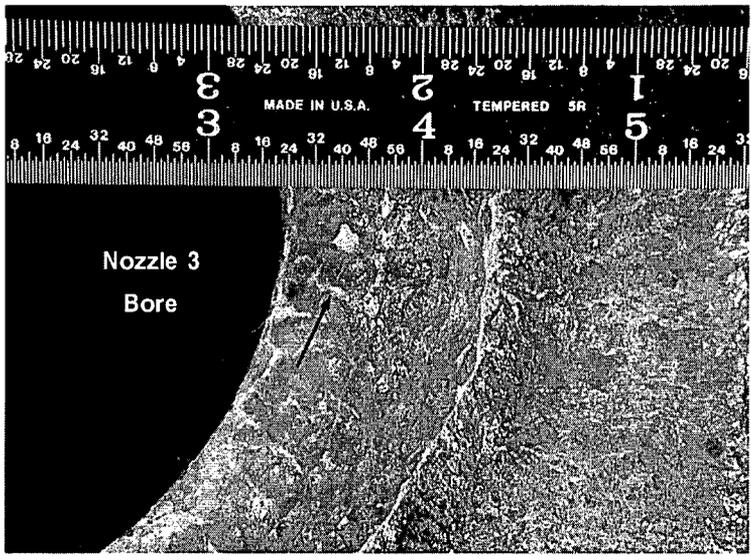
Top view of J-groove weld crack near 10°. ~1.4X

Figure 10.11 Photograph showing axial crack in CRDM nozzle 3 J-groove weld near 10°.

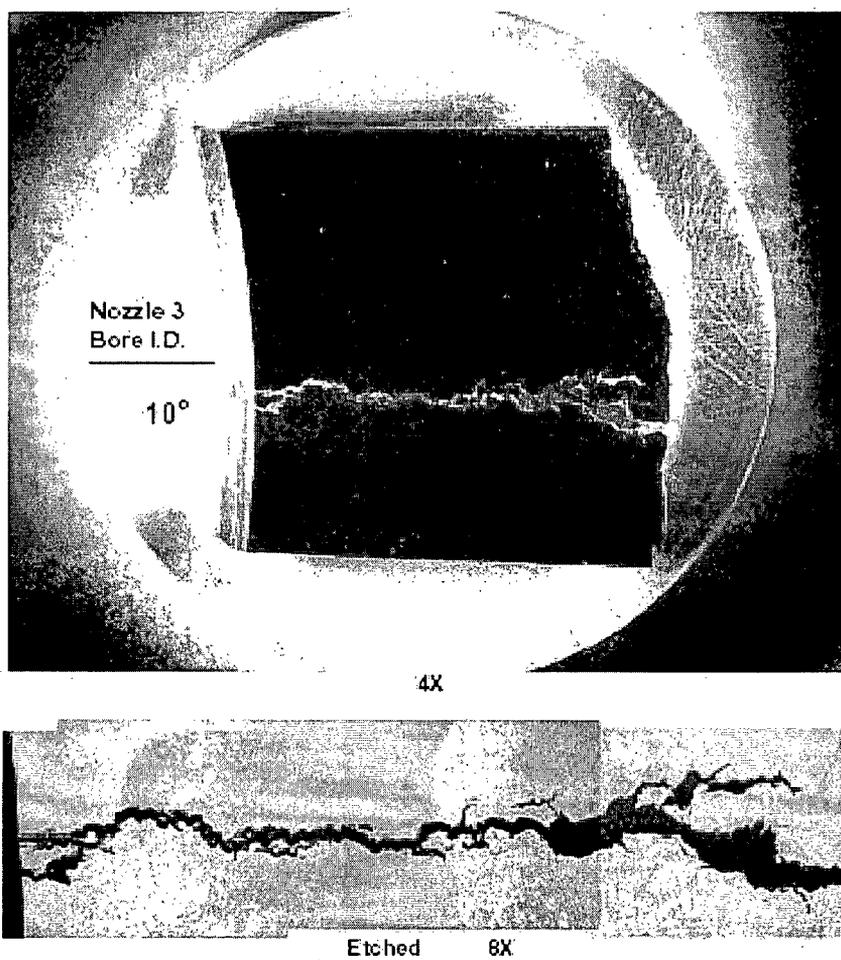
Figure 10.14 Macro photograph of metallographic mount sample A2A6B2 (see Figures 5.4 and 5.5 for the sample orientation). The axial cracking at $\sim 10^\circ$ is through the J-groove weld, in contrast to the cracking near 180° , which was partially through the weld. A slightly higher magnification micrograph is also provided
