UNITED STATES  
NUCLEAR REGULATORY COMMISSION  
OFFICE OF NUCLEAR REACTOR REGULATION  
WASHINGTON, DC 20555-0001

NRC INFORMATION NOTICE 2008-07:      CRACKING INDICATIONS IN THERMALLY  
TREATED ALLOY 600 STEAM GENERATOR  
TUBES

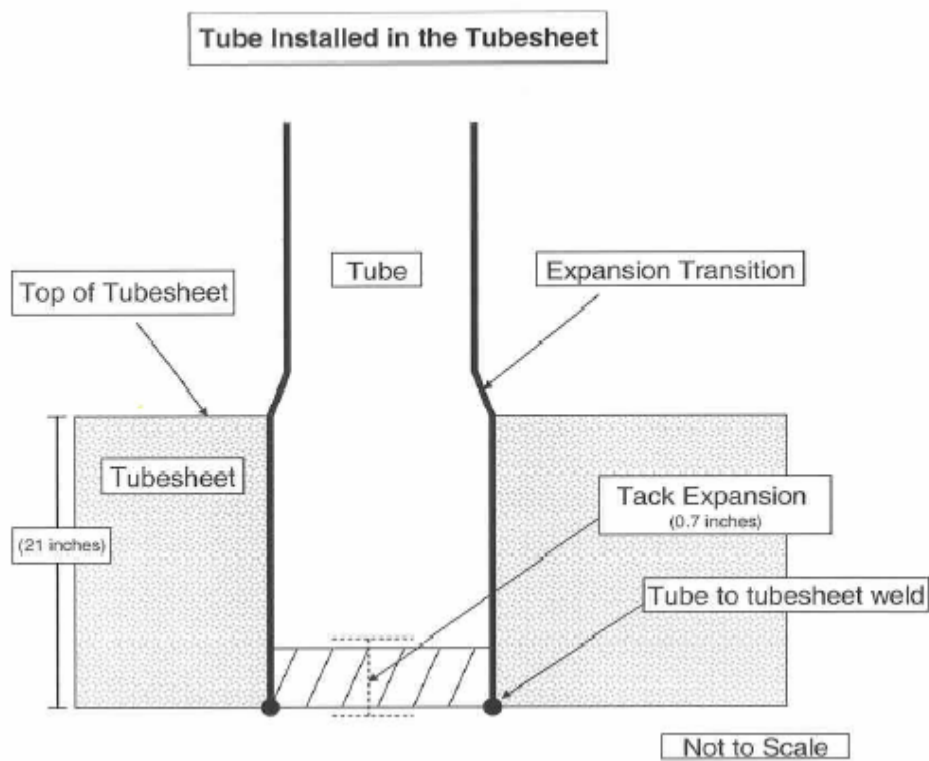
Figure 1

Vogtle, Unit 1, has four Westinghouse Model F recirculating steam generators. Each steam generator has approximately 5600 tubes fabricated from thermally treated Alloy 600. During fabrication of the steam generators, the lower portions of the tubes were inserted and hydraulically expanded into a thick plate called a tubesheet. The tubesheet is approximately 533.4 mm (21 inches) thick and has two holes for each tube (one hole on the hot-leg side of the steam generator and one hole on the cold-leg side). The tubes were hydraulically expanded for the full depth of the tubesheet. The transition from the expanded portion of the tube within the tubesheet to the unexpanded portion of the tube at the top of the tubesheet is referred to as the expansion transition region of the tube. The tubes are welded to the tubesheet at their lower ends (See Enclosure, Figure 1).
