Subject 2007 Annual Site Inspection and Monitoring Compliance Report for UMTRCA Title II
Disposal Sites

2007 Annual Site Inspection and Monitoring Report for Uranium Mill Tailings Radiation Control Act Title II Disposal Sites

November 2007

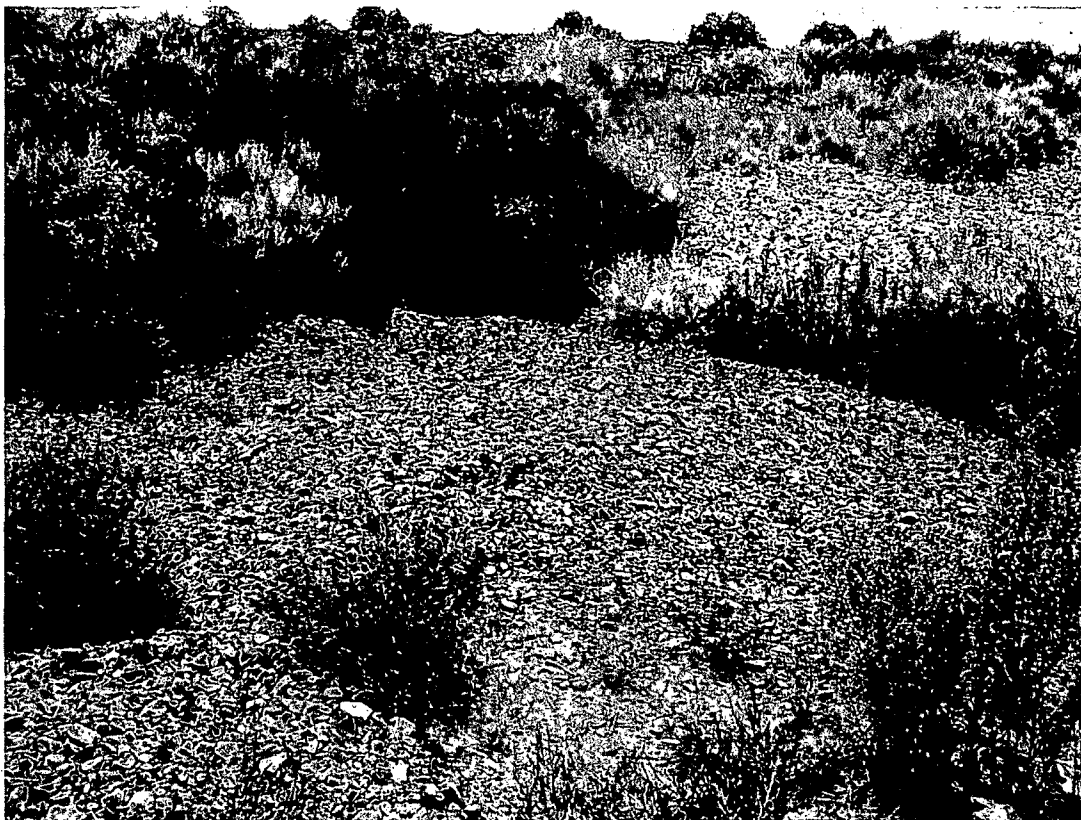
The asbestos disposal area is a bowl-like feature just south of the carbonate pile. The north, west, and south side slopes of this feature are covered by limestone riprap; the bottom of the bowl (the asbestos cell cover) is grass covered. A small depression was located along the south edge of the disposal area. The depression, probably the result of piping or collapse of uncontaminated fill material incompletely compacted during final grading, was first noted during the 1999 annual

BLU 8/2007. PL-7. Repaired depression in the asbestos disposal cell cover.

1C inspection but had not been a concern because it does not encroach on asbestos-containing materials. However, to mitigate the potential for encroachment into these materials, the depression was filled with crushed basalt rock during spring 2007. No additional settling had occurred since the repair was completed (PL-7). The asbestos disposal area is in excellent condition.

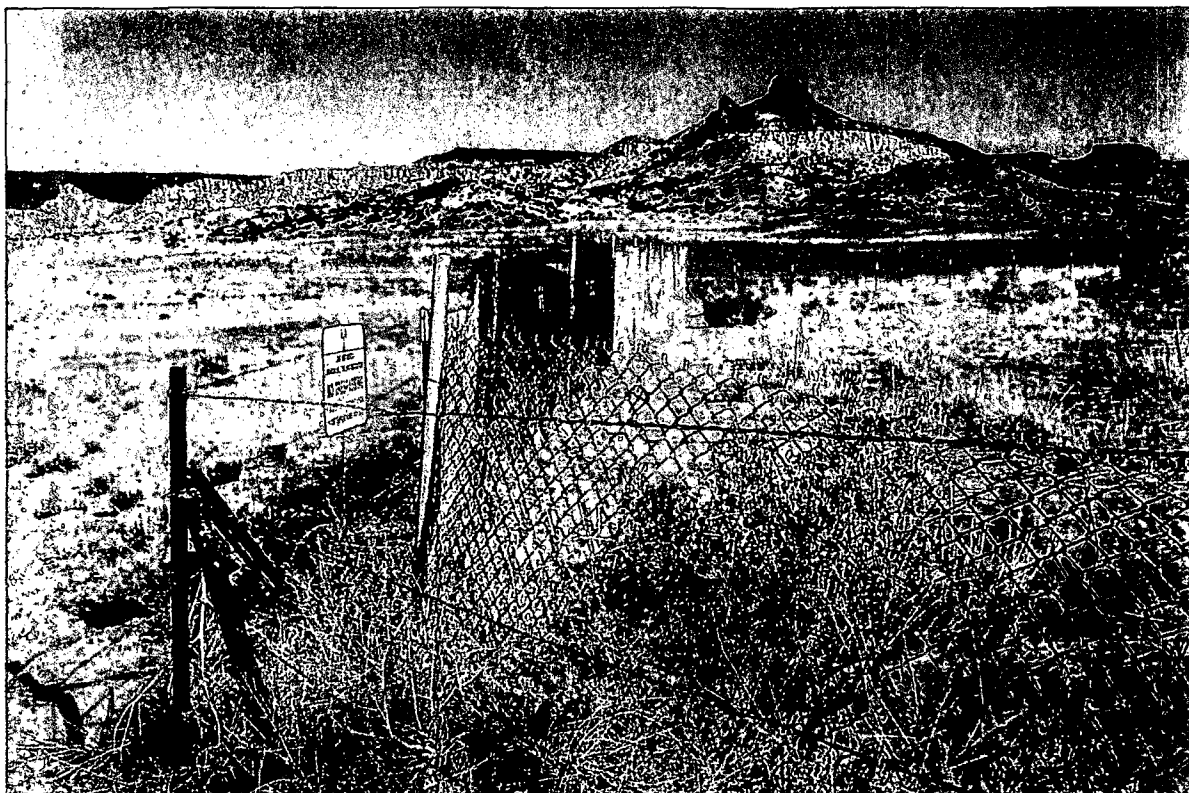
BAR 8/2007. PL-3. Chain-link fence left in place for erosion control upslope of the G3 Channel.

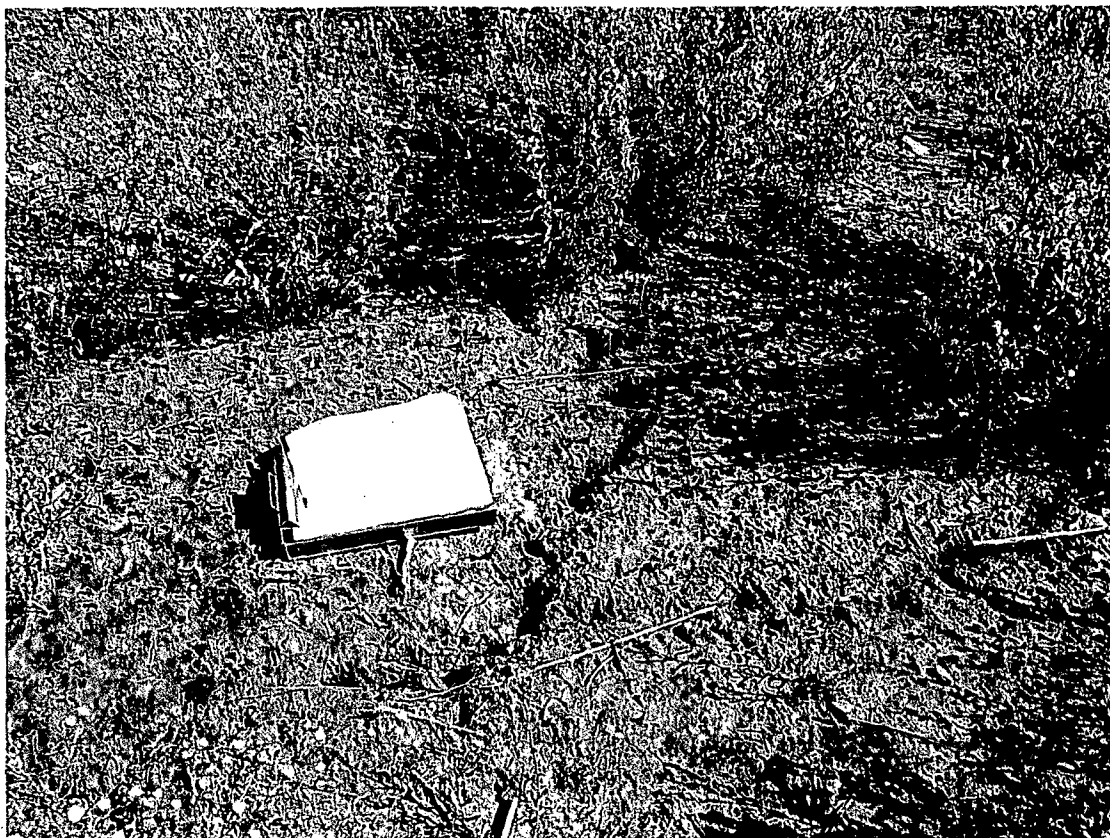
BAR 8/2007. PL-5. Cracks in the tailings impoundment cover soil near erosion monitoring point C2.

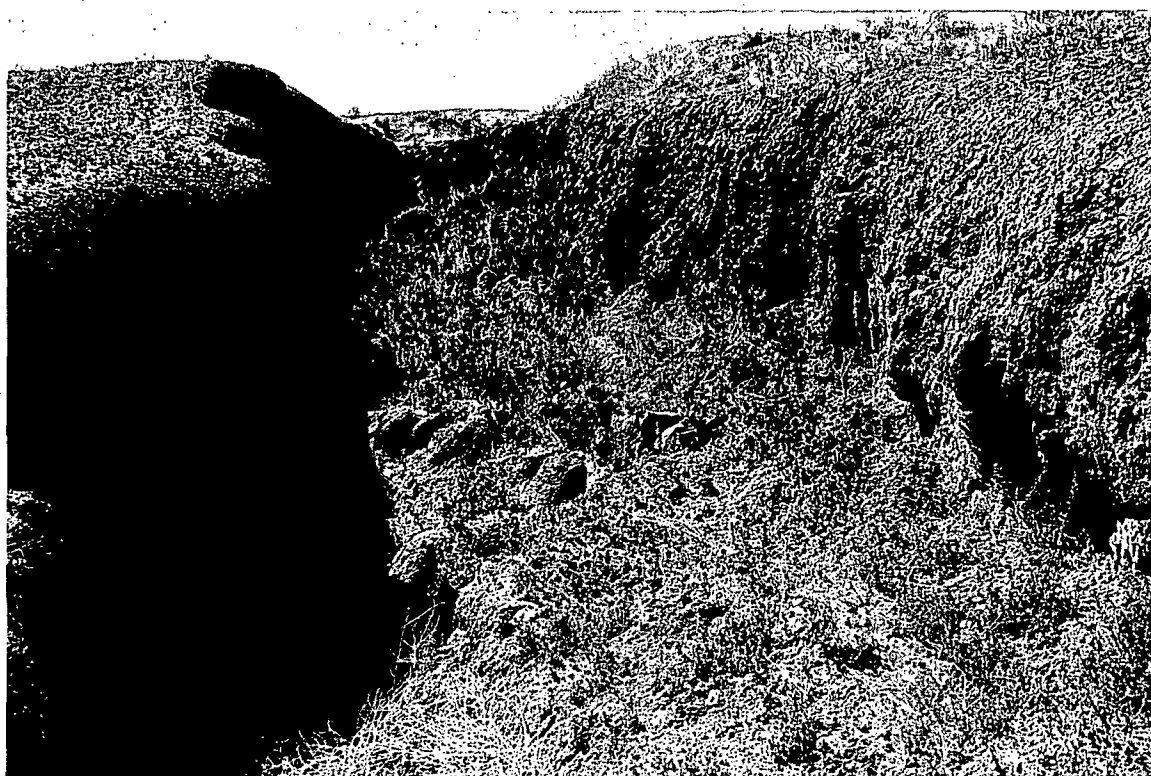
BAR 8/2007. PL-6. Gully upgradient of the sediment trap.

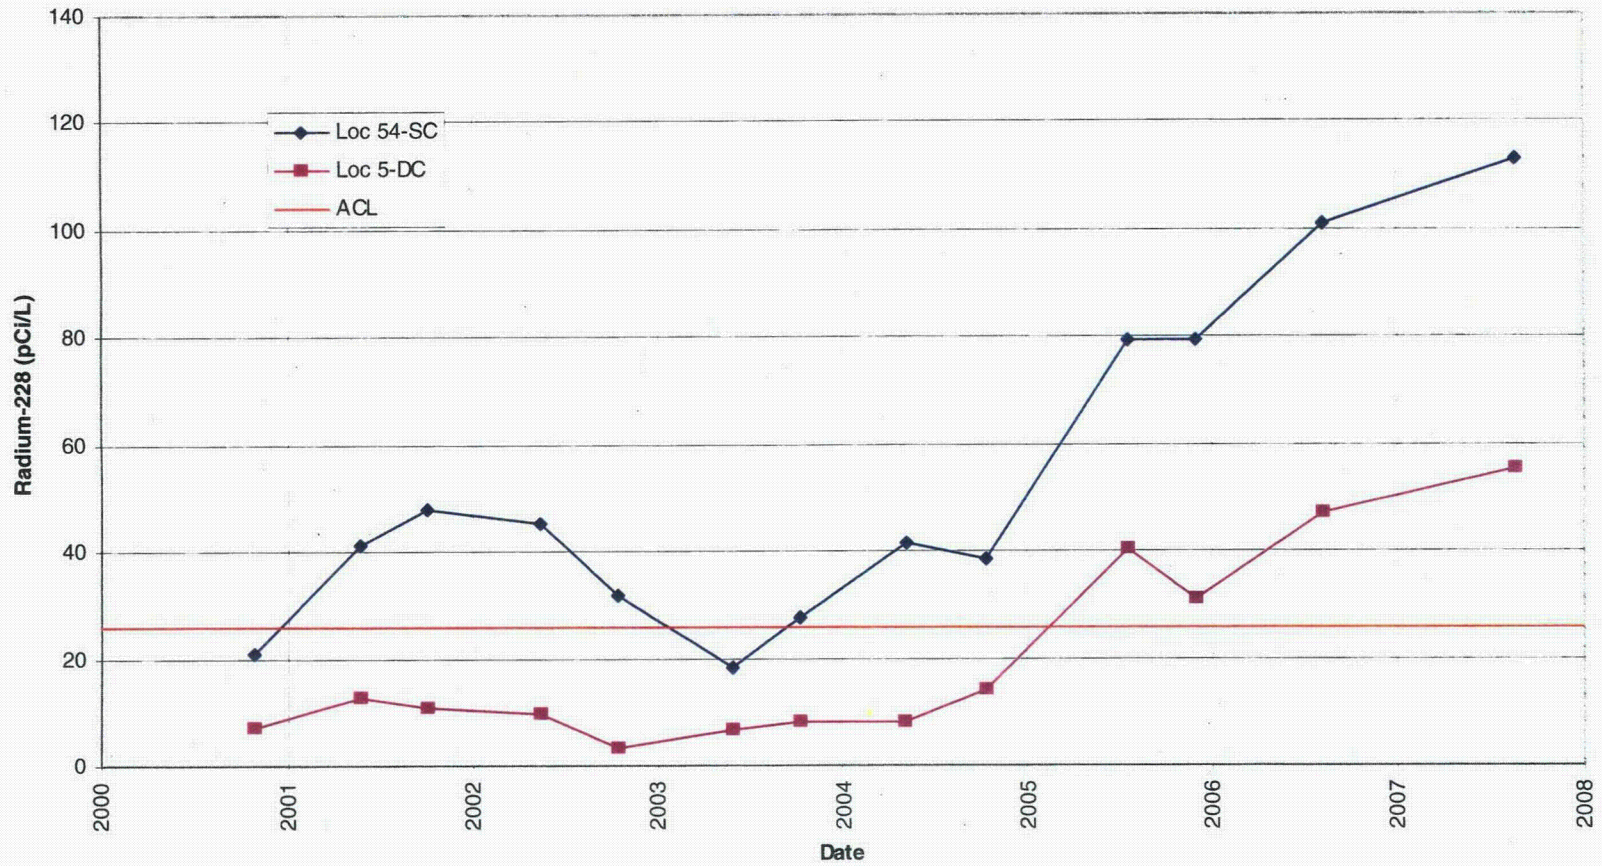
Figure 5-3. Radium-228 Concentrations in Wells MW-5-DC and MW-54-SC Since Completion of the Disposal Cell

The cause for the upward trend for radium-228 has not been determined. An upward trend has occurred for nickel in MW-54-SC since 1996, and TDS has increased in both MW-5-DC and MW-54-SC since measurements were initiated in 2004. However, the concentrations for the other constituents in these wells are remaining steady or are decreasing.
