Re: Turkey Point Unit 3  
Docket No. 50-250  
Inservice Inspection Report

TURKEY POINT PLANT  
UNIT 3

2007 REFUELING OUTAGE INSERVICE INSPECTION REPORT

35<sup>th</sup> Year Tendon Surveillance At Turkey Point

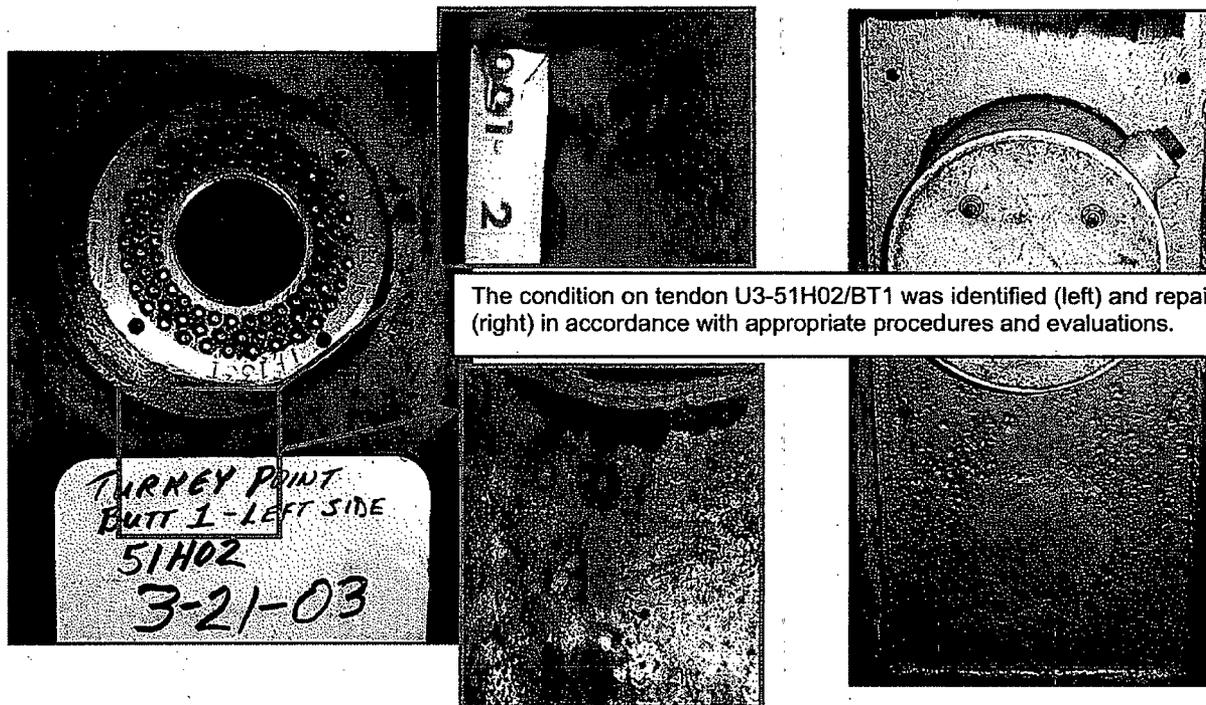
on all inspected tendons ends except two. No evidence of cracking was observed on any of the anchorage components.

4.3.2.2 The bearing plates on U3-51H02/BT1 and U4-51H01/BT5 were detected with Level 5 corrosion. The revealed corrosion is outside of the gasket seating area. These two tendons ends were evaluated deemed acceptable per CR2007-7394 and CR2007-6494, respectively. All of the Condition Reports are included in Appendix D of this report.

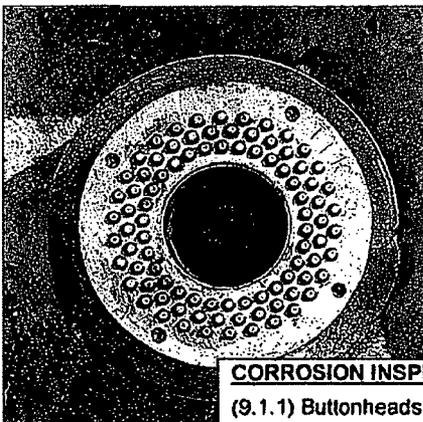
Inspection Results and picture of corrosion inspection on U3-12V22/Dome

CORROSION INSPECTION			
(9.1.1) Buttonheads	Level: <b>A</b> <sup>(1)</sup>		
(9.1.1) Anchorhead	Level: <b>1</b> <sup>(2)</sup>	(10.1 & 10.2) Cracks	<input type="checkbox"/> Yes <sup>(3)</sup> <input checked="" type="checkbox"/> No <input type="checkbox"/> N/A
(9.1.1) Shims	Level: <b>1</b> <sup>(2)</sup>	(10.1 & 10.2) Cracks	<input type="checkbox"/> Yes <sup>(3)</sup> <input checked="" type="checkbox"/> No <input type="checkbox"/> N/A
(9.1.1) Bearing Plate	Level: <b>2</b> <sup>(2)</sup>	(10.1 & 10.2) Cracks	<input type="checkbox"/> Yes <sup>(3)</sup> <input checked="" type="checkbox"/> No <input type="checkbox"/> N/A

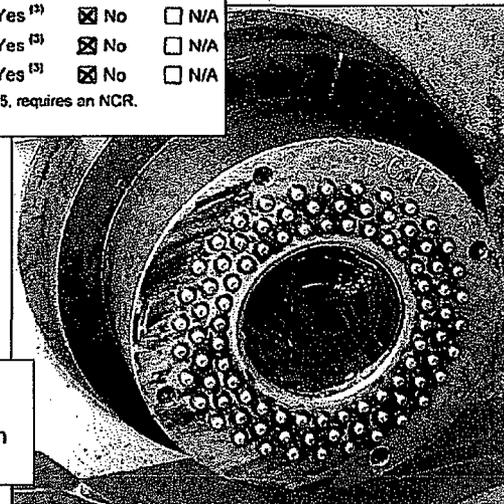
Inspection Results and picture of corrosion inspection on U3-3D51/BT.1

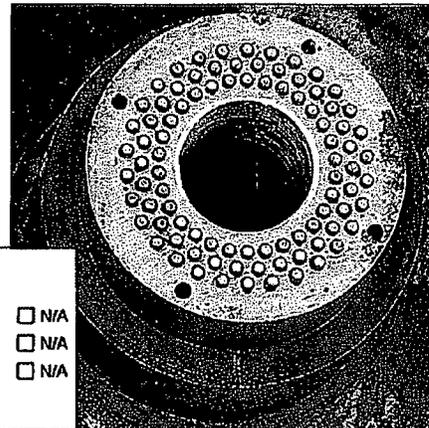
CORROSION INSPECTION		Inspection Results and picture of corrosion inspection on U4-45V23/DOME		
(9.1.1) Buttonheads	Level: 5 <sup>(1)</sup>			<input type="checkbox"/> N/A
(9.1.1) Anchorhead	Level: 2 <sup>(2)</sup>	(10.1 &		<input type="checkbox"/> N/A
(9.1.1) Shims	Level: 3 <sup>(2)</sup>	(10.1 & 10.2) Cracks	<input type="checkbox"/> Yes <sup>(3)</sup> <input checked="" type="checkbox"/> No	<input type="checkbox"/> N/A
(9.1.1) Bearing Plate	Level: 3 <sup>(2)</sup>	(10.1 & 10.2) Cracks	<input type="checkbox"/> Yes <sup>(3)</sup> <input checked="" type="checkbox"/> No	<input type="checkbox"/> N/A

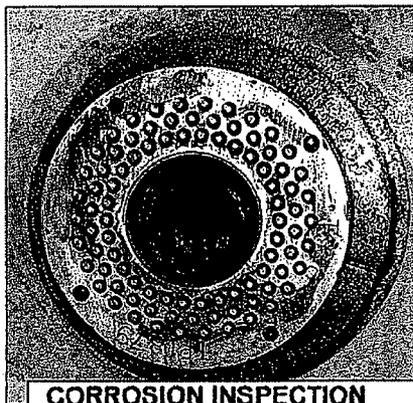
Inspection Results and picture of corrosion inspection on U4-2D34/BT.2

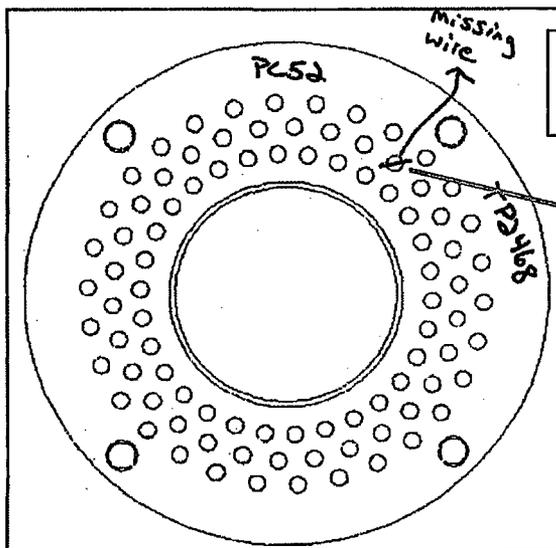
Inspection Results and picture of Buttonhead Count on U4-56V10/GALLERY

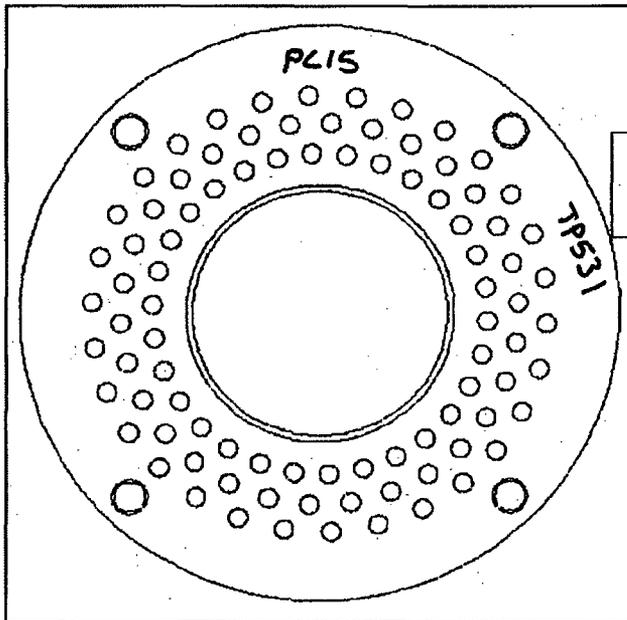
Inspection Results and picture of Buttonhead Count on U4-2D08/BT.6
