INSPECTION RECORD

Region III **Inspection Report No.** 030-35293/2008-001(DNMS)
License No. 24-32231-01 **Docket No.** 030-35293
NMED No. 080006

Licensee (Name and Address):
Jacobi Geotechnical Engineering, Inc.
798 Hoff Road
O'Fallon, Missouri 63366

This was a special inspection to review the circumstances surrounding a moisture/density gauge being damaged by a large construction vehicle. No change in the next inspection date is warranted.

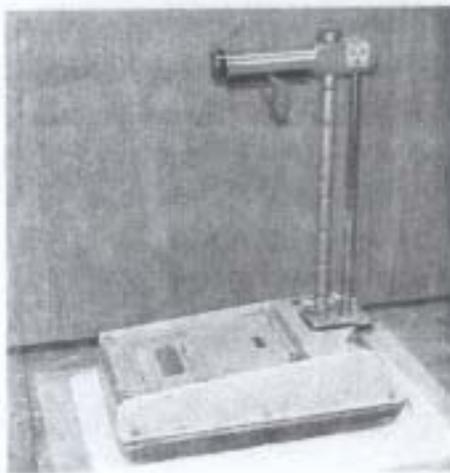
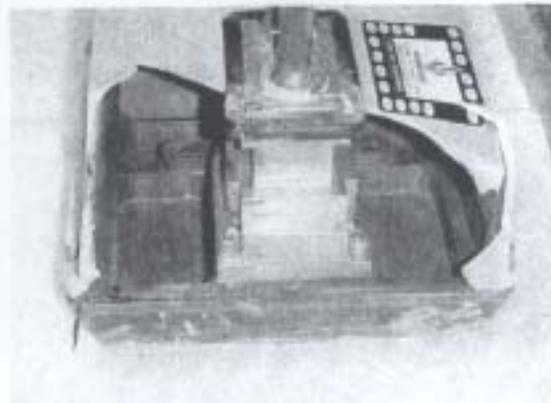
The Humboldt moisture/density gauge was examined in detail. The end of the base housing was damaged and a section of the plastic housing was broken as shown in the photos below:

The metal rods and the interior metal housing containing the sources were all visibly intact and handheld survey meters did not indicate any contamination. Two wipes were taken of the interior of the device and one wipe was taken of the exterior. One wipe was also taken of the truck used to transport the broken device in its case.

As shown in the attached Soil Analysis Report there was no indication of contamination in the soil samples and The Wipe Test Report indicates no indication of leakage of the source or contamination of the truck.

The incident was reported to the NRC(incident number: 43868) and the device was shipped to Humboldt on December 28th 2007.
