SUBJECT:
Beaver Valley Power Station, Unit No. 1
Docket No. 50-334, License No. DPR-66
LER 2007-002-00

Enclosed is Licensee Event Report (LER) 2007-002, "Undetected Loss of 138 kV 'A' Phase to System Station Service Transformer Leads to Condition Prohibited by Plant Technical Specification."

4. TITLE
Undetected Loss of 138 kV 'A' Phase to System Station Service Transformer Leads to Condition Prohibited by Plant Technical Specification

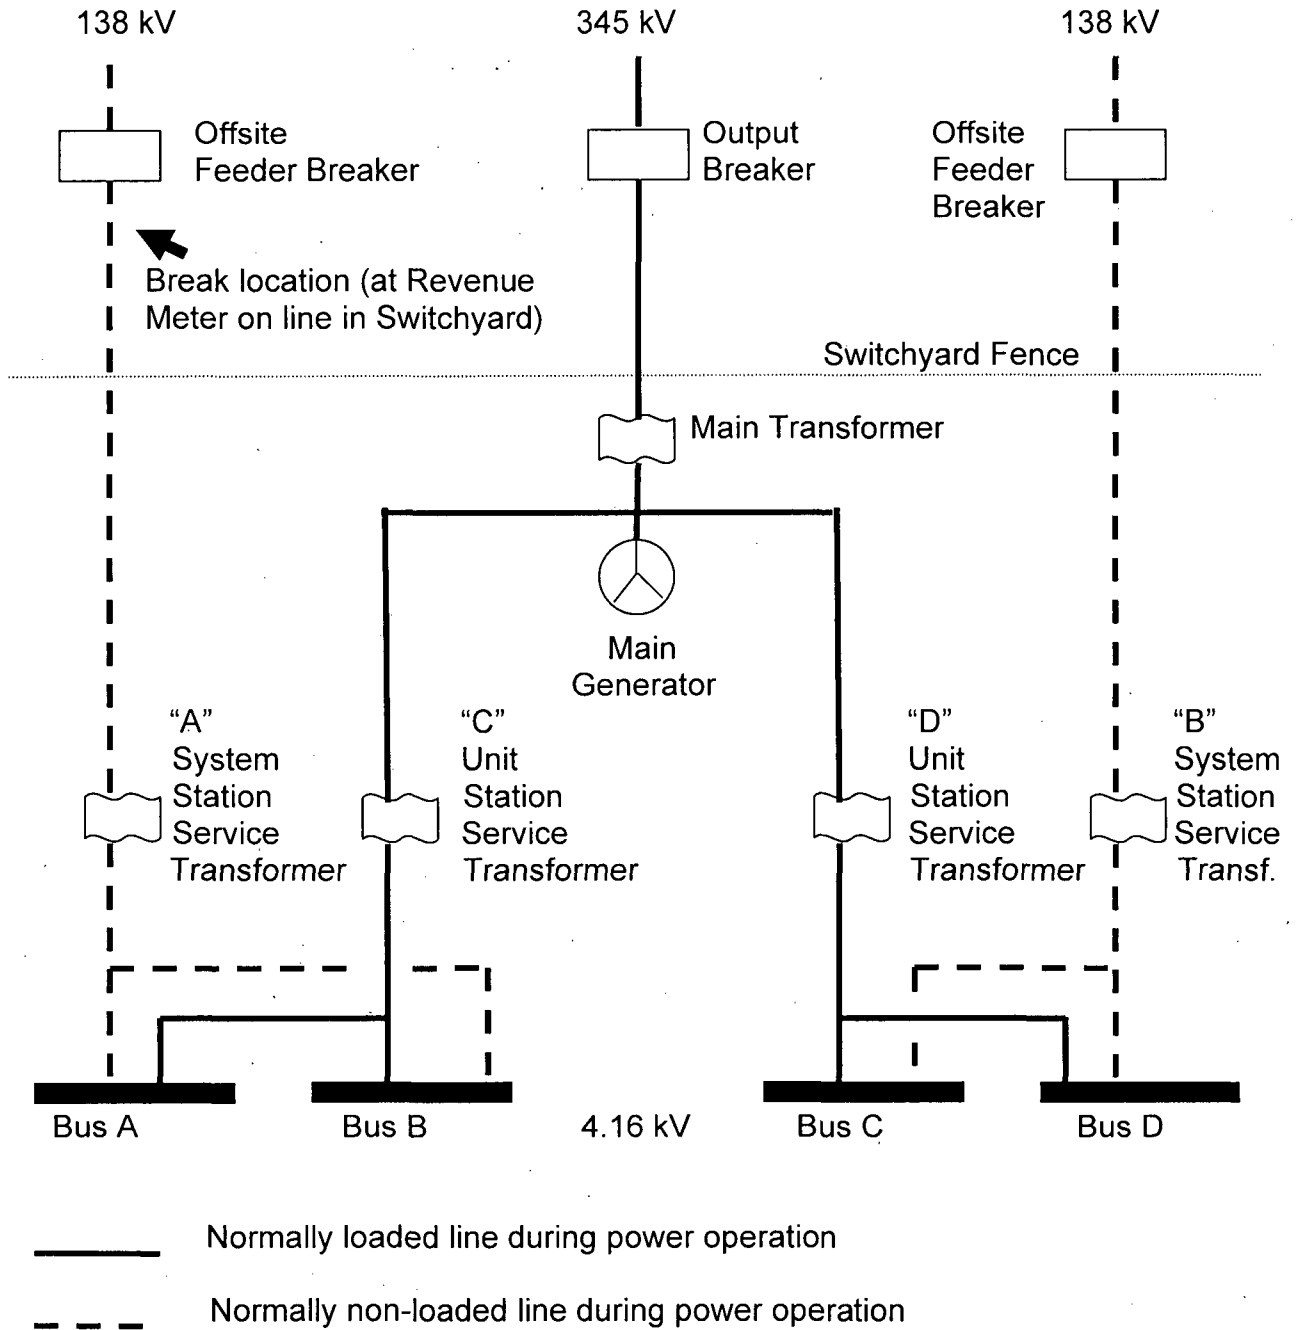
Simplified Unit Electrical Distribution Drawing

During a non-routine walkdown of the offsite switchyard on 11/27/2007, a site construction supervisor discovered that the 'A' phase conductor on a Beaver Valley Power Station Unit No. 1 (BVPS-1) three-phase 138 kV power line had broken off in the switchyard. This break occurred between the offsite feeder breaker (OCB-92-FDS) and the line running onsite to the 'A' train System Station Service Transformer (SSST) located inside the site security fence. The switchyard walkdown was being performed to investigate line voltage differences. The terminal broke on the switchyard side of a Revenue Metering Current Transformer/Voltage Transformer (CTVT), which was installed in 2006 to track the station's power usage through this line. During normal station power operation, there is no appreciable current going through this 138 kV line as the station busses (loads) are normally powered from the unit generator. [See simplified power sketch on page 7.]
