UNITED STATES  
NUCLEAR REGULATORY COMMISSION  
OFFICE OF INSPECTION AND ENFORCEMENT  
WASHINGTON, D.C. 20555

IE Bulletin No. 79-09

FAILURES OF GE TYPE AK-2 CIRCUIT BREAKER IN SAFETY RELATED SYSTEMS

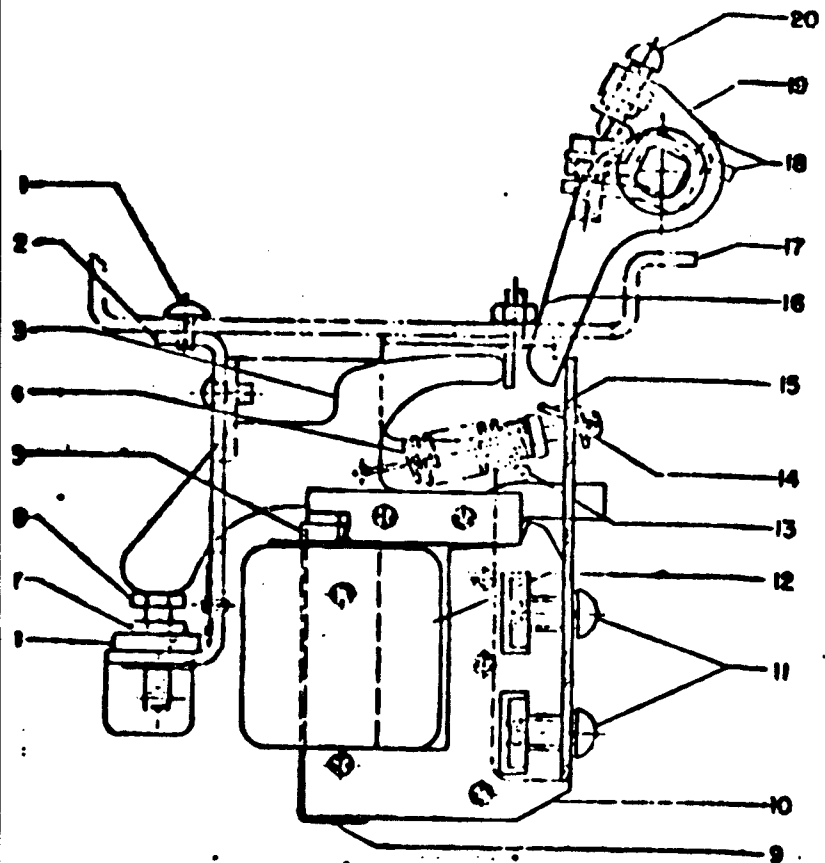
AK-2-15 and AK-2/3-25 Undervoltage Tripping Device

The causes for failure were attributed to either binding within the linkage mechanism of the undervoltage (UV) trip device and trip shaft assembly or out-of-adjustment conditions in the same linkage mechanism. Babcock and Wilcox (B&W) and GE determined that the binding and out-of-adjustment resulted from inadequate preventive maintenance programs

1. Check the undervoltage trip device to assure there is not excessive clearance between the armature and the rivet and that there are no binds as the armature moves through its travel when manually operated. If excessive clearance or binding exists, it should be adjusted by loosening screws (11) and moving the magnet (10) up or down as necessary to obtain the proper freedom of the armature (3) with respect to its pivot on magnet (10) and the guide provided by rivet (13).

To adjust the pick-up of the instantaneous undervoltage trip device, remove the Locking Wire (15) and turn the adjusting screw (14) clockwise to raise the pick-up to the desired setting. A suitable voltmeter and adjustable voltage source should be connected to the undervoltage device coil leads at the terminal board for stationary breakers or the secondary disconnects for drawout type breakers. On AC devices, the pick-up voltage should be read immediately before the armature closes its air gap. After the pick-up is adjusted, locking wire (15) should be installed.

5. The adjustment between the undervoltage trip device and the trip paddle on the trip shaft should be checked to assure the required positive trip is maintained (positive trip exists when approximately 1/32 inch additional travel of the armature occurs after the undervoltage device trips the breaker). This adjustment is made with adjusting screw (20).
