UNITED STATES
NUCLEAR REGULATORY COMMISSION
OFFICE OF INSPECTION AND ENFORCEMENT
WASHINGTON, D.C. 20555

June 25, 1979

IE Bulletin No. 79-13

CRACKING IN FEEDWATER SYSTEM PIPING

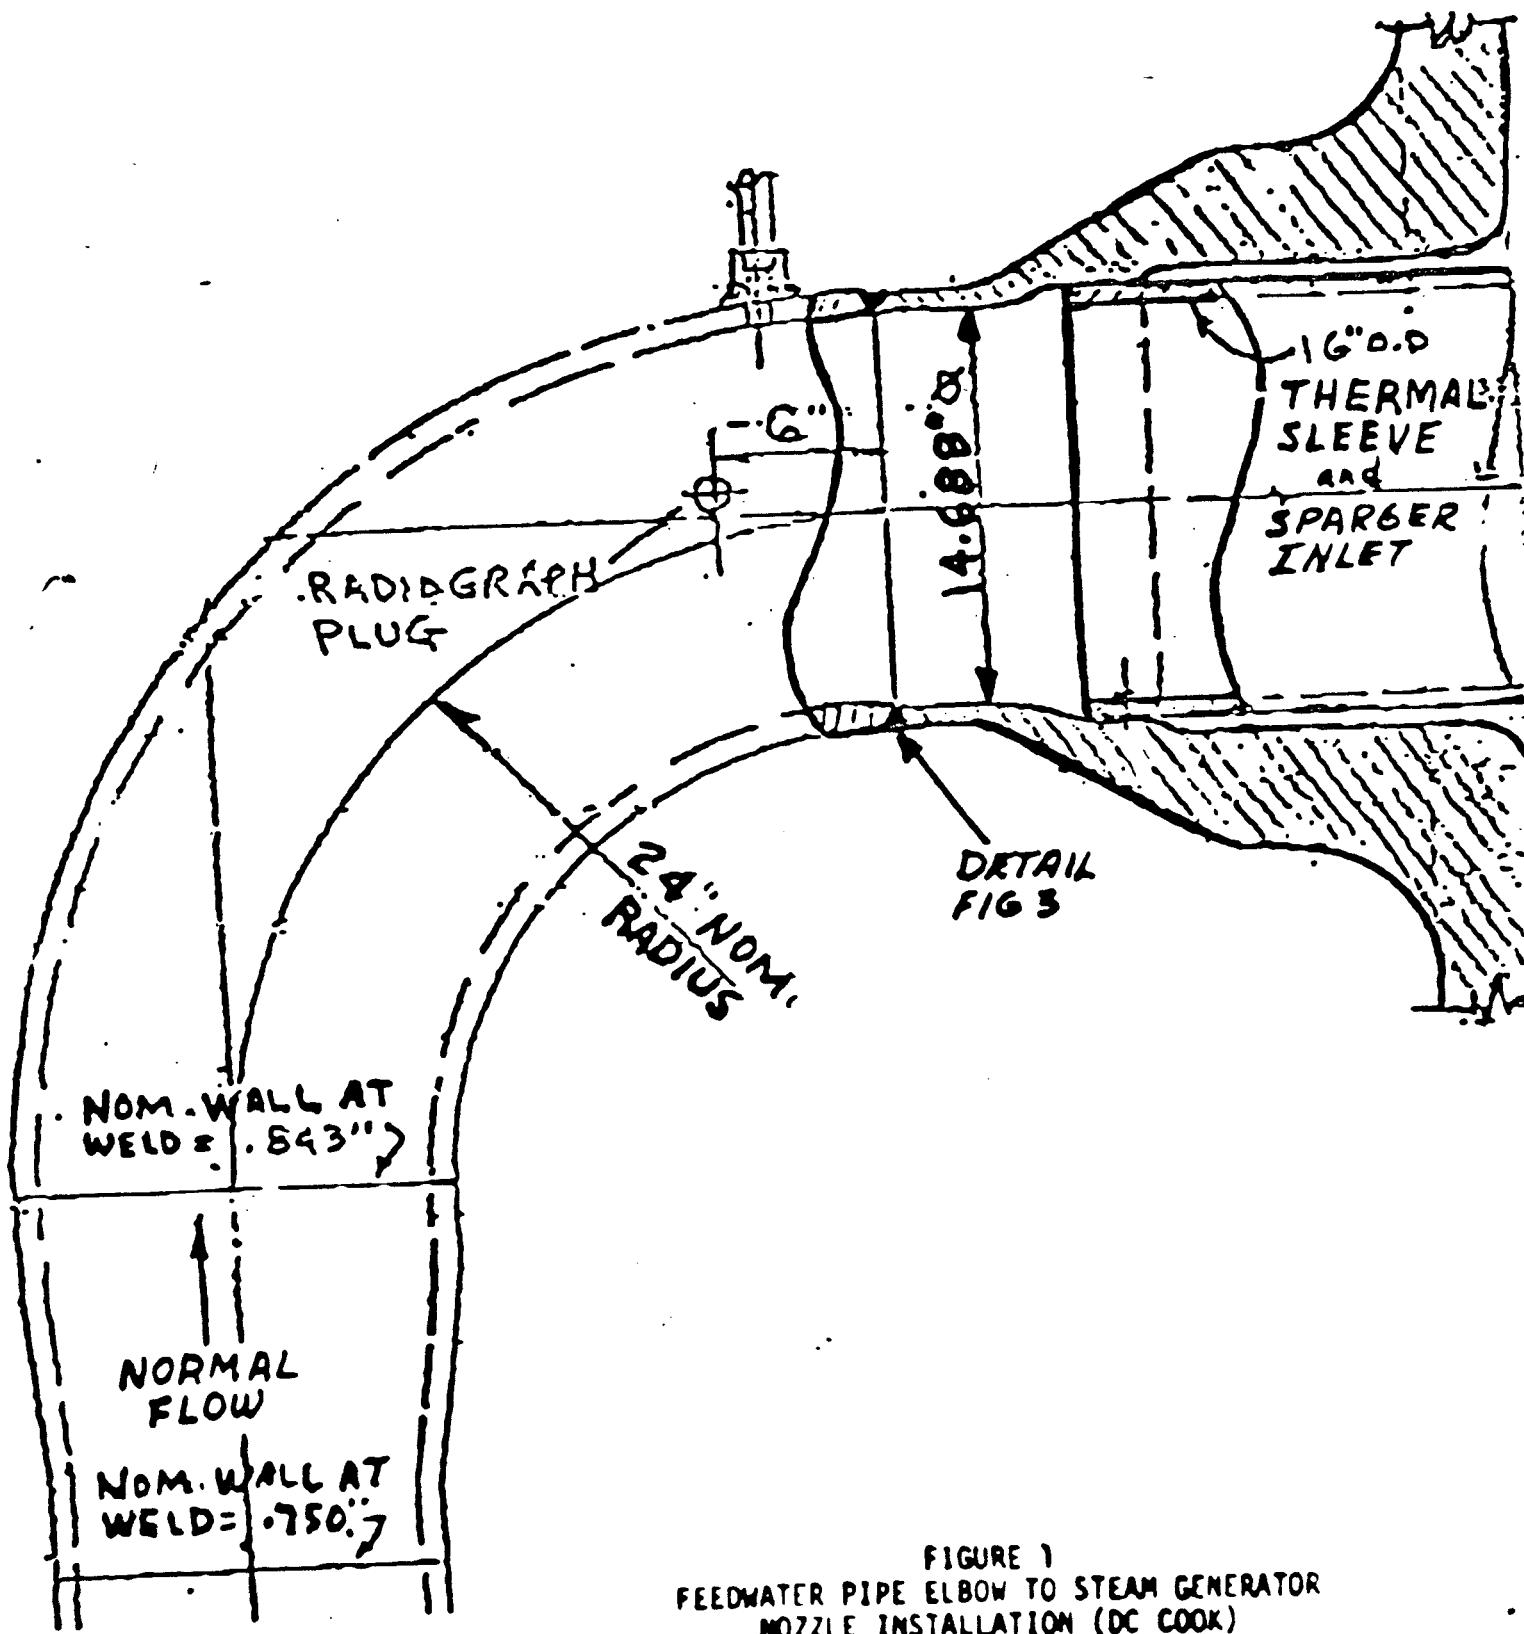
FIGURE 1
 FEEDWATER PIPE ELBOW TO STEAM GENERATOR
 NOZZLE INSTALLATION (DC COOK)

On May 20, 1979, Indiana and Michigan Power Company notified the NRC of cracking in two feedwater lines at their D. C. Cook Unit 2 facility. The cracking was discovered following a shutdown on May 19 to investigate leakage inside containment. Leaking circumferential cracks were identified in the 16-inch feedwater elbows adjacent to two steam generator nozzle elbow welds. Subsequent radiographic examination revealed crack indications in all eight steam generator feedwater lines at this location on both Units 1 and 2.

The feedwater nozzle-to-pipe configurations for D.C. Cook and for San Onofre are shown on the attached figures 1 and 2. A typical feedwater pipe-to-nozzle joint detail showing the principal crack locations for D.C. Cook and San Onofre are shown on the attached figure 3.

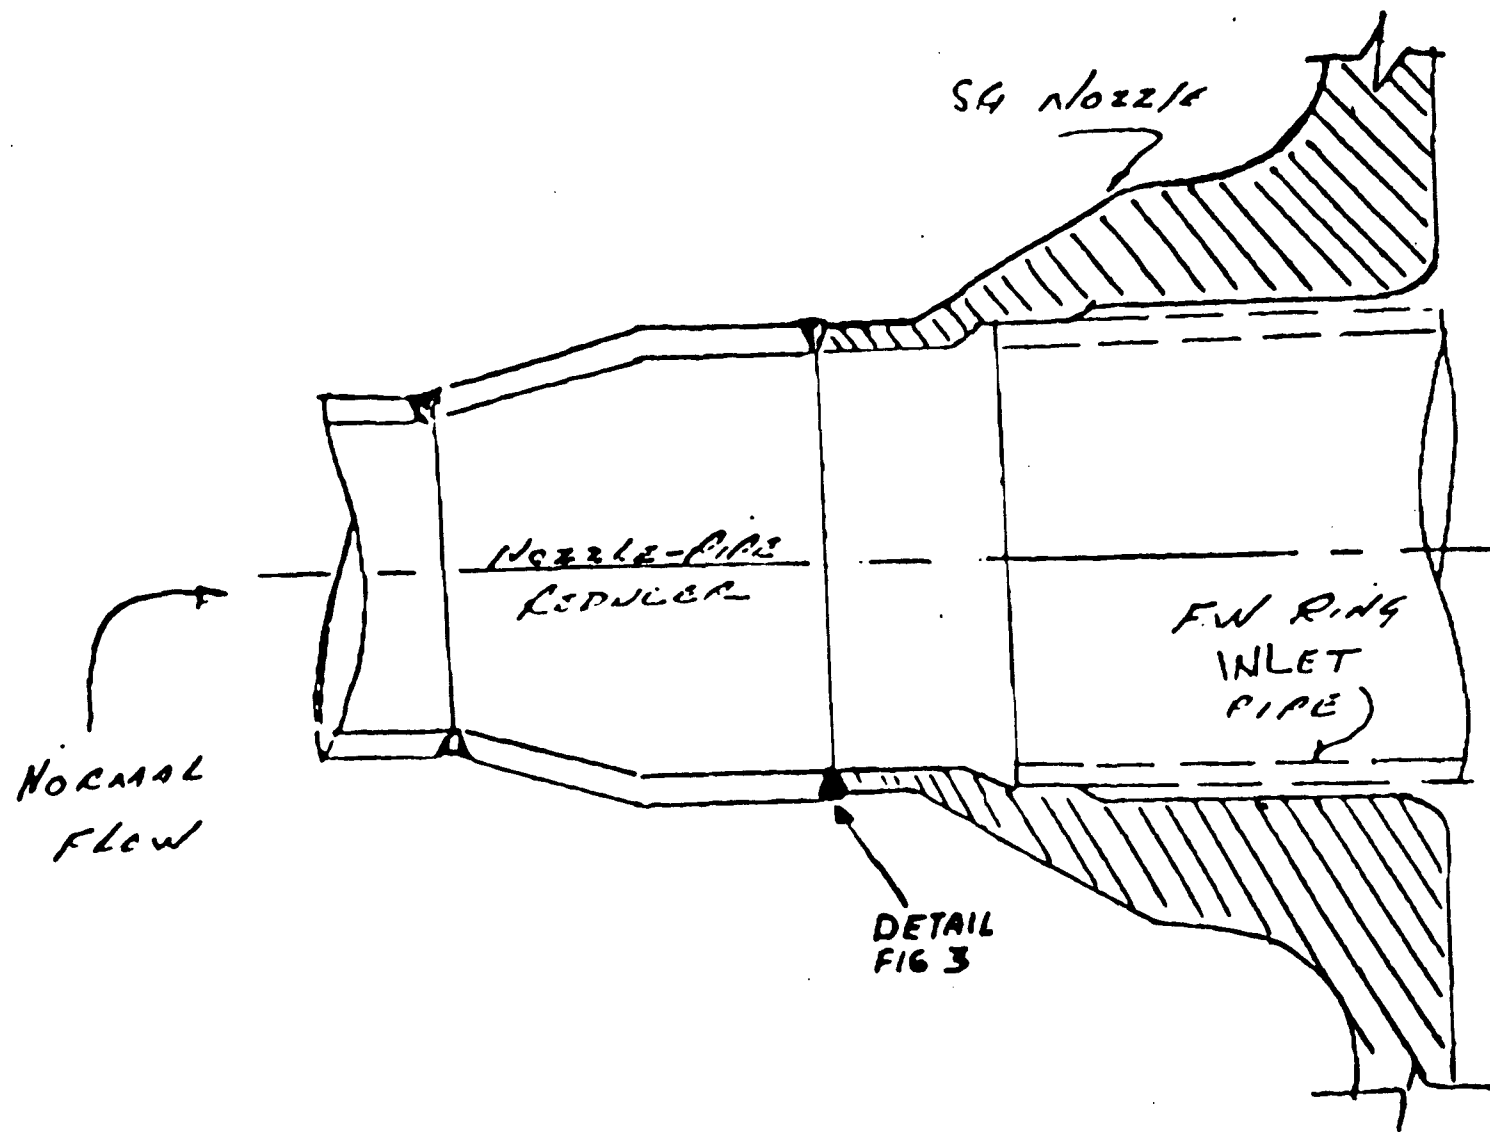
FIGURE 2
FEEDWATER PIPE REDUCER TO STEAM GENERATOR
NOZZLE INSTALLATION (SAN ONOFRE)

As a result of these actions, several other licensees with Westinghouse steam generators reported crack indications. Southern California Edison reported on June 5, 1979, that radiographic examination revealed indications of cracking in feedwater nozzle-to-piping welds on two of three steam generators of San Onofre Unit 1. On June 15, 1979, Carolina Power and Light reported that radiography showed crack indications in similar locations at their H. B. Robinson Unit 2. Duquesne Power and Light confirmed on June 18, 1979, that radiography has shown cracking in their Beaver Valley Unit 1 feedwater piping to vessel nozzle weld. Public Service Electric and Gas Company reported on June 20, 1979 that Salem Unit 1 also has crack indications. Wisconsin Public Service company decided on June 20, 1979 to cut out a feedwater nozzle-to-pipe weld which contained questionable indication, for metallurgical examination. As of June 22, 1979 and since May 25, 1979 seven other PWR facilities have inspected the feedwater nozzle-to-pipe welds without finding cracking indications.

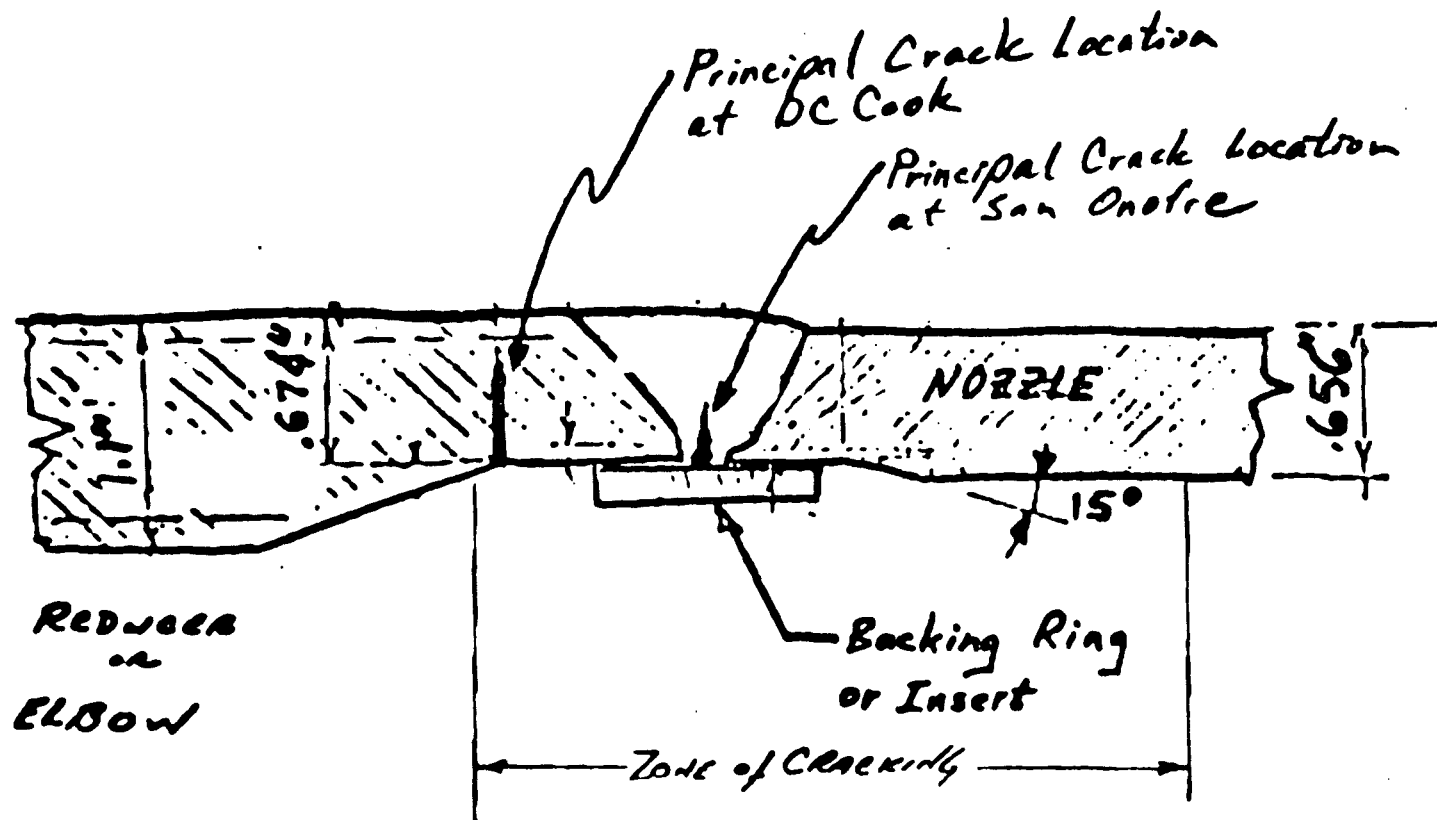
FIGURE 3
 TYPICAL FEEDWATER PIPE TO NOZZLE
 WELD JOINT DETAIL
 (W . CE)

Cracked weldments have been removed from the D. C. Cook Units 1 and 2 and San Onofre Unit 1 feedwater systems for extensive metallurgical investigation by Westinghouse. Based on preliminary analysis, Westinghouse stated the D. C. Cook failure may be "fatigue assisted by corrosion." The San Onofre cracking was stated to be characteristic of "stress assisted corrosion."
