UNITED STATES  
NUCLEAR REGULATORY COMMISSION  
OFFICE OF INSPECTION AND ENFORCEMENT  
WASHINGTON, D.C. 20555

IE Bulletin No. 79-13  
Revision 1

CRACKING IN FEEDWATER SYSTEM PIPING

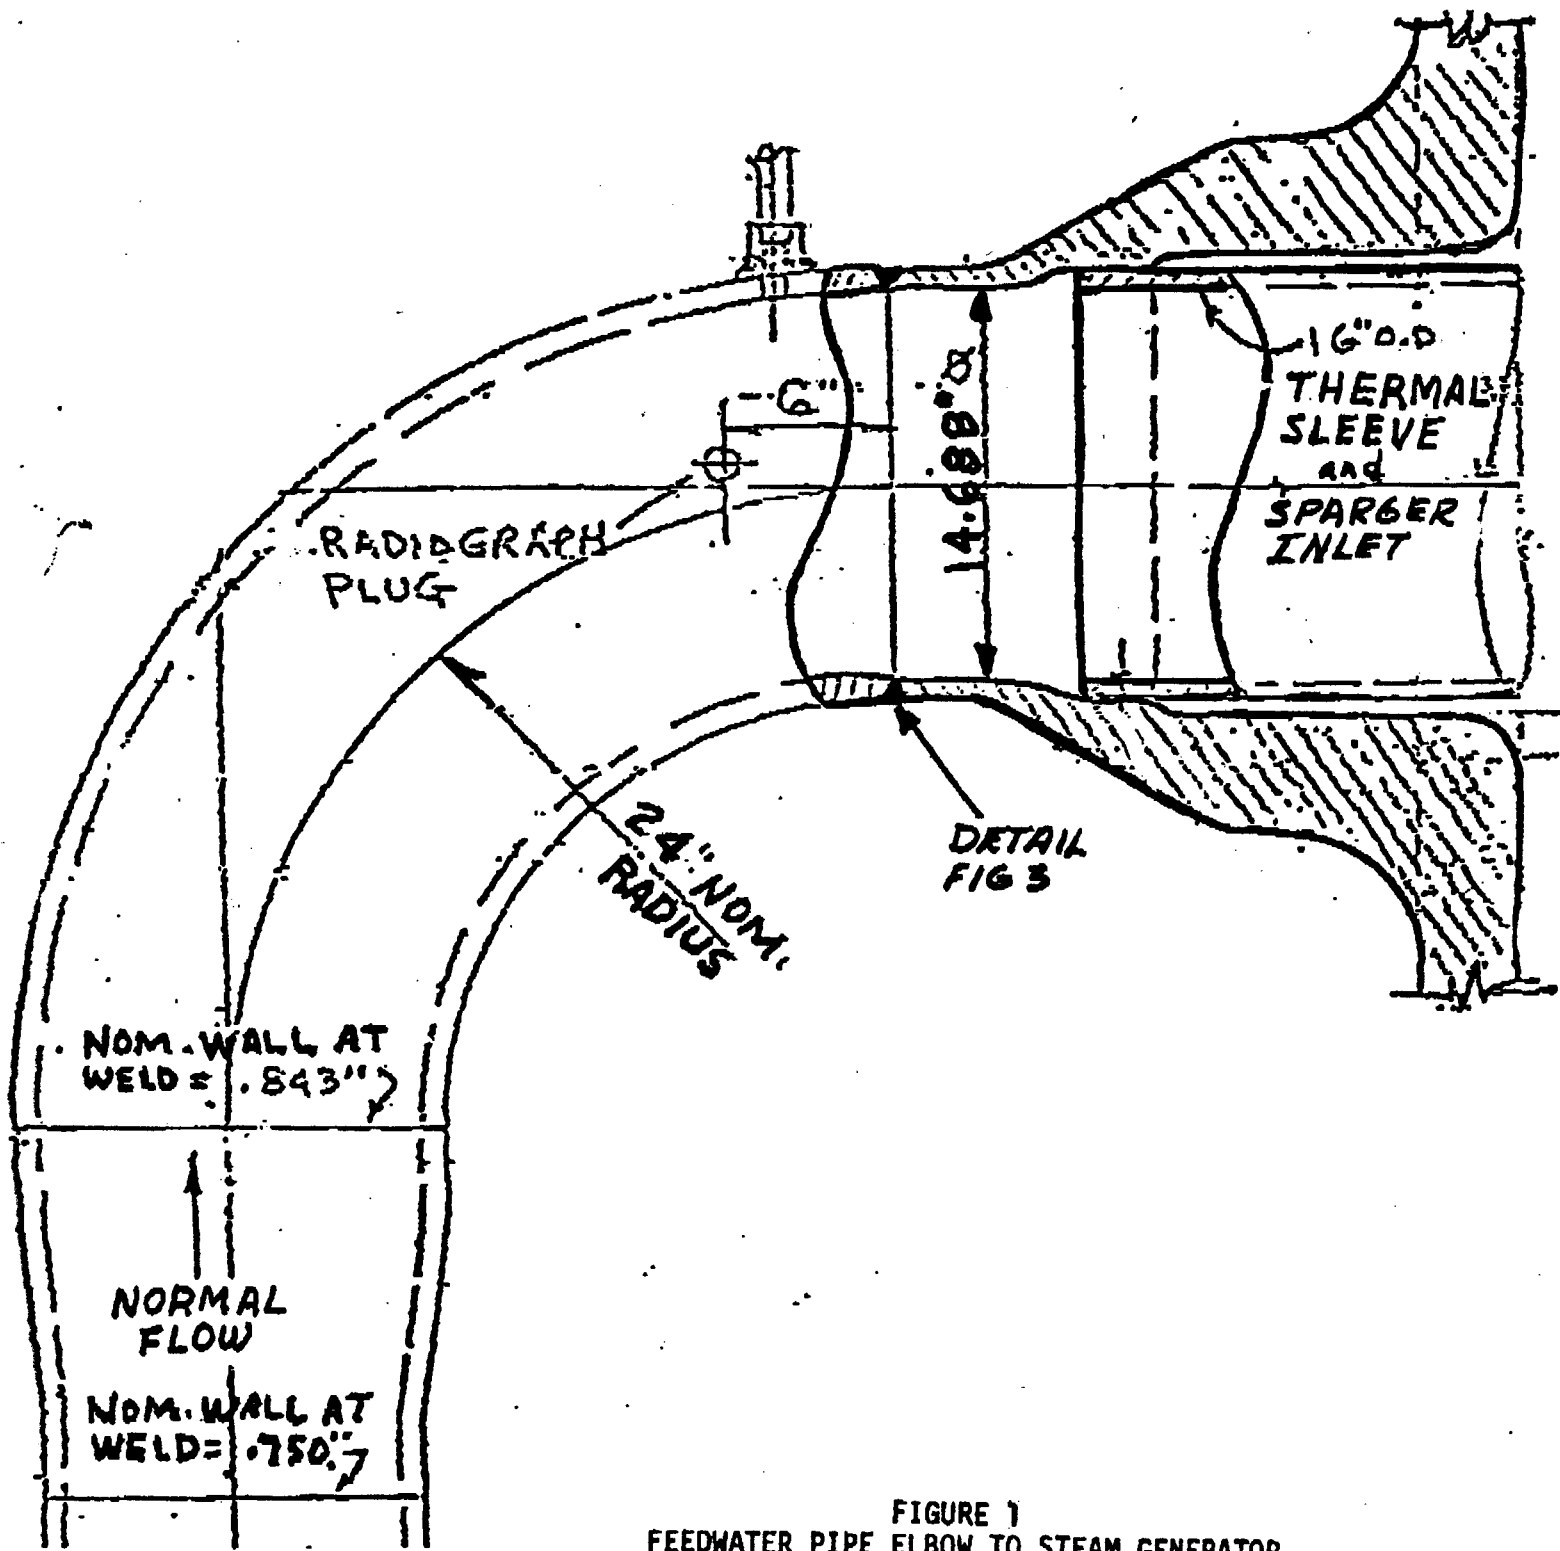
FIGURE 1  
 FEEDWATER PIPE ELBOW TO STEAM GENERATOR  
 NOZZLE INSTALLATION (DC COOK)

On May 20, 1979, Indiana and Michigan Power Company notified the NRC of cracking in two feedwater lines at their D. C. Cook Unit 2 facility. The cracking was discovered following a shutdown on May 19 to investigate leakage inside containment. Leaking circumferential cracks were identified in the 16-inch feedwater elbows adjacent to two steam generator nozzle elbow welds. Subsequent radiographic examination revealed crack indications in all eight steam generator feedwater lines at this location on both Units 1 and 2.

Cracked weldments have been removed from the D. C. Cook Units 1 and 2 and San Onofre Unit 1 feedwater systems for extensive metallurgical investigation by Westinghouse. Based on preliminary analysis, Westinghouse stated the D. C. Cook failure may be "fatigue assisted by corrosion." The San Onofre cracking was stated to be characteristic of "stress assisted corrosion."

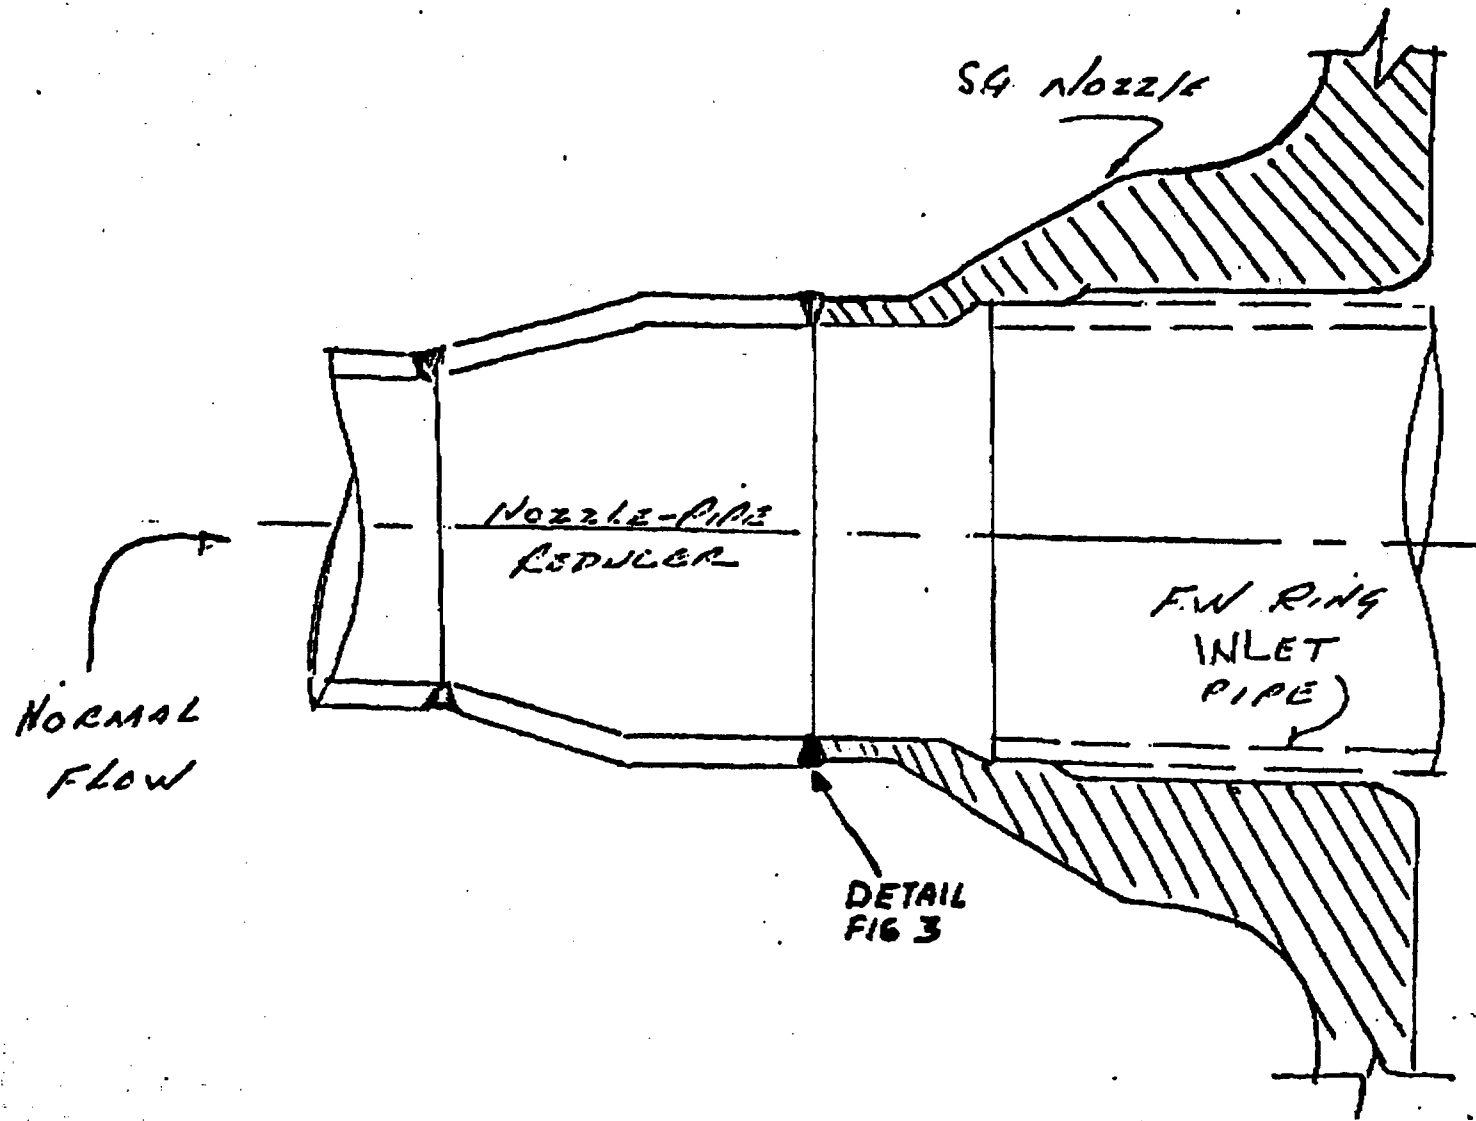
FIGURE 2  
FEEDWATER PIPE REDUCER TO STEAM GENERATOR  
NOZZLE INSTALLATION (SAN ONOFRE)

As a result of these actions, several other licensees with Westinghouse steam generators reported crack indications. Southern California Edison reported on June 5, 1979, that radiographic examination revealed indications of cracking in feedwater nozzle-to-piping welds on two of three steam generators of San Onofre Unit 1. On June 15, 1979, Carolina Power and Light reported that radiography showed crack indications in similar locations at their H. B. Robinson Unit 2. Duquesne Power and Light confirmed on June 18, 1979, that radiography has shown cracking in their Beaver Valley Unit 1 feedwater piping to vessel nozzle weld. Public Service Electric and Gas Company reported on June 20, 1979 that Salem Unit 1 also has crack indications. Wisconsin Public Service company decided on June 20, 1979 to cut out a feedwater nozzle-to-pipe weld which contained questionable indication, for metallurgical examination. As of June 22, 1979 and since May 25, 1979 seven other PWR facilities have inspected the feedwater nozzle-to-pipe welds without finding cracking indications.

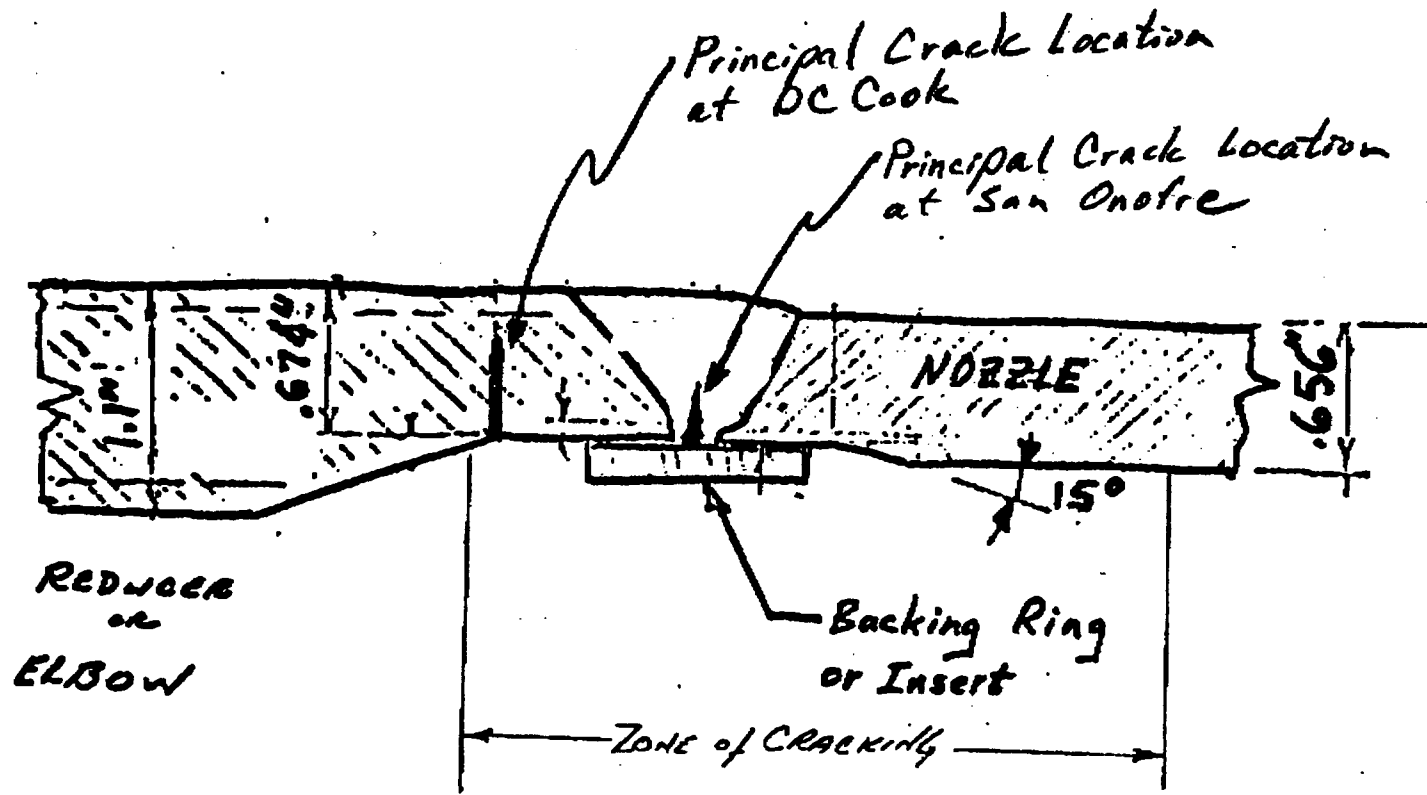
FIGURE 3  
 TYPICAL FEEDWATER PIPE TO NOZZLE  
 WELD JOINT DETAIL  
 ( W , CE )

The feedwater nozzle-to-pipe configurations for D.C. Cook and for San Onofre are shown on the attached figures 1 and 2. A typical feedwater pipe-to-nozzle weld joint detail showing the principal crack locations for D.C. Cook and San Onofre are shown on the attached figure 3.

1. Facilities which have steam generators fabricated by Westinghouse or Combustion Engineering that have not conducted volumetric examination of feedwater nozzles since May 1979 shall complete the inspection program described below at the earliest practical time but no later than 90 days after the date of this Bulletin.
  - a. Perform radiographic examination, supplemented by ultrasonic examination as necessary to evaluate indications, of all feedwater nozzle-to-piping welds and of adjacent pipe and nozzle areas (a distance equal to at least two wall thicknesses). Evaluation shall be in accordance with ASME Section III, Subsection NC, Article NC-5000. Radiography shall be performed to the 2T penetrometer sensitivity level, in lieu of Table NC-5111-1, with systems void of water.

- b. If cracking is identified during examination of the nozzle-to-piping weld, all feedwater line welds up to the first piping support or snubber and high stress points in containment shall be volumetrically examined in accordance with 1.a. above. All unacceptable code discontinuities, other than cracking, shall be subject to repair unless justification for continued operation is provided.
