UNITED STATES
NUCLEAR REGULATORY COMMISSION
OFFICE OF INSPECTION AND ENFORCEMENT
WASHINGTON, D.C. 20555

IE Bulletin No. 79-13
Revision 2

CRACKING IN FEEDWATER SYSTEM PIPING

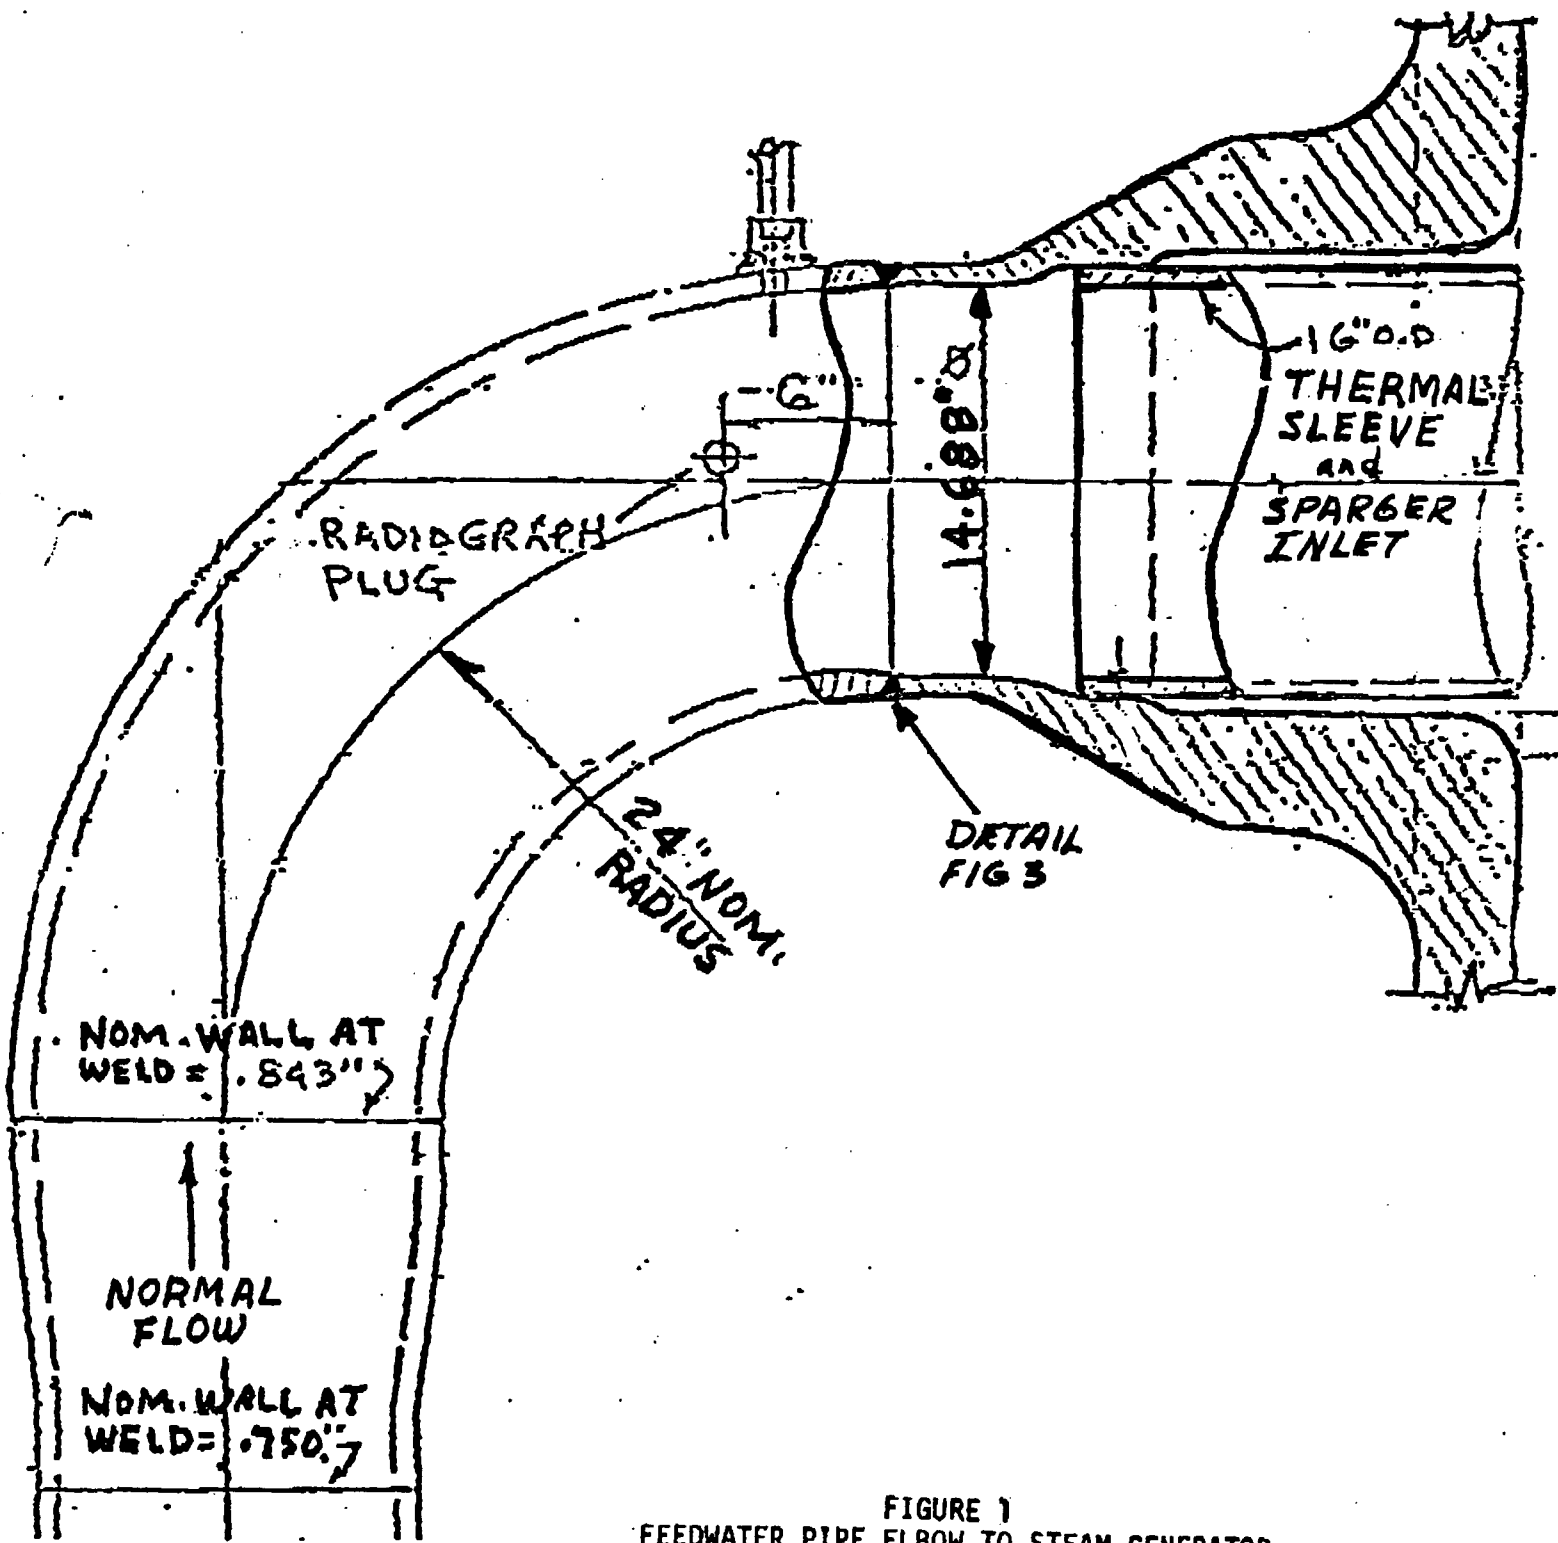
FIGURE 1
 FEEDWATER PIPE ELBOW TO STEAM GENERATOR
 NOZZLE INSTALLATION (DC COOK)

On May 20, 1979, Indiana and Michigan Power Company notified the NRC of cracking in two feedwater lines at their D. C. Cook Unit 2 facility. The cracking was discovered following a shutdown on May 19 to investigate leakage inside containment. Leaking circumferential cracks were identified in the 16-inch feedwater elbows adjacent to two steam generator nozzle elbow welds. Subsequent radiographic examination revealed crack indications in all eight steam generator feedwater lines at this location on both Units 1 and 2.

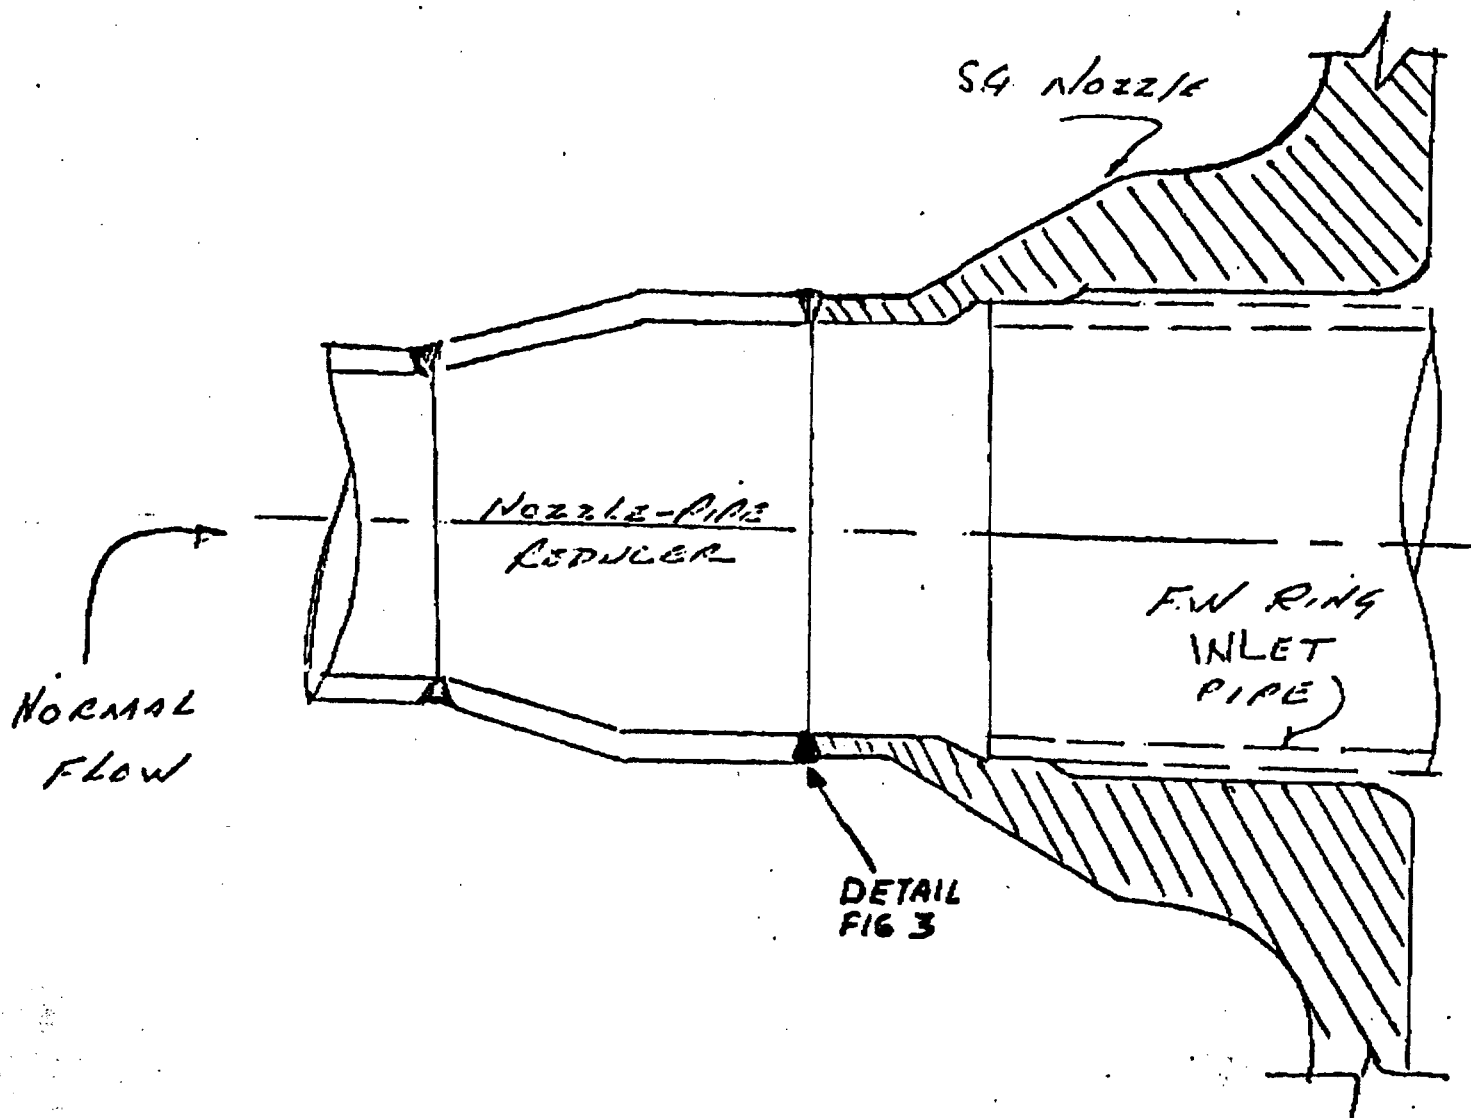
FIGURE 2
FEEDWATER PIPE REDUCER TO STEAM GENERATOR
NOZZLE INSTALLATION (SAN ONOFRE)

As a result of these actions, several other licensees with Westinghouse steam generators reported crack indications. Southern California Edison reported on June 5, 1979, that radiographic examination revealed indications of cracking in feedwater nozzle-to-pipe welds on two of three steam generators of San Onofre Unit 1. On June 15, 1979, Carolina Power and Light reported that radiography showed crack indications in similar locations at their H. B. Robinson Unit 2. Duquesne Power and Light confirmed on June 18, 1979, that radiography has shown cracking in their Beaver Valley Unit 1 feedwater piping-to-vessel nozzle weld. Public Service Electric and Gas Company reported on June 20, 1979 that Salem Unit 1 also has crack indications. Wisconsin Public Service company decided on June 20, 1979 to cut out a feedwater nozzle-to-pipe weld which contained questionable indication, for metallurgical examination. As of June 22, 1979 and since May 25, 1979 seven other PWR facilities have inspected the feedwater nozzle-to-pipe welds without finding cracking indications.

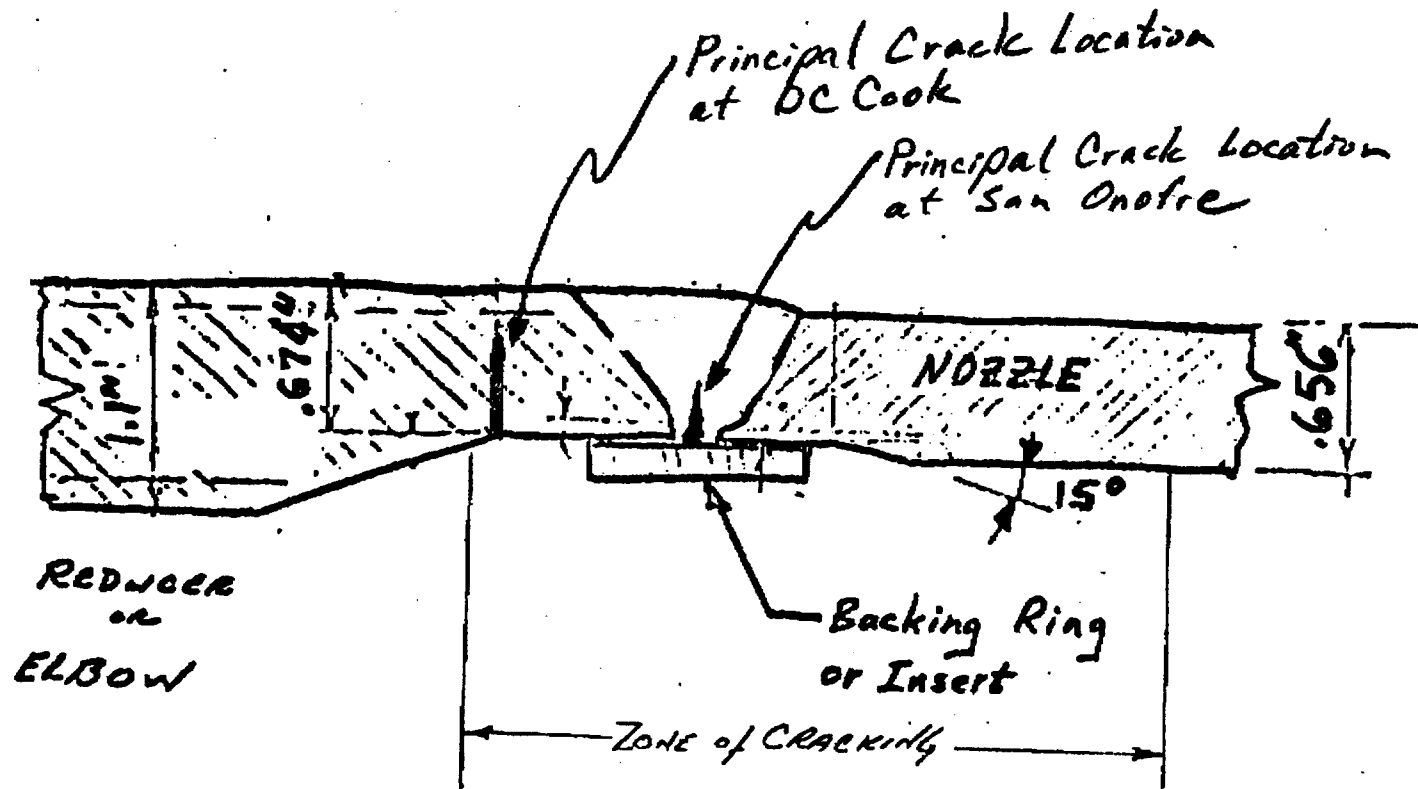
FIGURE 3
 TYPICAL FEEDWATER PIPE TO NOZZLE
 WELD JOINT DETAIL
 (W , CE)

The feedwater nozzle-to-pipe configurations for D. C. Cook and for San Onofre are shown on the attached figures 1 and 2. A typical feedwater nozzle-to-pipe weld joint detail showing the principal crack locations for D. C. Cook and San Onofre are shown on the attached figure 3.

An extensive metallurgical investigation has been conducted by Westinghouse on a substantial number of cracked weldments removed from the above plants. Results of the metallurgical analysis lead to the conclusion that a corrosion fatigue phenomenon is the probable failure mechanism, except for the San Onofre piping which has been characterized as stress assisted corrosion.

- a. Perform radiographic examination, supplemented by ultrasonic examination as necessary to evaluate indications, of all feedwater nozzle-to-pipe welds and of adjacent pipe and nozzle areas (a distance equal to at least two wall thicknesses). Evaluation shall be in accordance with ASME Section III, Subsection NC, Article NC-5000. Radiography shall be performed to the 2T penetrameter sensitivity level, in lieu of Table NC-5111-1, with systems void of water.
