UNITED STATES
NUCLEAR REGULATORY COMMISSION
OFFICE OF INSPECTION AND ENFORCEMENT
WASHINGTON, D.C. 20555

IE Circular No. 79-24

PROPER INSTALLATION AND CALIBRATION OF CORE SPRAY PIPE BREAK DETECTION EQUIPMENT
ON BWRs

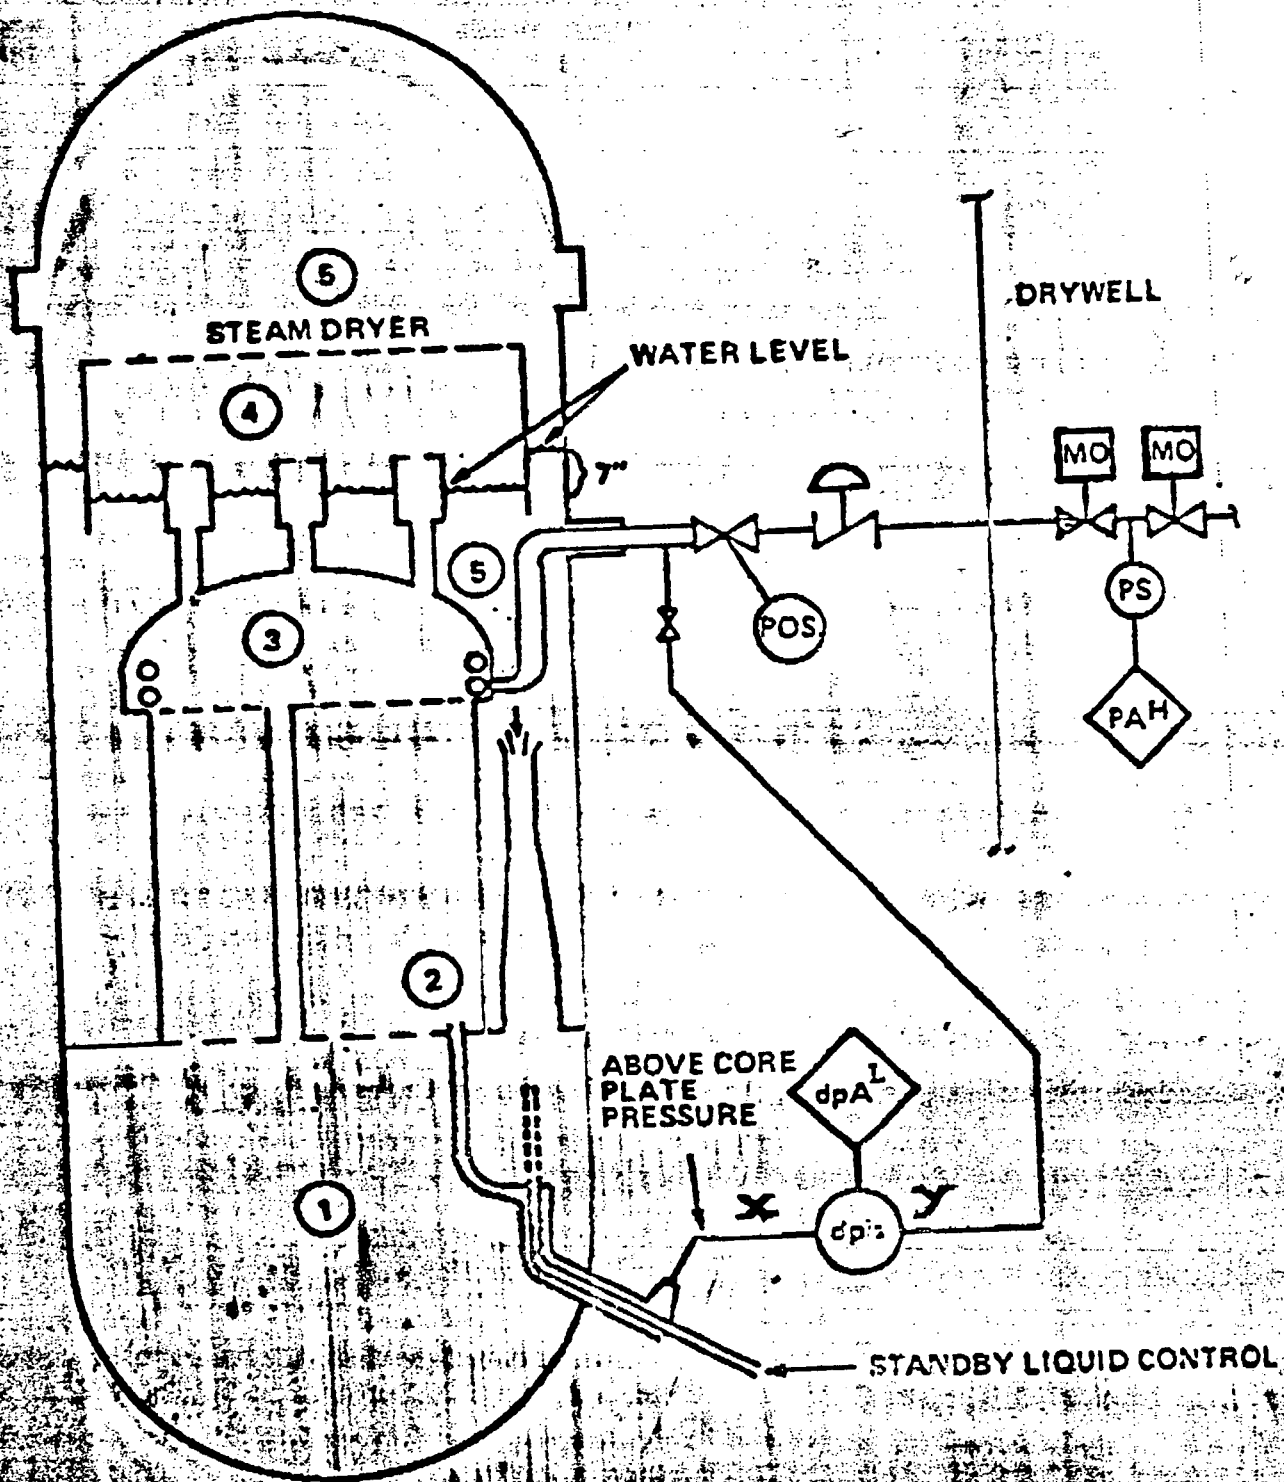
Figure 1 Core Spray System Pipe Break Detection Instrumentation

The licensee's investigation of the downscale deflection revealed that the original piping arrangement and calibration did not adequately take into account the effect of density changes of the water in the pressure leg connections. The original installation had the high pressure side of the dp instrument (see attached Figure 1) connected to the reference leg in the vessel (Figure 1 Connection X) and the low pressure side to the core spray piping outside the vessel but inside the drywell (Figure 1 Connection Y). With the piping intact, this arrangement senses the pressure difference between bottom and top of core. With a break in CS piping in the annulus area the instrument then senses the additional pressure drop across the separators (dp \approx 7 psi additional) and dryers (dp \approx 7-inches water). This installation was in accordance with GE design requirements.

Also in accordance with GE instructions the calibration of the dp instrument was performed with the reactor in the cold condition and the alarm was set to trip at 5 psid increasing. Because of this cold calibration the dp instrument then indicated full downscale negative during operation. This negative dp was due to the heat up of the reference leg (Figure 1 Connection X) which caused the fluid density to decrease as the plant reached hot conditions. The magnitude of this dp was determined to be about 3.5 psid following completion of the modification discussed below.

Adding the 3.5 psi downscale deflection to the 5 psi alarm setpoint results in a total required deflection of 8.5 psi to initiate the alarm at the setpoint. Since the total dp available across the separators and dryer is only 7 psi (1.5 psi less than the total required deflection), the alarm would not be actuated by a CS pipe break in the annulus. Therefore, the original installation, including calibration procedure, was deficient.

To correct the problem, Iowa Electric modified the installation by interchanging the pressure leg connections and resetting the alarm to trip at 2 psid decreasing. In this orientation it was found that going from cold to hot produced a 3.5 psid positive deflection. The technical specifications were changed to reflect the revised alarm setpoint.

- "1. BWR operators, who have differential pressure (ΔP) instrumentation which reads only positive values, interchange their core spray line break instrument connections so that the high side connection is to the core spray sparger sensing line and the low side connection is to the above the core plate sensing line. This instrumentation should be calibrated for a zero ΔP reading during cold shutdown; it will then give a positive ΔP reading during normal rated power operation and a pegged zero reading for a line break indication during normal rated power operation.

Also, when this change is made, the recommended alarm setpoint (on decreasing ΔP) setting is 0.5 ± 0.25 PSID; and for those plants that have a value in their technical specifications, > 0 PSID is recommended as a limit.
