UNITED STATES
NUCLEAR REGULATORY COMMISSION
OFFICE OF INSPECTION AND ENFORCEMENT
WASHINGTON, D.C. 20555

July 31, 1980

IE Bulletin No. 80-20

FAILURES OF WESTINGHOUSE TYPE W-2 SPRING RETURN TO NEUTRAL CONTROL SWITCHES

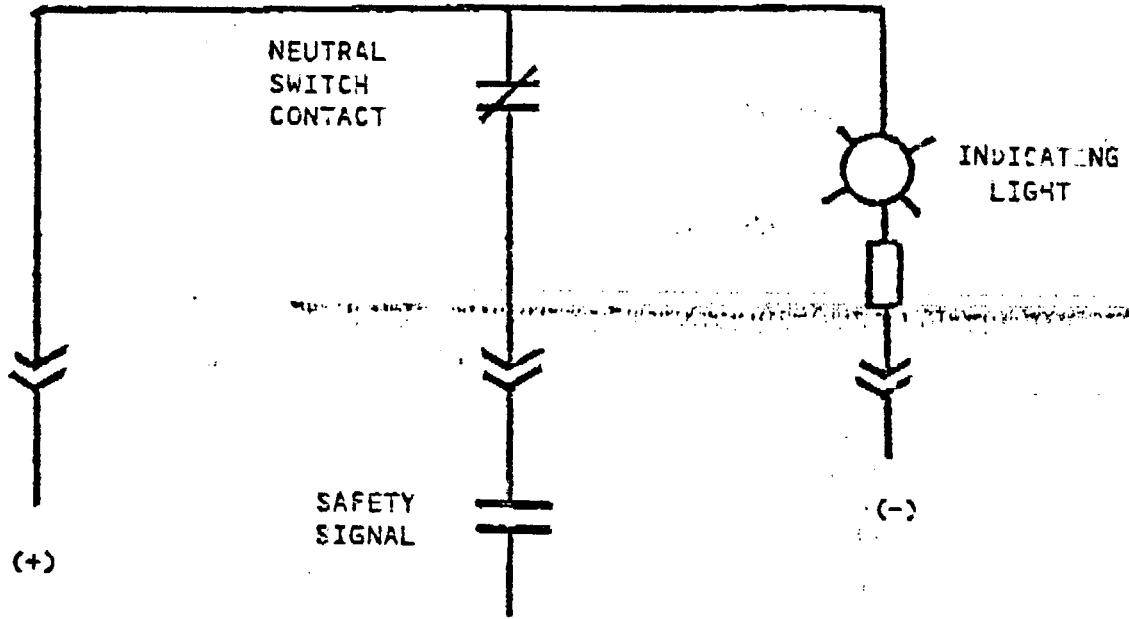
EXISTING INDICATING LIGHT CIRCUIT (TYPICAL)

Depending on how the indicating light circuit is wired, loss of continuity thru the neutral position contact of a W-2 switch could remain undetected until the equipment associated with the switch were called upon to operate. Since such a failure would be equivalent to by-passing the system associated with the switch, consideration should be given to rewiring the switches used in safety-related applications as shown in Figure 1. Such rewiring would provide an acceptable means for detecting contact failure, provided the indicating light is in the control room and readily visible by the operator. If the indicating light is not so located, consideration should be given to annunciating the neutral position contact failures at the control room to alert the operator of the inoperable status of a safety-related system. In addition, consideration should be given to adding redundant contacts to the W-2 switches or to replacing the W-2 switches with others having a more positive contact wiping action.

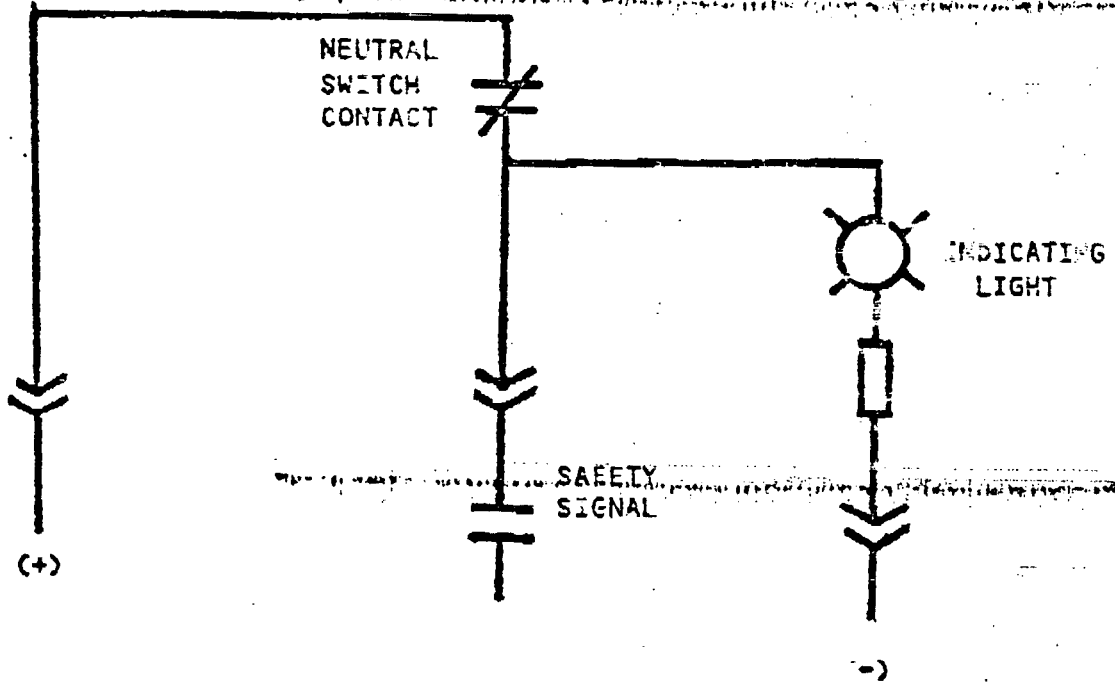
PROPOSED REWIRING OF INDICATING LIGHT CIRCUIT (TYPICAL)

REWIRING OF INDICATING LIGHT CIRCUIT OF W-2 SWITCHES
AS RECOMMENDED BY WESTINGHOUSE TECHNICAL BULLETIN WSD-TB-80-9

A review of this matter by Westinghouse led to the issuance of NSD Technical Bulletin No. NSD-TB-80-9 to the utility owners of all Westinghouse operating plants. The recommendations contained in the Westinghouse technical bulletin include: (i) testing the neutral position contacts of the subject W-2 switches for continuity, and (ii) rewiring of the indicating light circuit to permit the early detection of a neutral contact failure as shown in Figure 1.

3. Licensees of operating plants and holders of construction permits shall describe the longer term corrective measures planned and the date by which such measures will be implemented by actual installation or by design change, as appropriate. As a minimum, the longer term corrective measures should include rewiring the indicating light as shown in Figure 1 provided the light is readily visible to the control room operator. If not, failures of the neutral position contacts should be annunciated in the control room.
