# Preliminary report of the July 16, 2007 Niigata prefecture Chuetsu Off shore (Niigata-ken Chuetsu-Oki), Japan, Earthquake

Based on the reconnaissance conducted from July 17-19, 2007  
(Strong motion records by K-NET are acknowledged.)

Disaster Prevention Research Institute  
Kyoto University, Japan

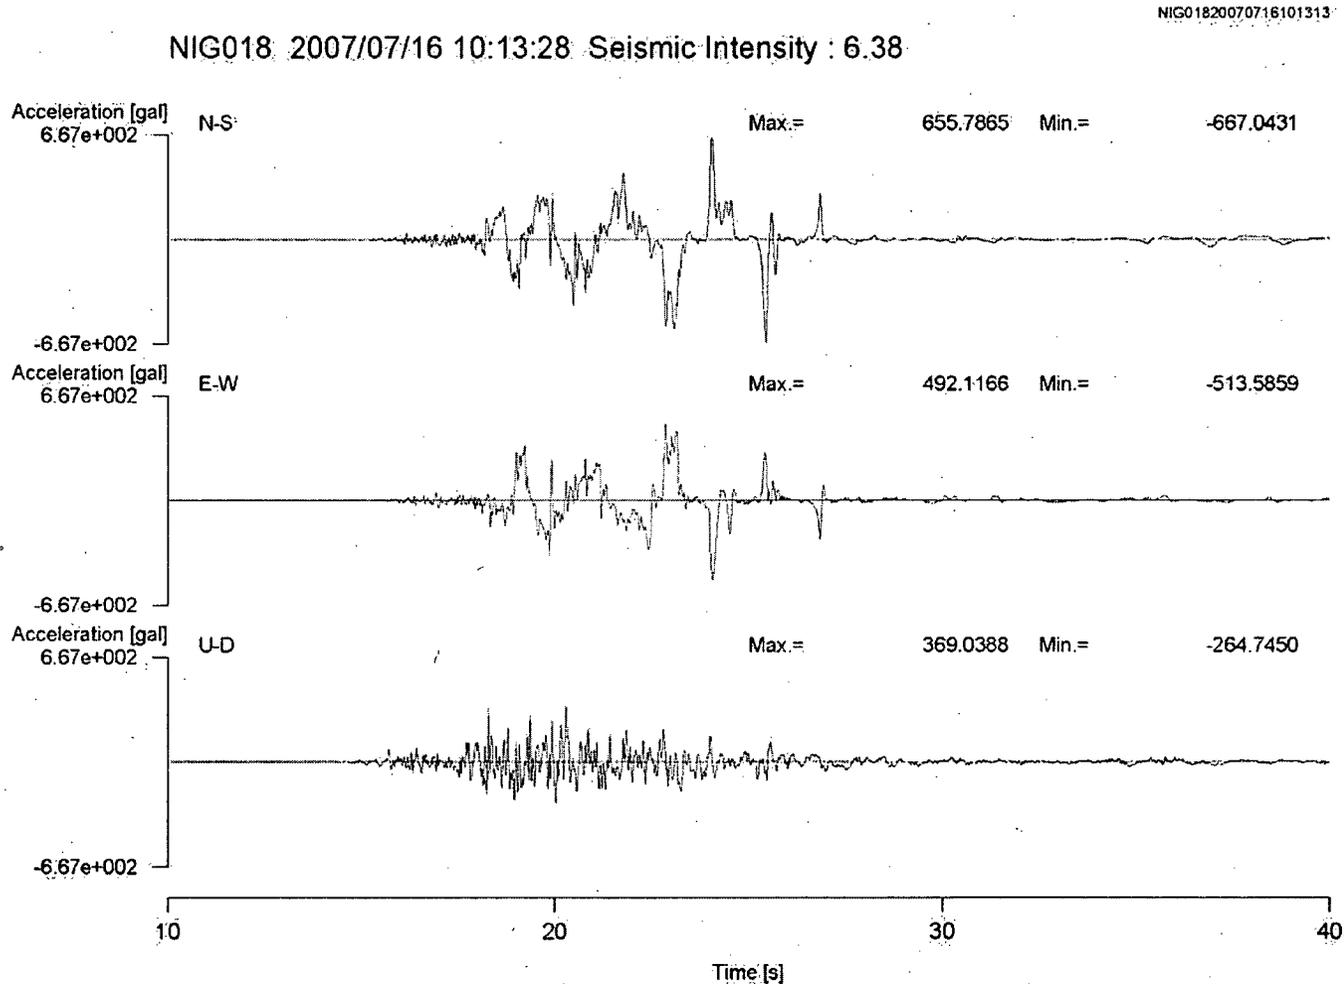
Figure 2 Acceleration record of NIG018, K-NET, 10:13AM, July 16, 2007

Recorded K-NET strong motion (Fig. 2) shows spiky response in the horizontal records which is typically seen for dense sands under the state of cyclic mobility caused by a liquefaction. Peak accelerations are observed in the time period of 25 - 28 seconds when the spiky response is dominant. Their values are 6.67 and 5.13 and 3.69 m/s<sup>2</sup>, respectively, in the NS, EW and UD directions. Duration of shaking is about 10 seconds. Soil profile at the site also indicates dominance of dense sands at shallower depth < 5 m (Fig. 3).

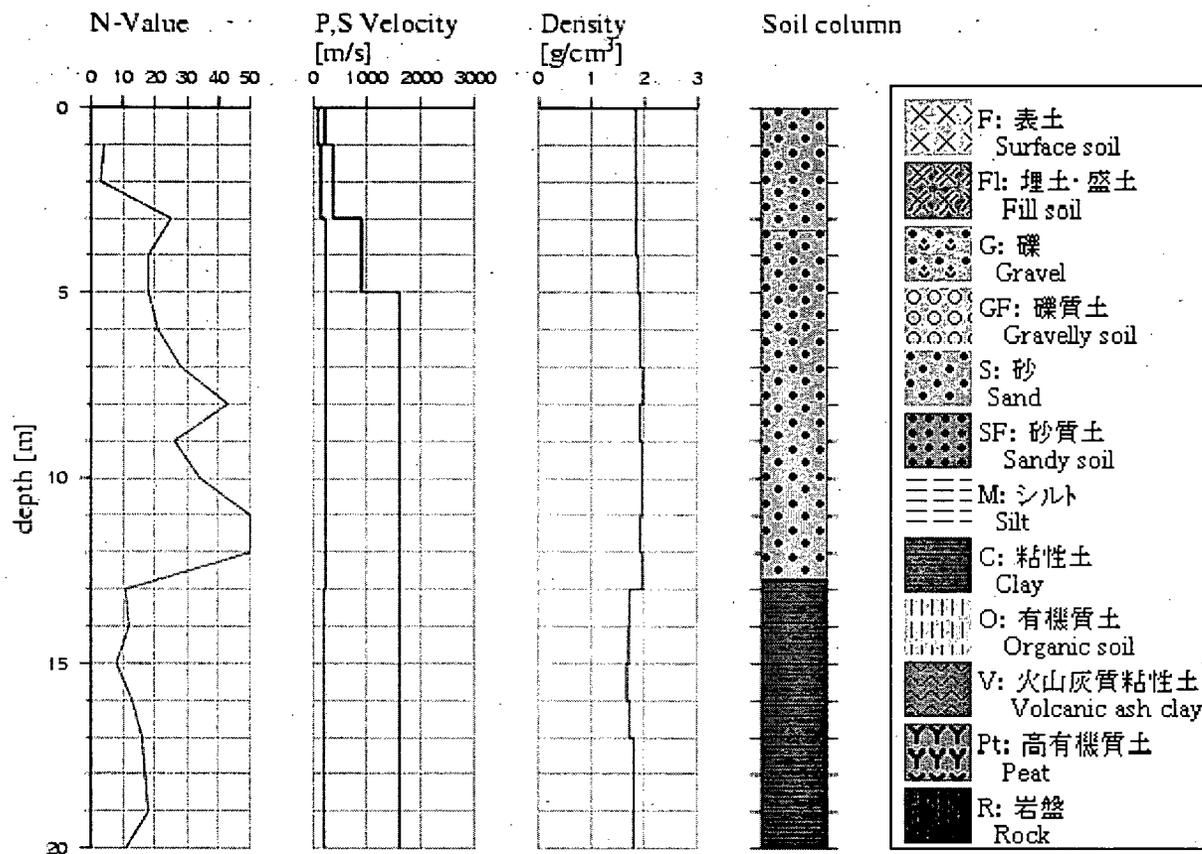
Figure 3 Soil profile at Kashiwazaki, NIG018, K-NET (after NIED).

From P wave velocity, the ground water level is expected to be about G.L. - 4 to -5 m. The ground water level at the event has to be investigated. The amount of precipitation in July, 2007 in Kashiwazaki is 46 mm that is 21 % less than the average year(220 mm) (JMA AMEDAS).

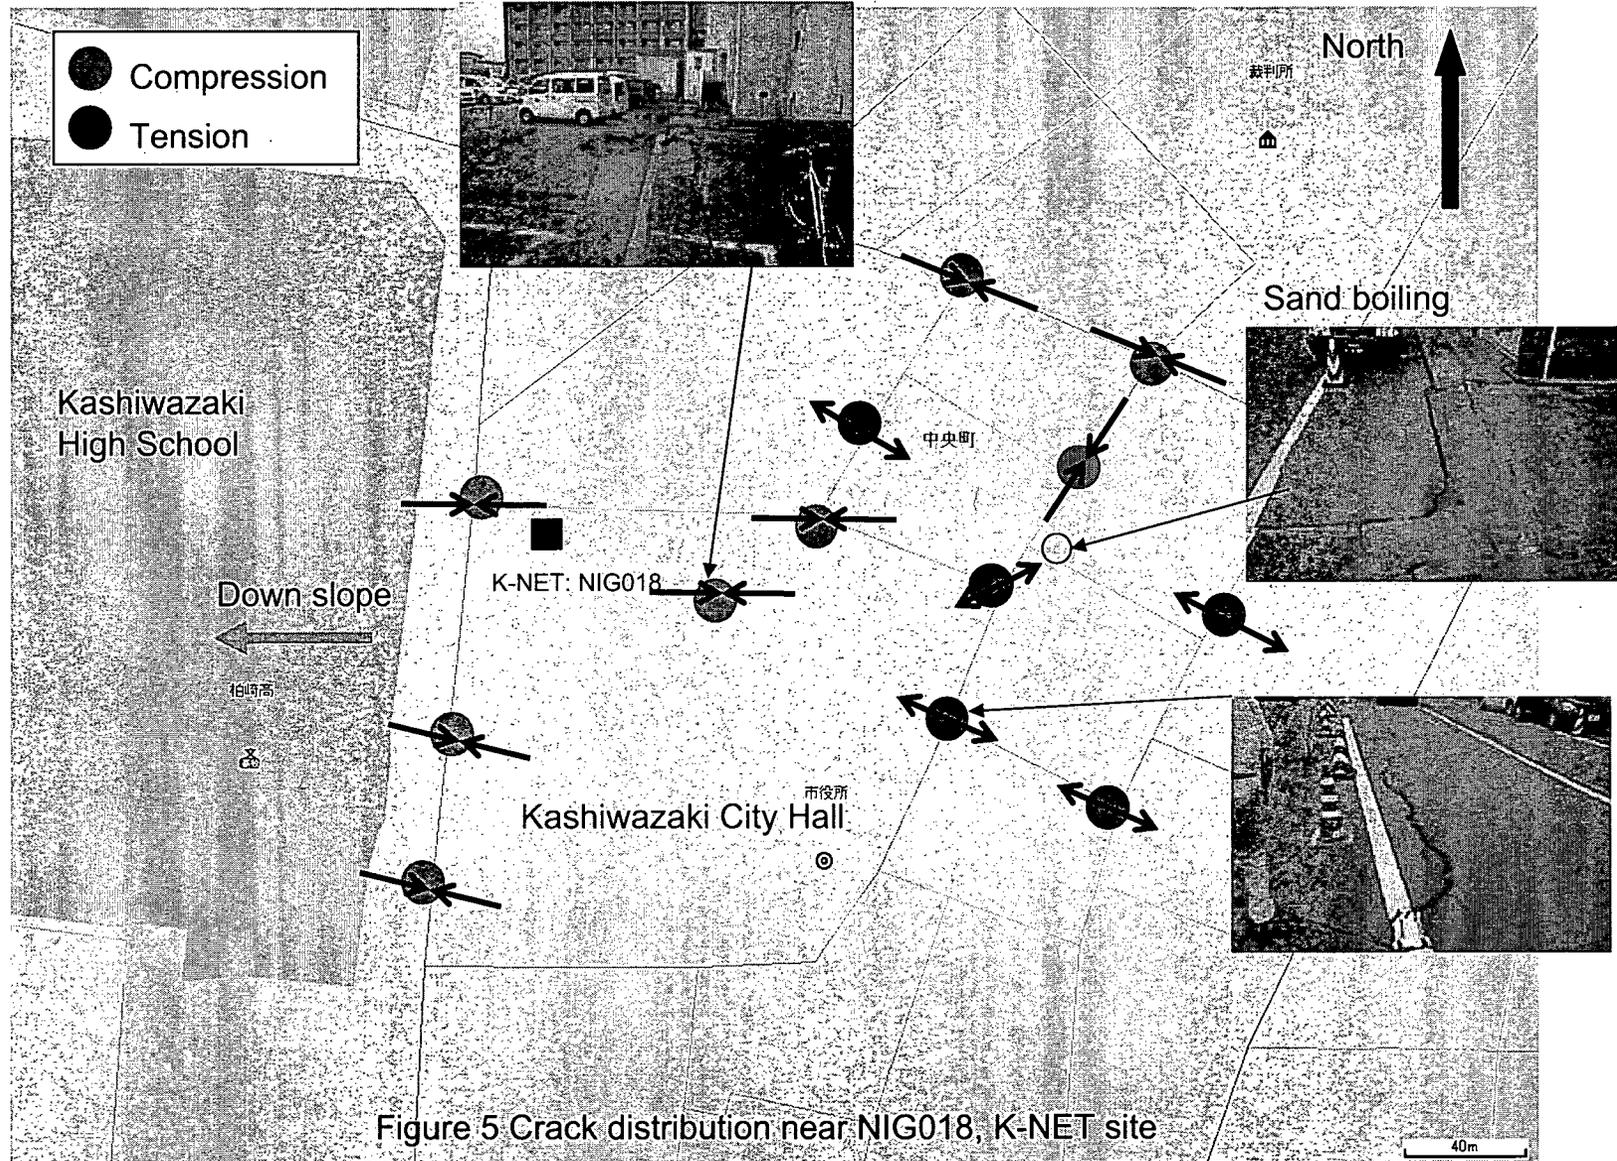
Figure 5 Crack distribution near NIG018, K-NET site

Near the K-Net site, major cracks on road asphalt may indicate occurrence of lateral spreads toward down-slope. (Fig. 5).

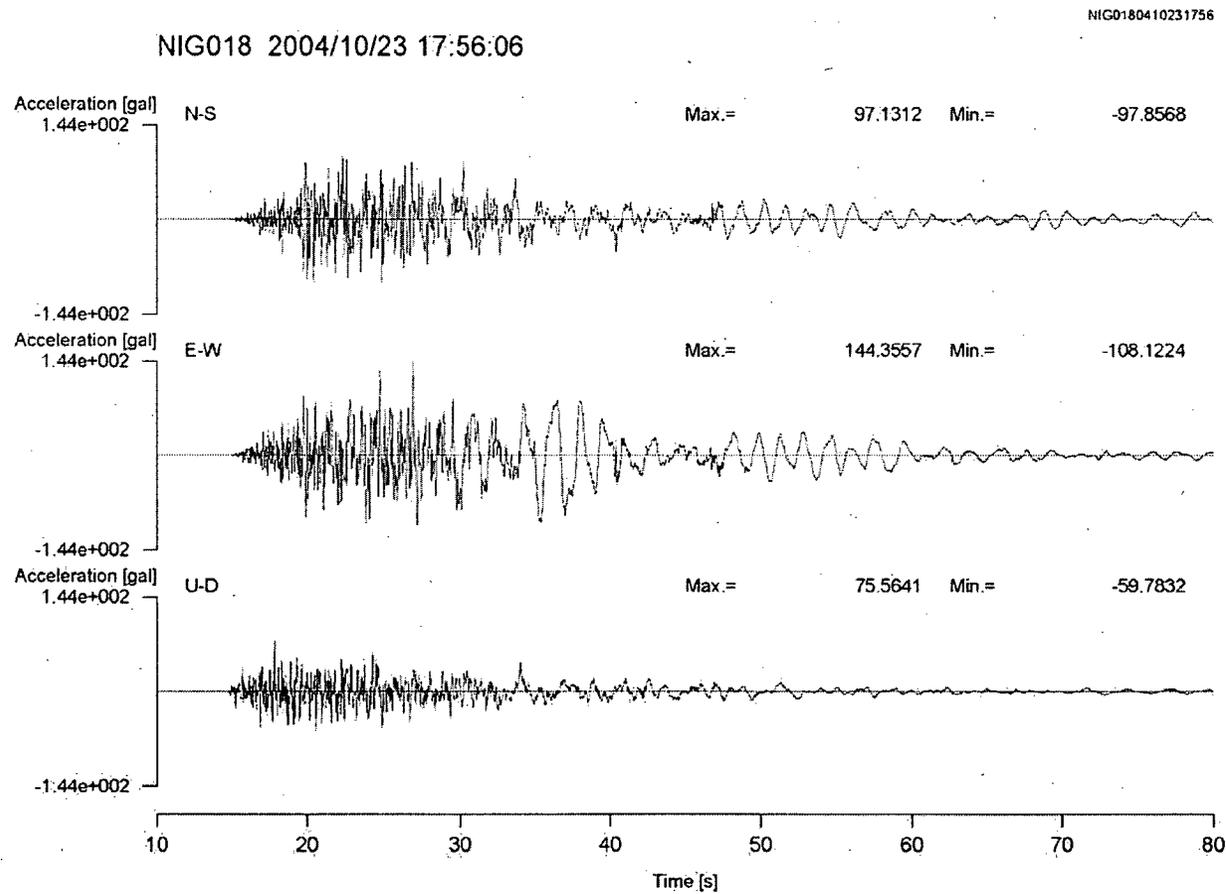
Figure 4 Acceleration time history of 2003 Niigata-ken Chuetsu earthquake recorded at NIG018, K-NET, 17:56, October 23, 2004

The acceleration time histories of 2003 Niigata-ken Chuetsu earthquake recorded at NIG018 show no spikes due to cyclic mobility (Fig. 4).

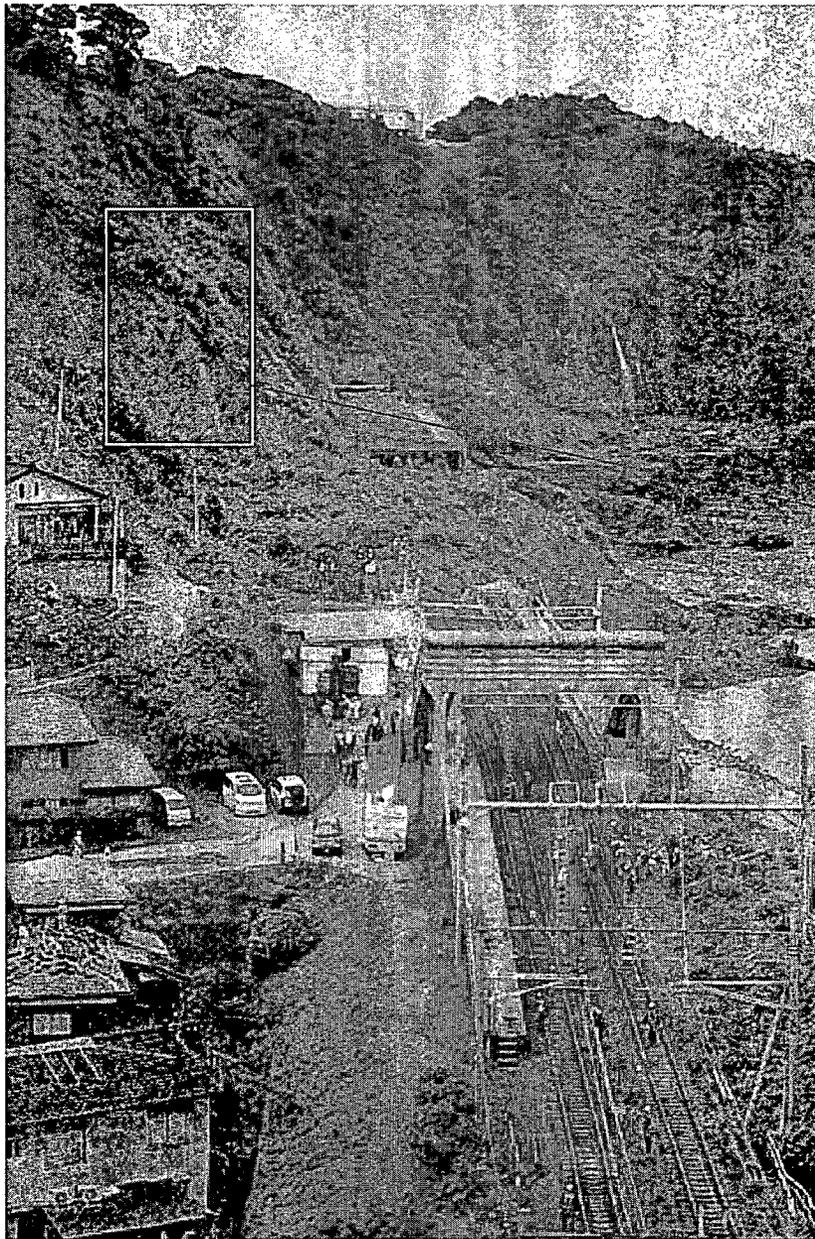
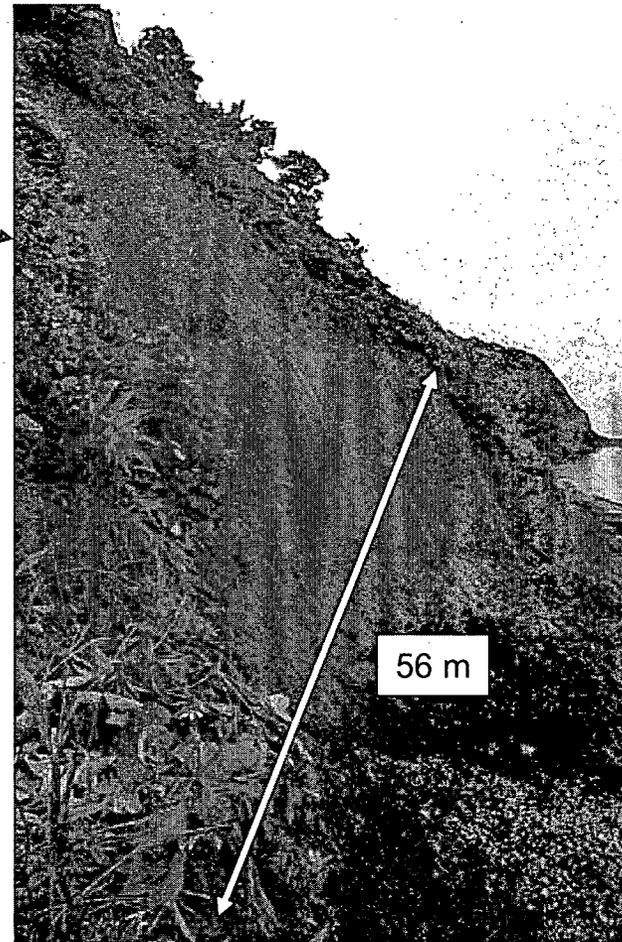
Ohmigawa: 7/18/07

Two landslides near the Ohmigawa station of JR Shin-Etsu line covered rail tracks by the coast line. According to a fisherman who was in the sea for catching oysters near the site, the landslide started simultaneously with strong shaking and, in his impression, duration of sliding was in a very short time.

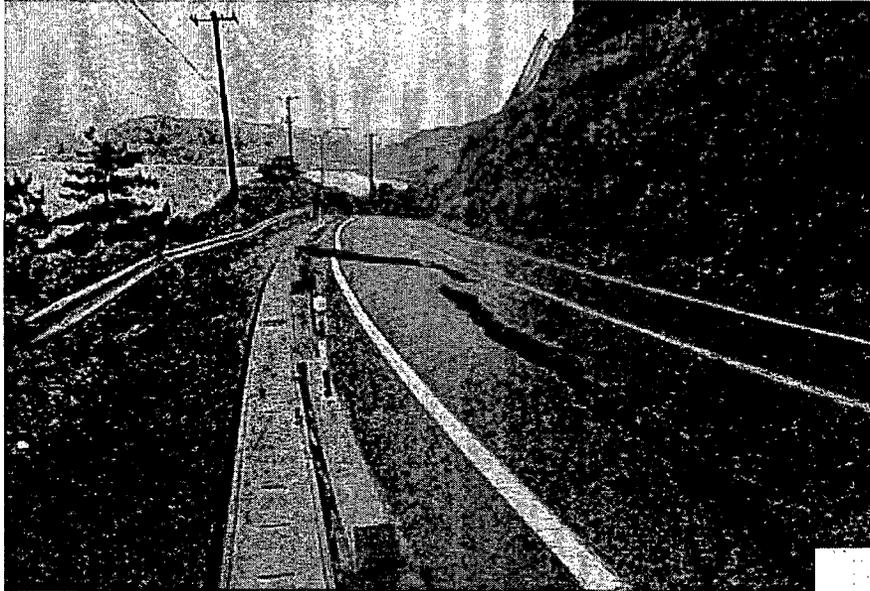
Kan-non Misaki: 7/17/07

Landslide at Kan-non misaki (Cape Kan-non)

Two landslides were occurred in the North of Kan-non misaki, the nearest land from the epicenter. The landslides covered the Route 352.

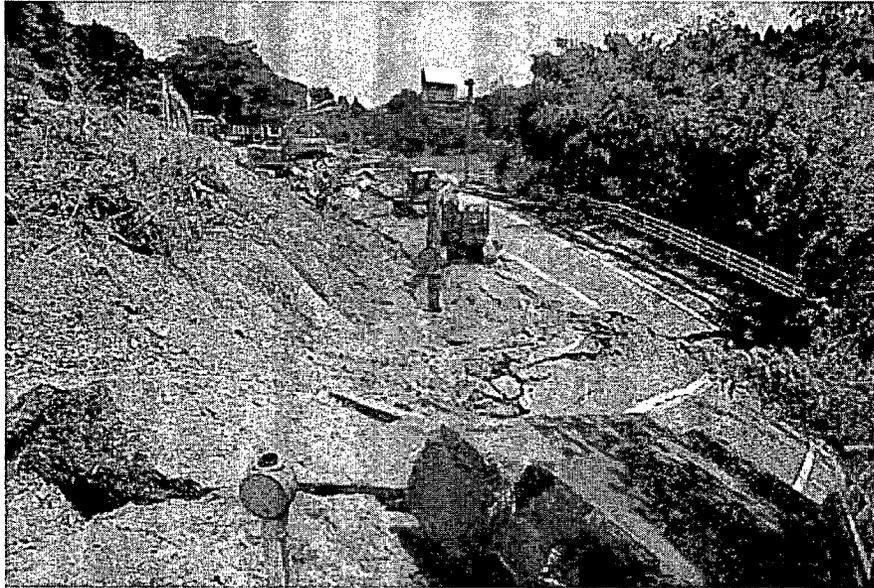
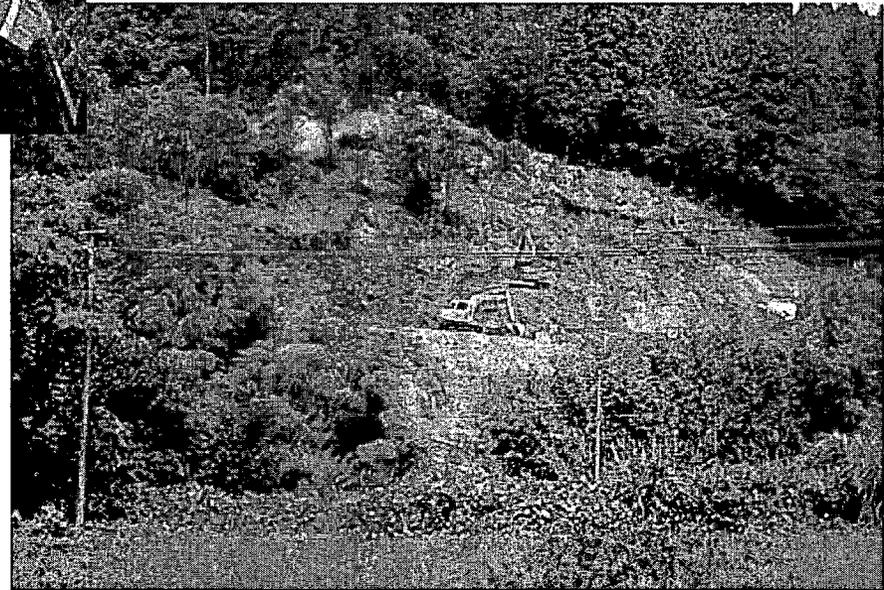
Major arterial road, Route 8, which connects Kashiwazaki to Nagaoka was damaged at Senbon due to landslides. Slide started at about 60 m above the road pavement. Width of broken road was about 80 m.

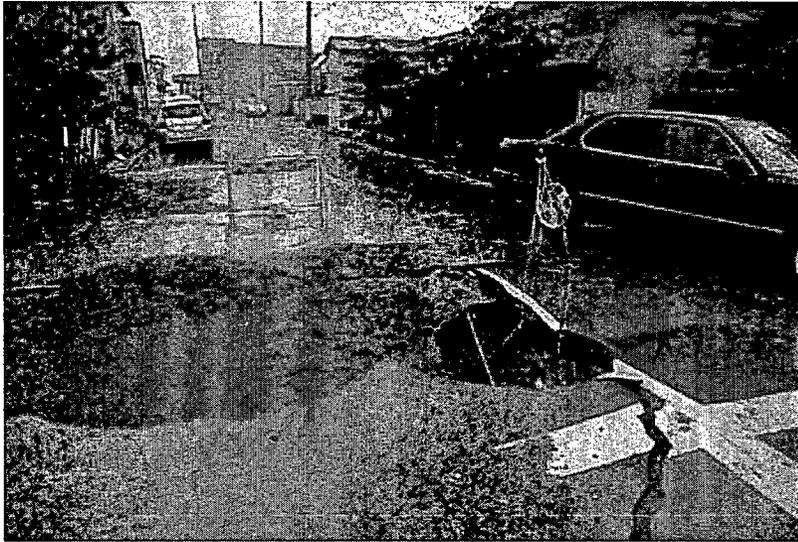
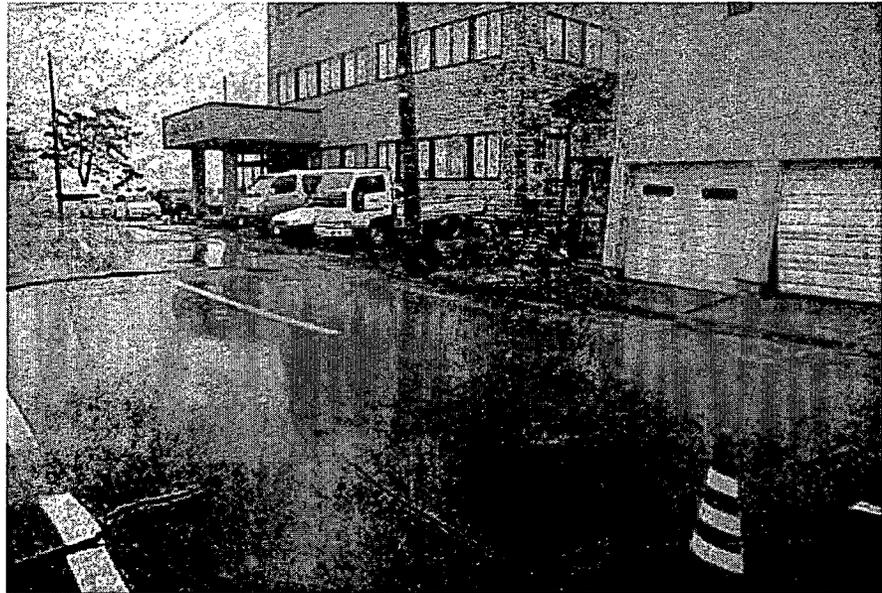
Matsunami 2: 7/17/07

Damage on utility poles, asphalt roads, houses due to liquefaction were found in Matsunami 2, Kashiwazaki city. The site which was originally farm lands and sand dunes was developed as a residential site in 1973-1976. The area is 14 ha and east part of the developed land suffered heavy damage due to liquefaction. Eye witness accounts of evidence confirms the occurrence of liquefaction after the large shaking with an eruption of muddy water at 2 m high.

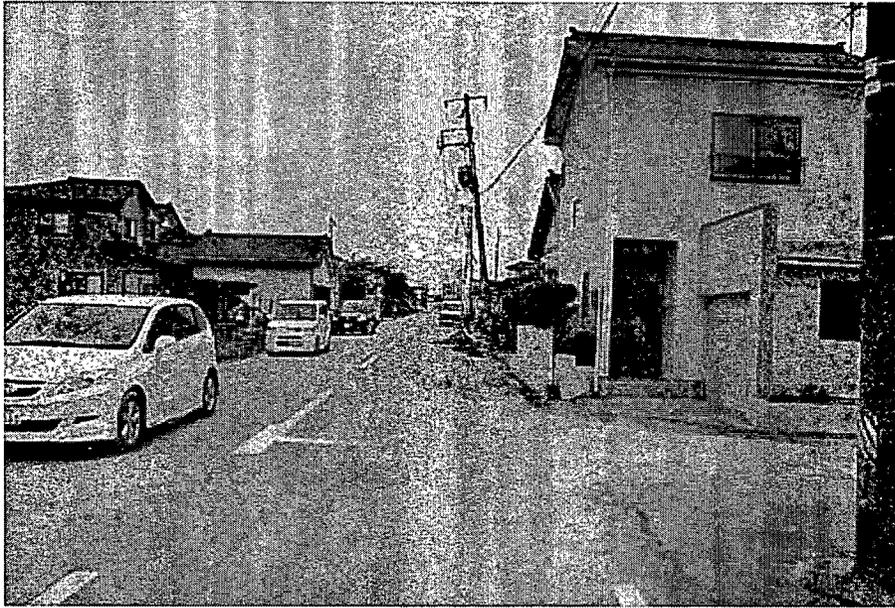
Utility poles were settled and tilted, but no manholes were uplifted.

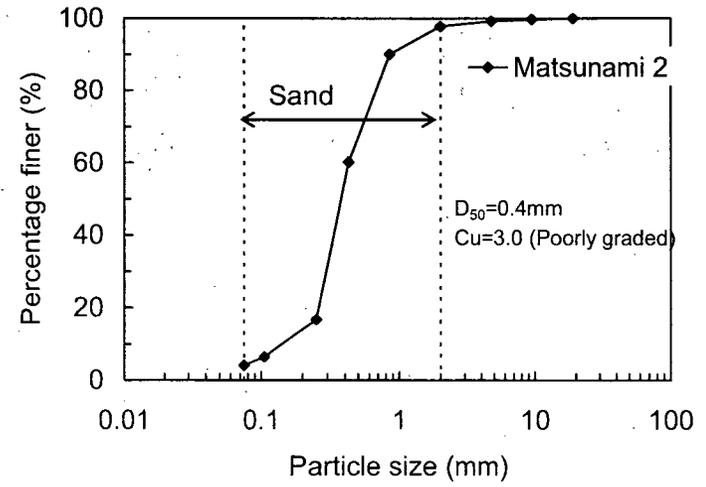
Erupted sand was medium to coarse sand

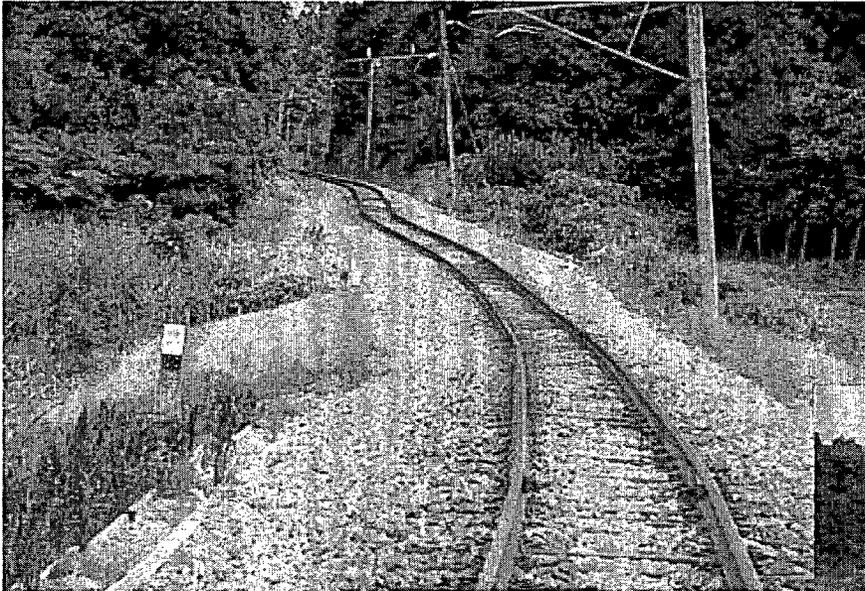
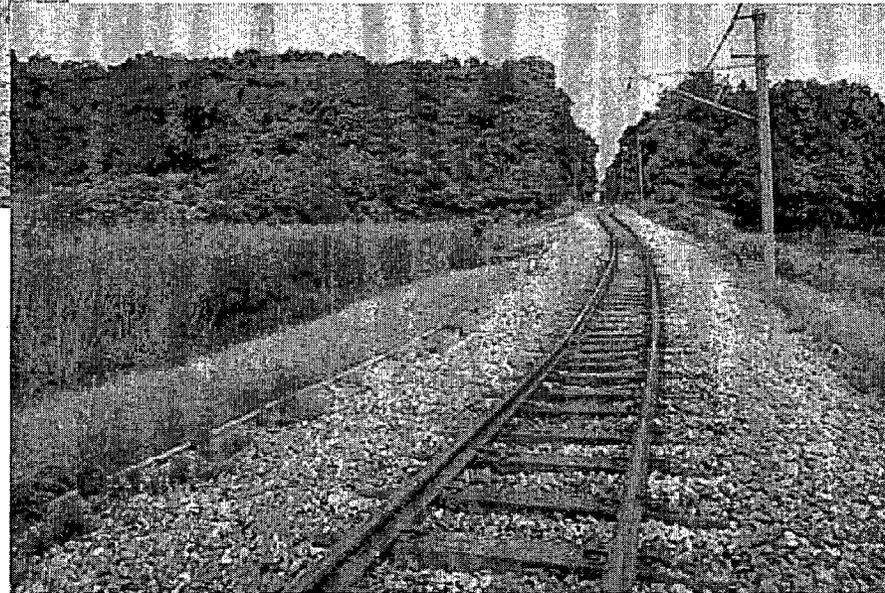
Doh-ai: 7/18/07

Settlement of a railway embankment due to the loss of the bearing capacity of its base ground was found in Doh-ai. The railway is crossing a pond with distance of 125 m and that part was settled. Evidence of liquefaction was NOT? found?? (need confirmation). Cross sectional dimension of the embankment after deformation is 6.8 m at the crest, and 16 m at the toe. Its height after deformation is 1.2 m.

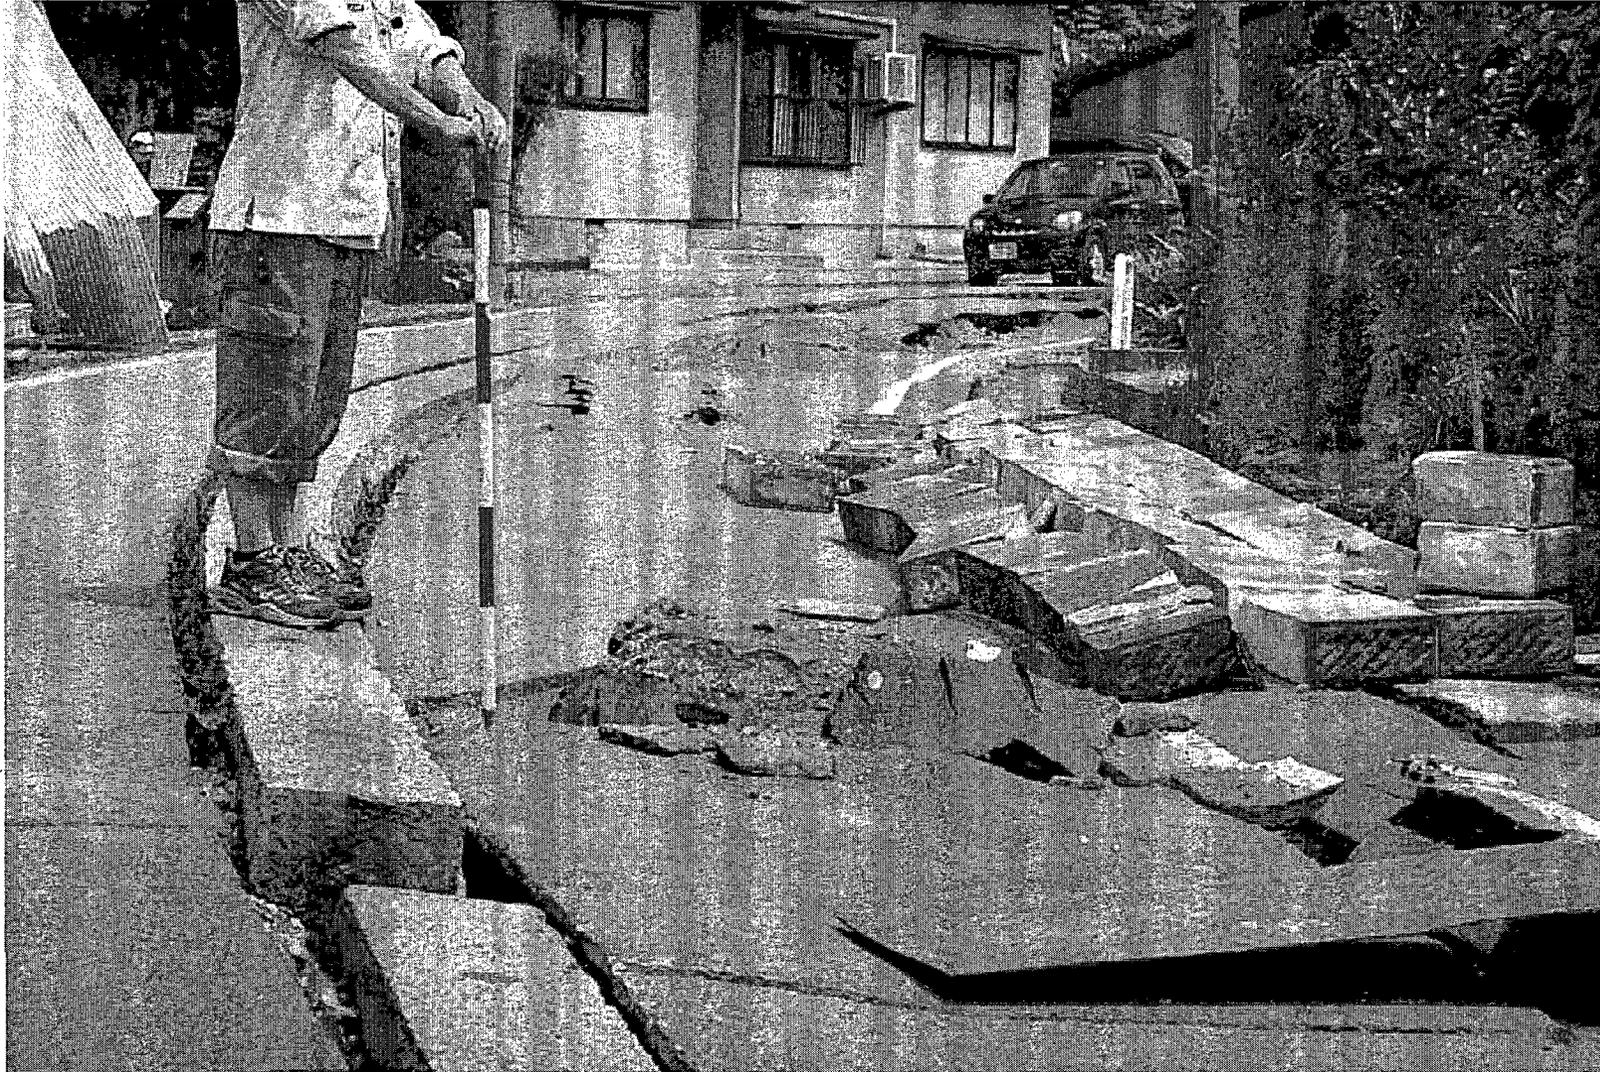
Doh-ai: 7/18/07

Road pavements near the railway settlement were damaged due to a possible liquefaction of filled material for constructions of swage pipes and manholes. This indicates that a predominant soil in this area is cohesive and low permeable material.

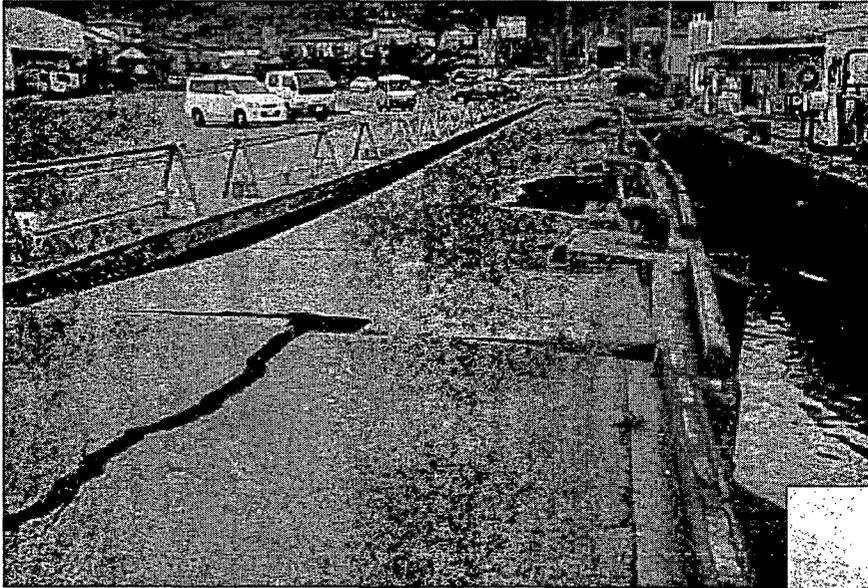
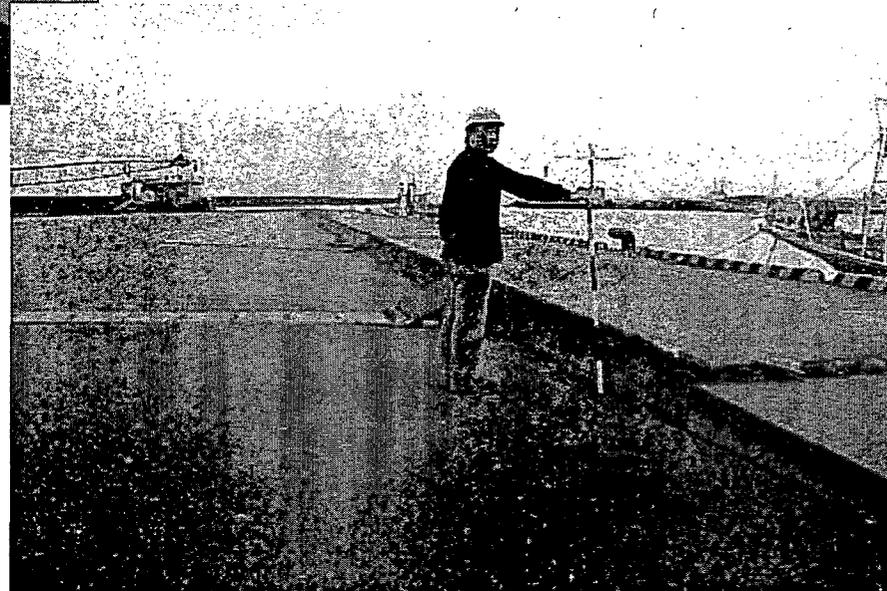
Kashiwazaki fishery port: 7/17/07

Minor to 50 cm of settlement of apron was found.

Deformation toward sea < 1m: Sheet pile type quay wall with tie rods

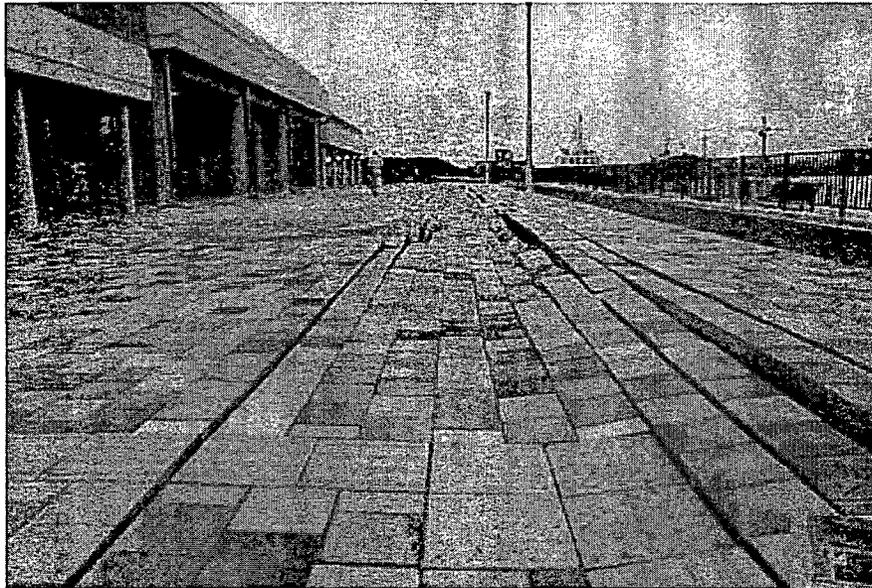
Kashiwazaki ferry terminal building:  
Building suffered no damage but evidence of liquefaction was found.  
Pavement blocks were separated and settled.

Sand volcanoes at the back of the building

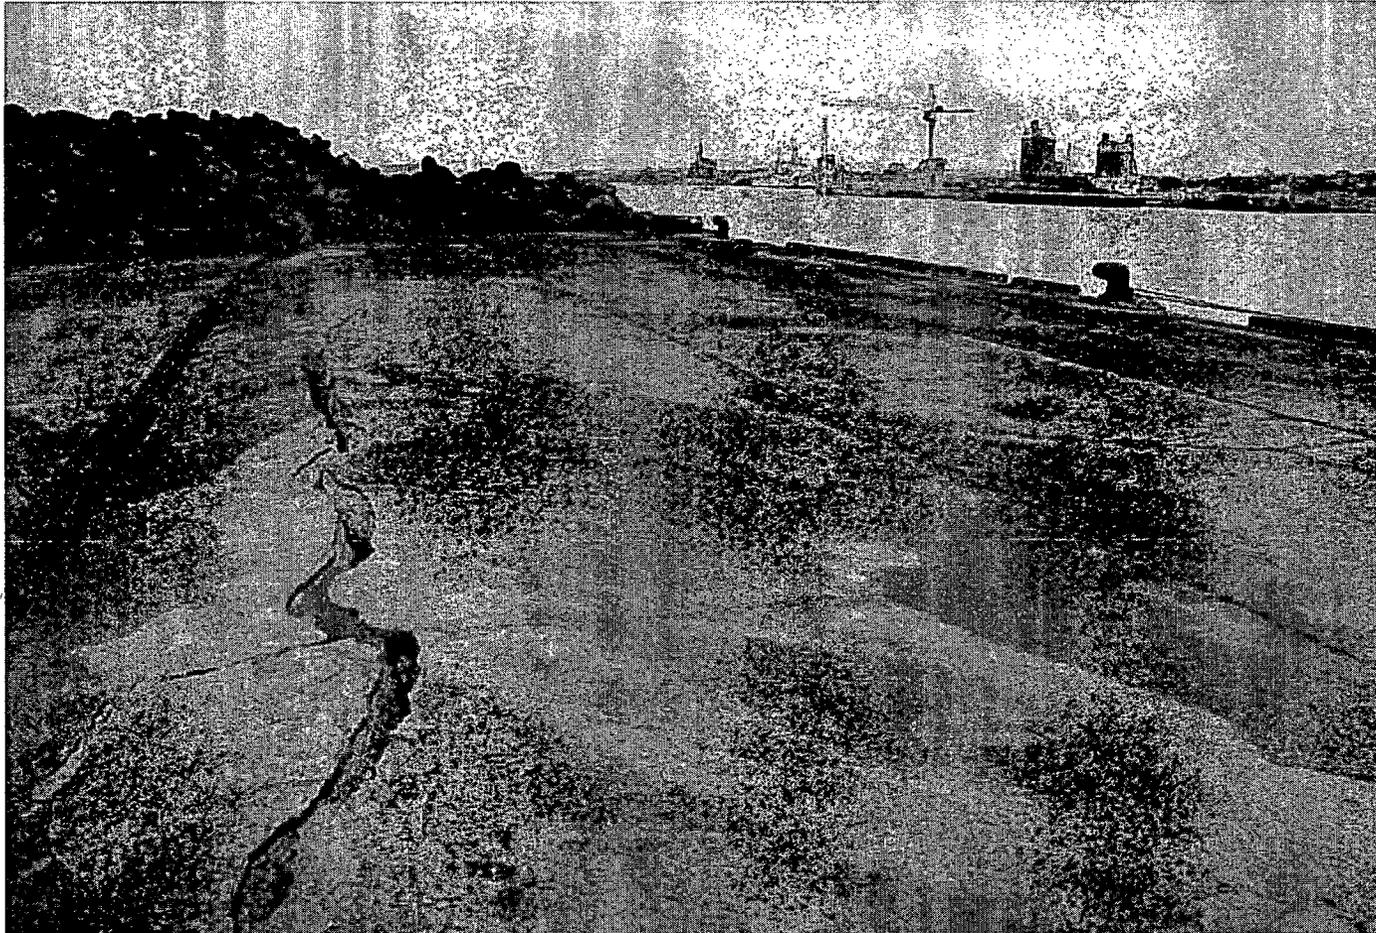
Kashiwazaki fishery port: 7/17/07

Damage of a sheet pile type quay wall with tie rods

Broken concrete slab indicates that tie rods connected sheet pile walls pulled anchoring piles toward sea.

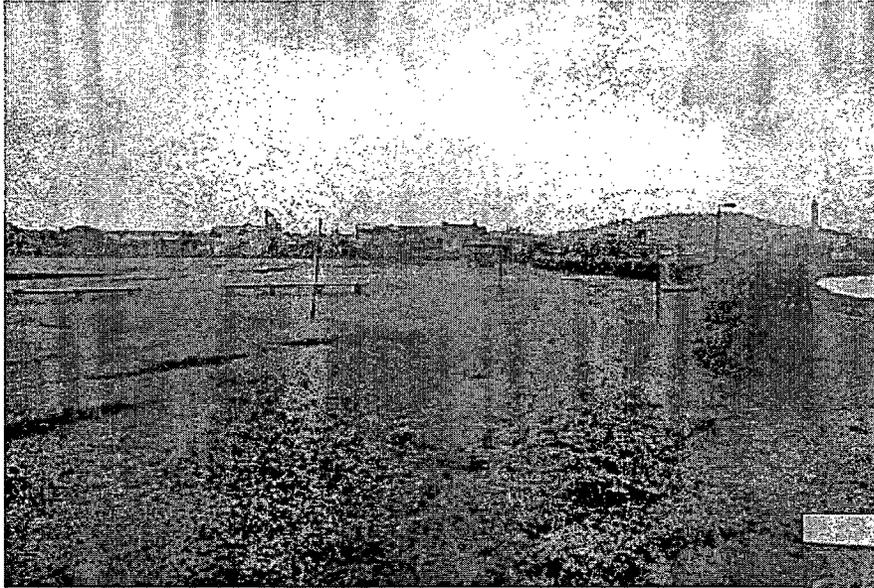
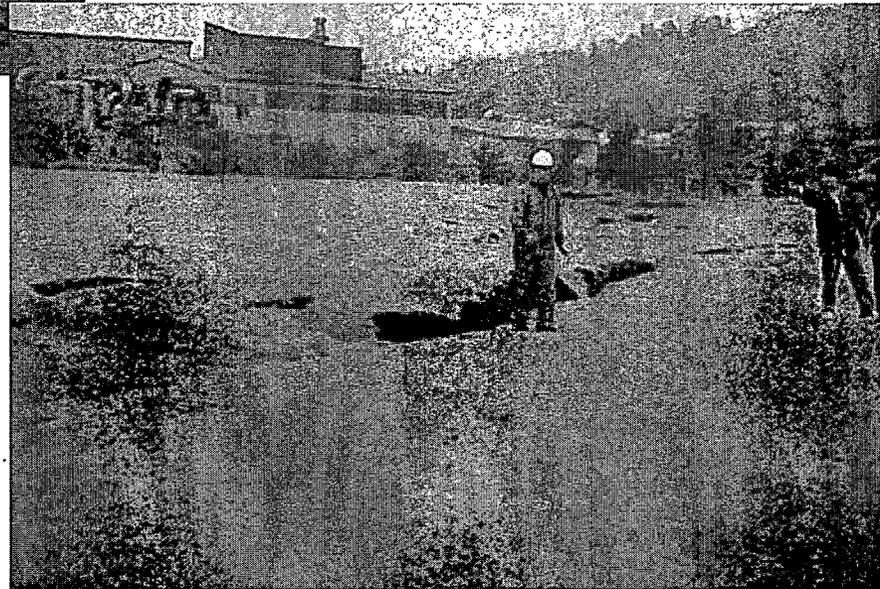
Sabaishigawa kaishu-kinen park: 7/17/07

Large ground fissures due to liquefaction were found in the Sabaishigawa kaishu-kinen park, Makihara, Kashiwazaki. The park was constructed on a sandbar along the Sabaishi river.

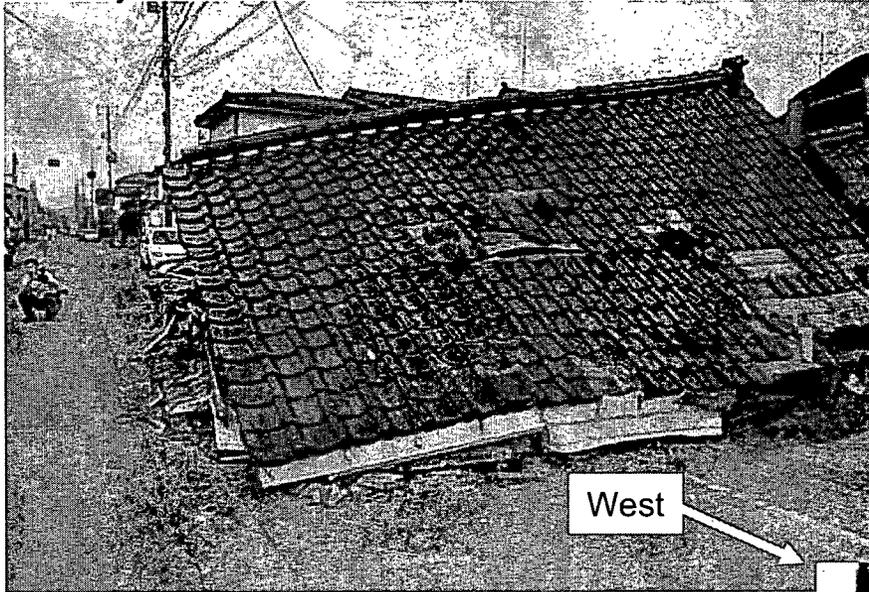
Many wooden houses collapsed. One of the most damaged area in Kashiwazaki.

Typical collapse pattern of wooden houses

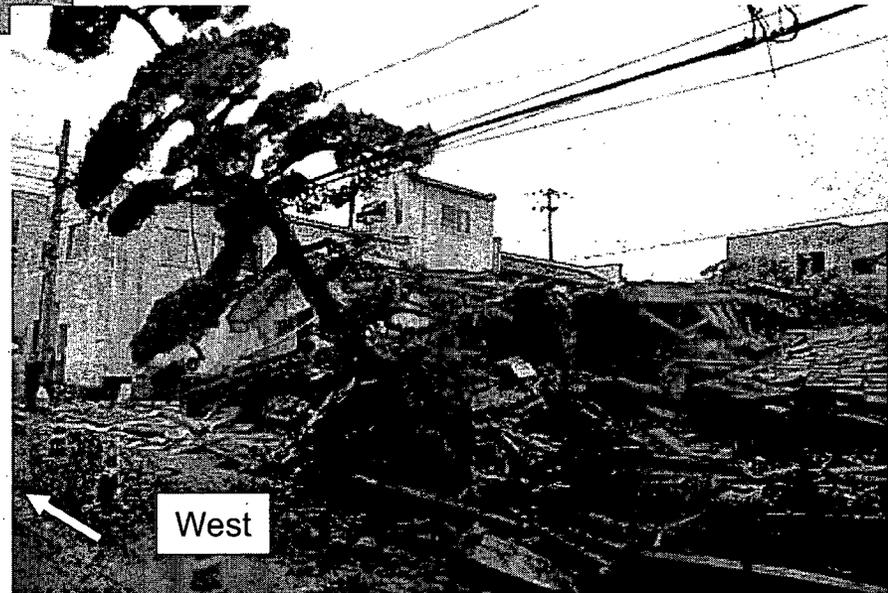
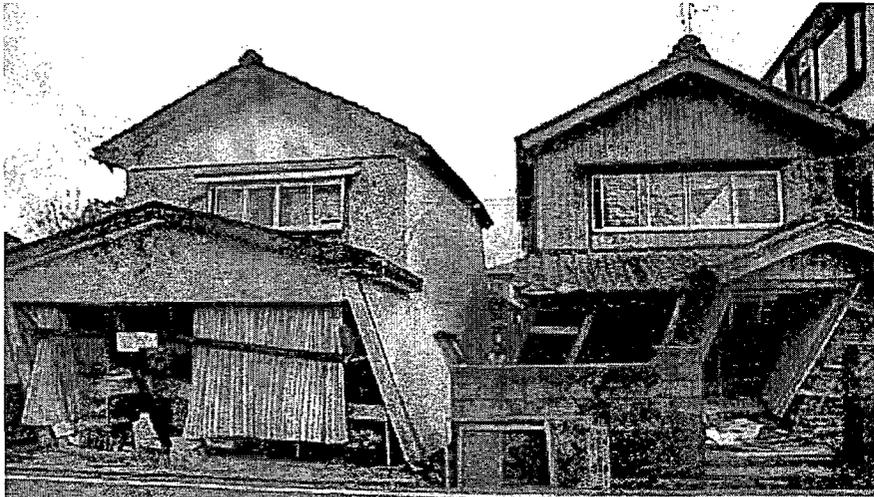
First floor of wooden houses shown above tilted into the opposite direction each other. This indicates that houses were shaken with their natural period.

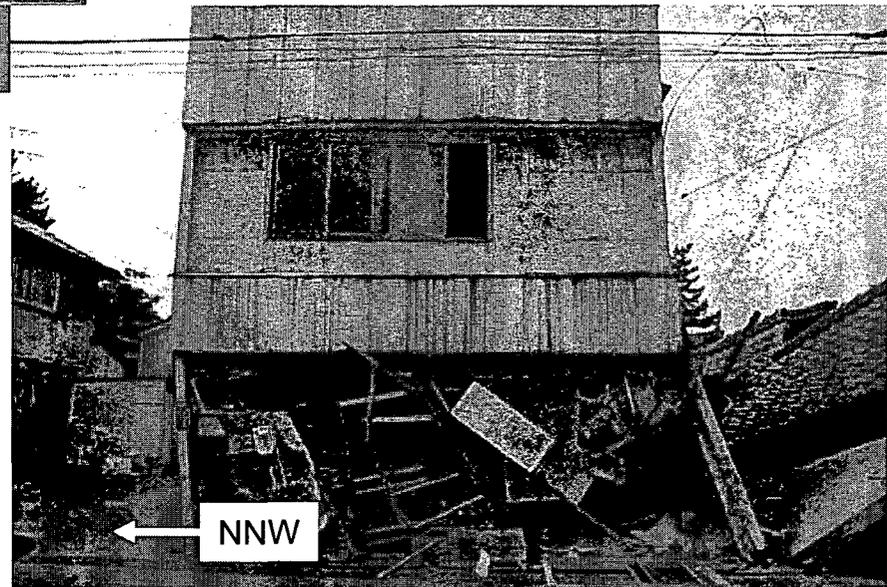
Old steel frame building were also damaged

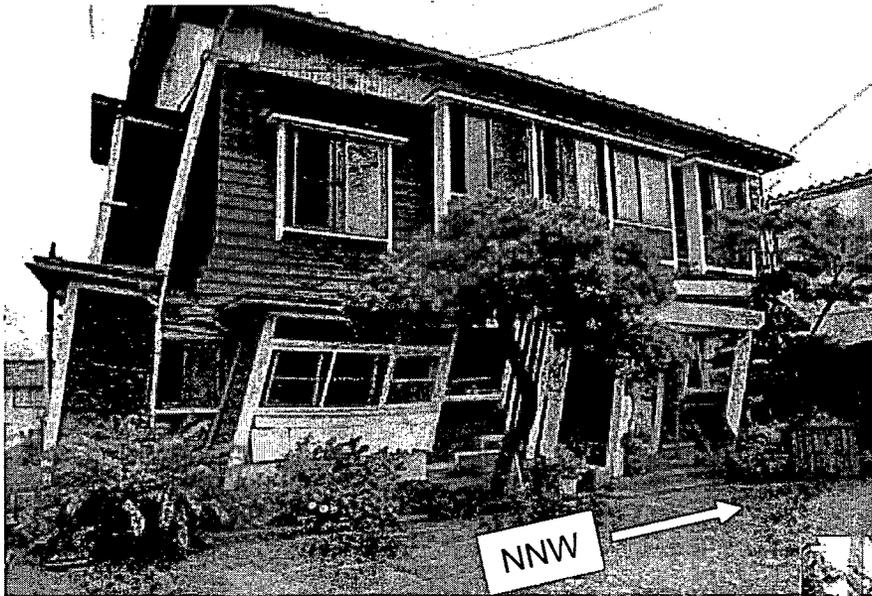
Two story wooden building used as a museum

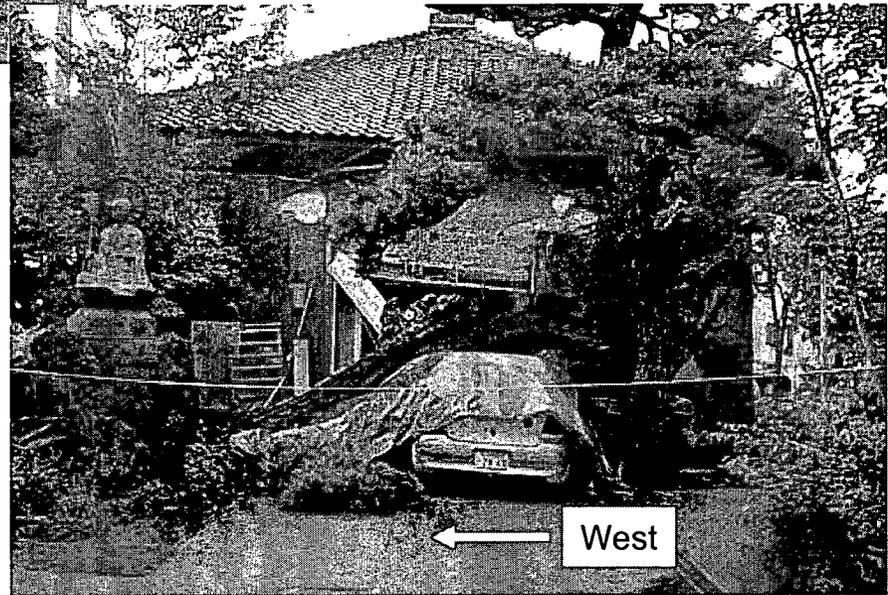
Collapsed entrance roof of the Enma-do, temple

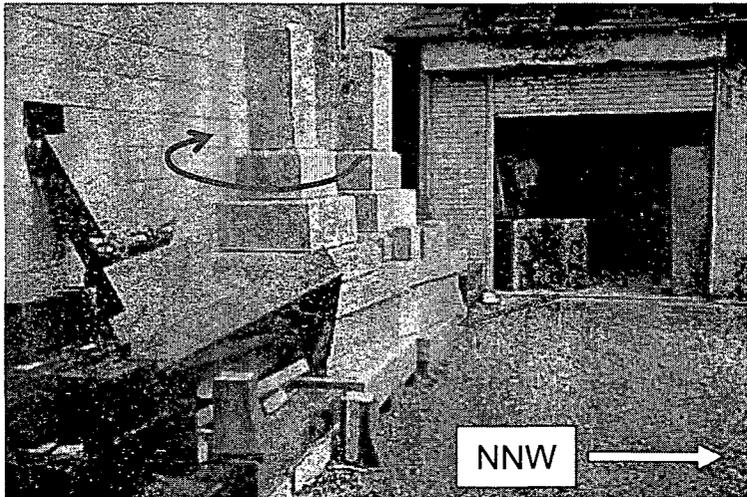
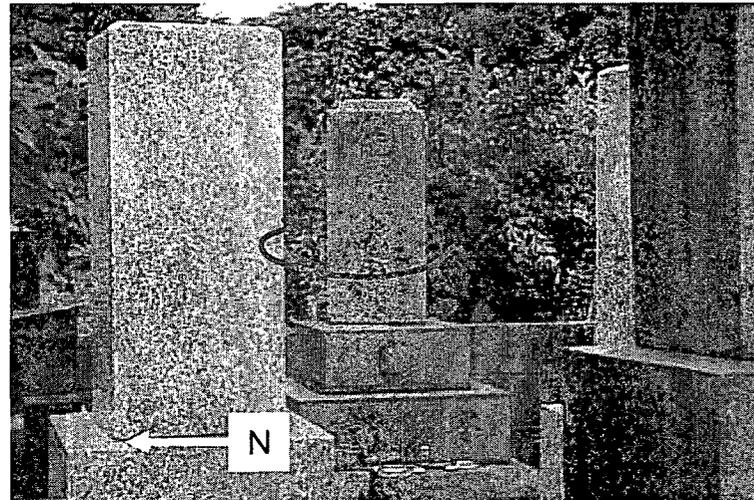
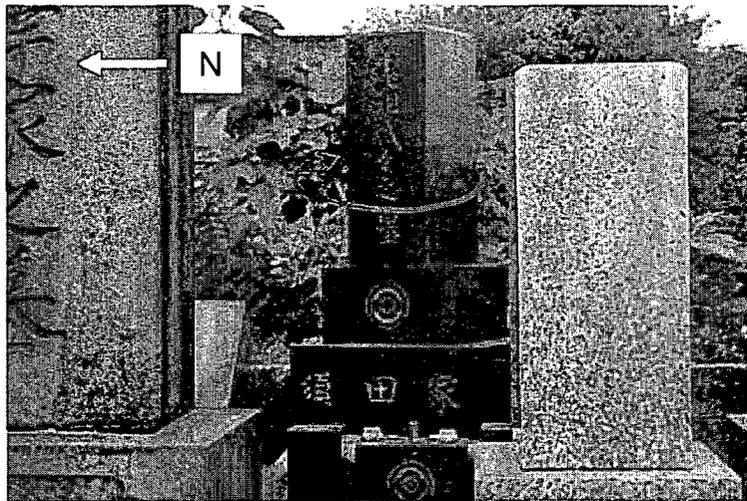
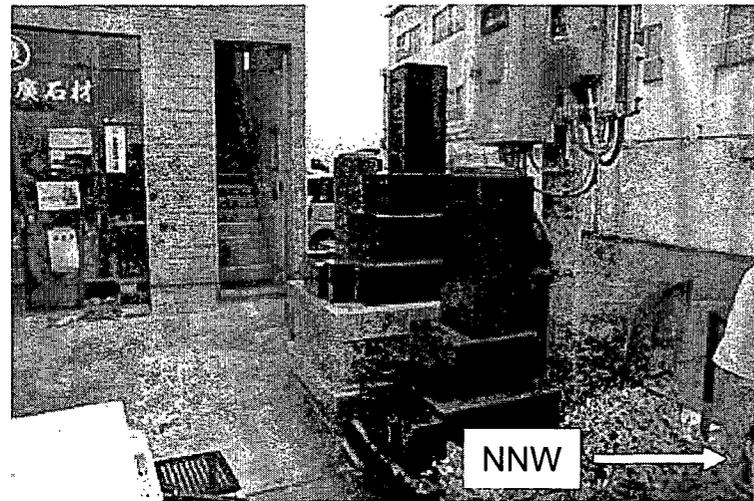
Many Japanese-style tomb stones were rotated in the clockwise direction in Honmachi. However, some collapsed to the east and some slid to the west.
