# Preliminary report of the July 16, 2007 Niigata prefecture Chuetsu Off shore (Niigata-ken Chuetsu-Oki), Japan, Earthquake

Based on the reconnaissance conducted from July 17-19, 2007  
(Strong motion records by K-NET are acknowledged.)

Disaster Prevention Research Institute  
Kyoto University, Japan

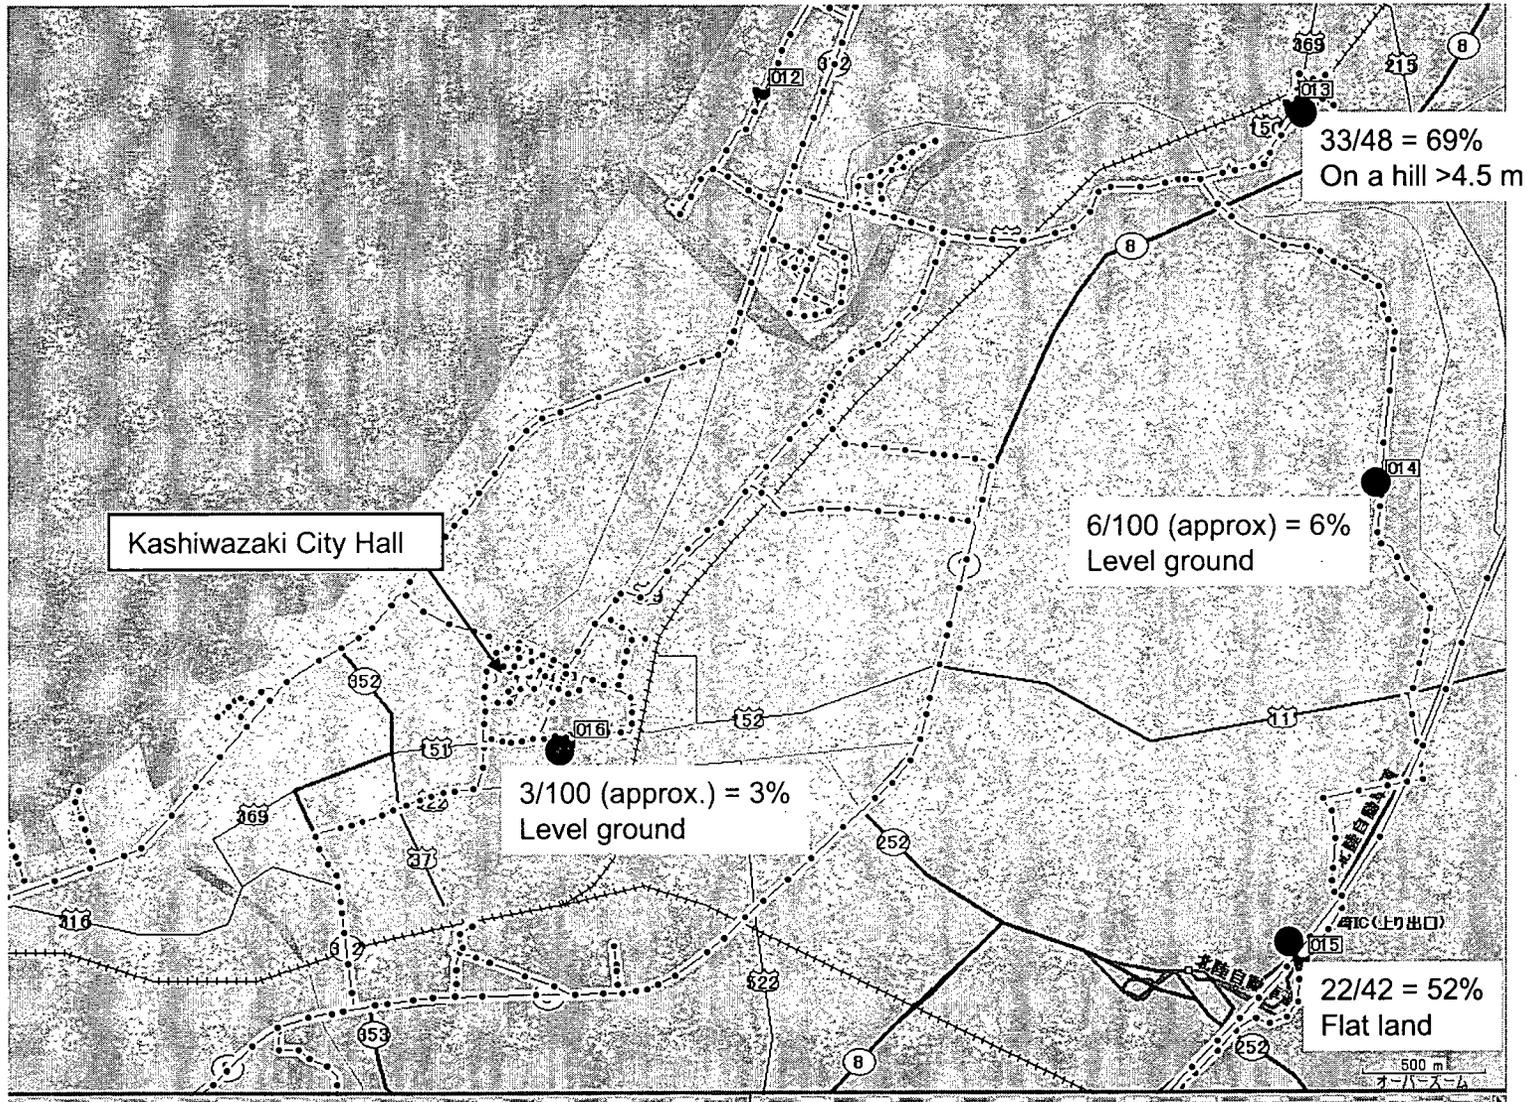
Overturning ratio of tomb stones (Number of overturning)/(Number of standing)

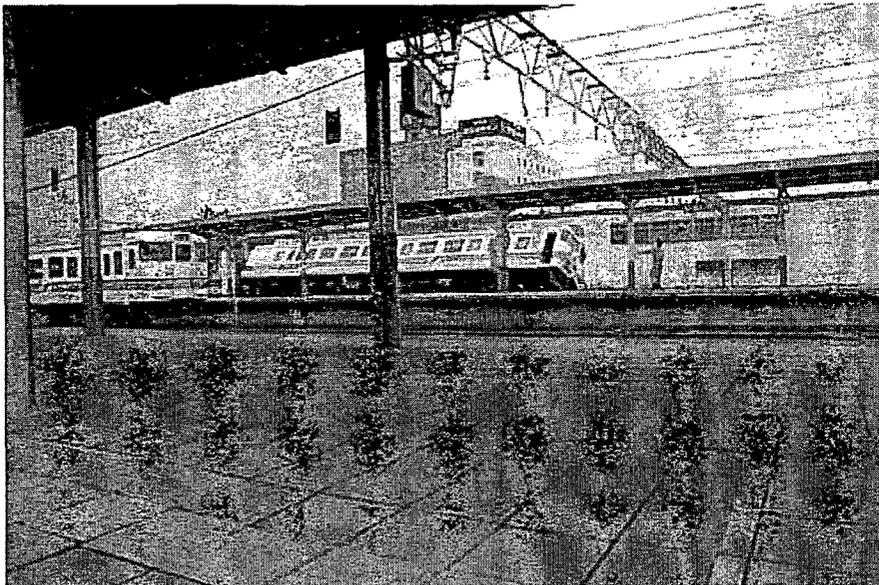
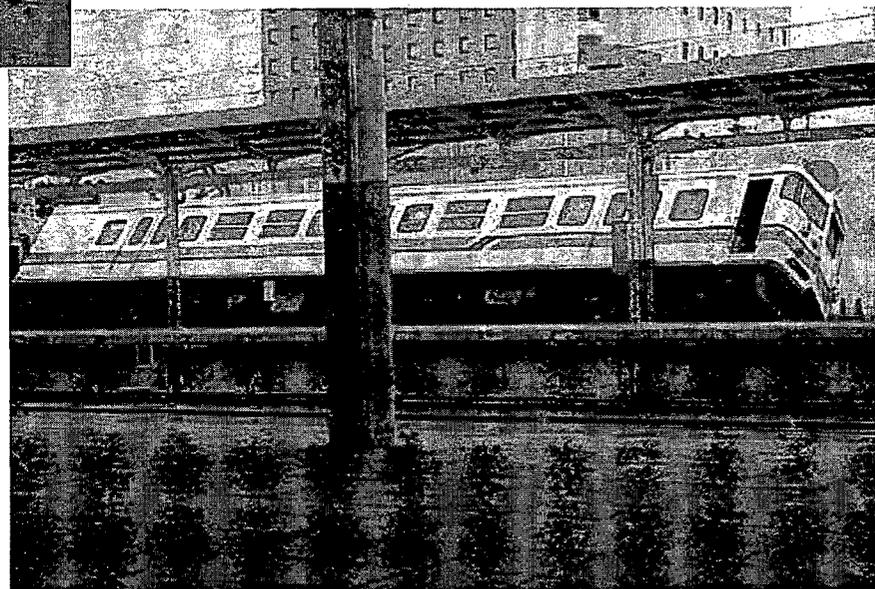
7/19/07: Kashiwazaki station

In Kashiwazaki station, first car of local lines, which consisted of two cars, derailed just before leaving at the station. Some passengers were on board, but no one was hurt.
