FERRET EXPLORATION COMPANY OF NEBRASKA, INC.

January 18, 1993

RE: Docket No. 40-8943  
License No. SUA-1534

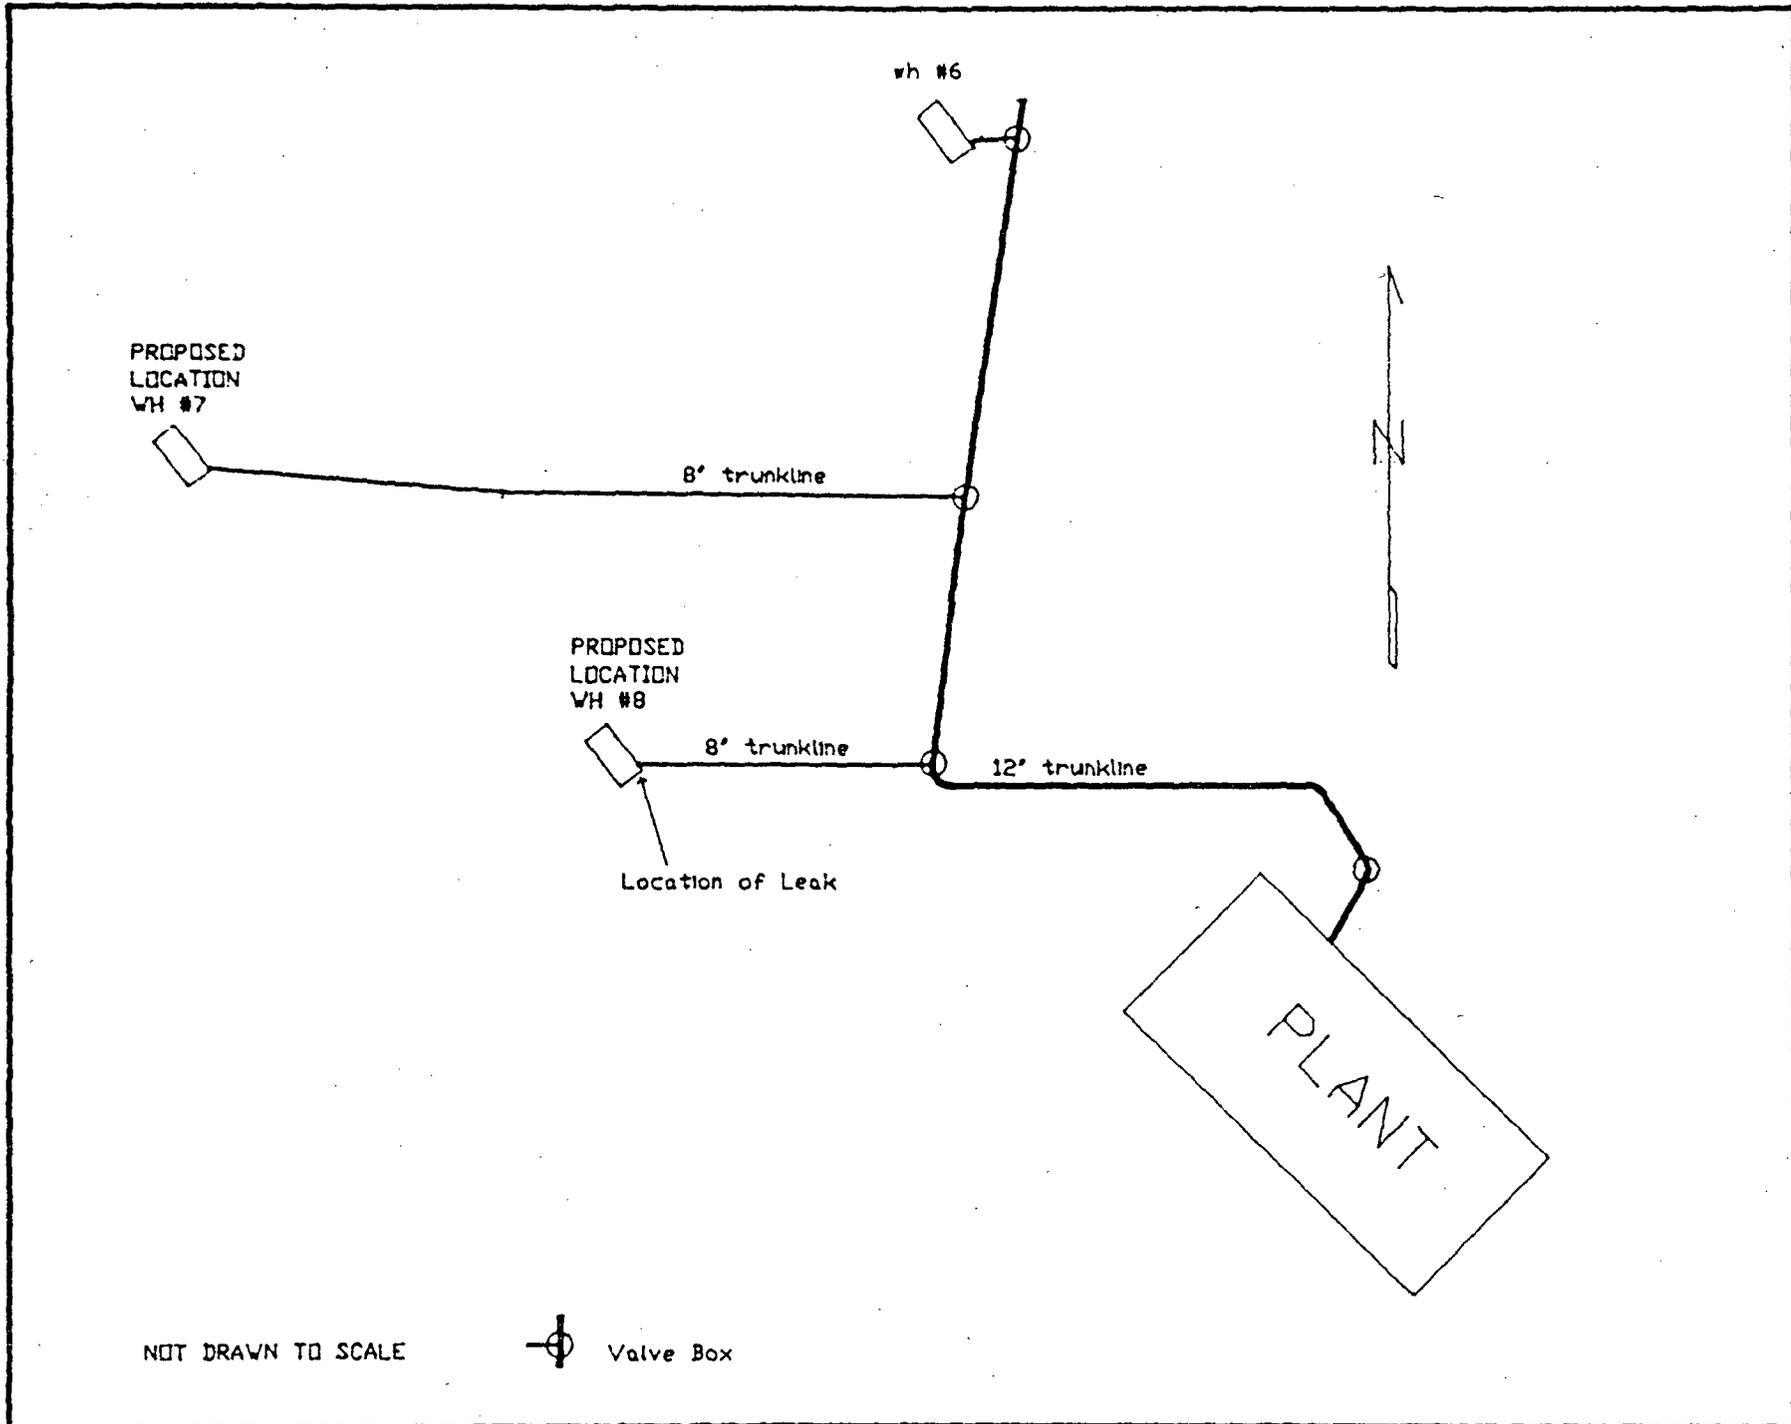
Location of Leak

Monday, January 11, 1993 at approximately 7:00 pm, FEN experienced a leak from an injection trunkline in Mine Unit 3 (MU3). Plant operators experienced a series of low flow alarms and upon immediate initial inspection of the operating wellfields did not detect a leak. Within twenty minutes from the first low flow alarm the injection tank level had dropped significantly and the plant was shut down. Upon further inspection of the wellfields, it was discovered a gasket type pipe joint had failed in a trunkline at the site of future wellfield house 8 (see enclosed map).

The section of trunkline that failed was not meant to be in service and should have been isolated by an in-line valve on the main trunkline. The valve was shut isolating the failed section of trunkline and the plant was restarted within approximately thirty minutes with no further problems. Interviews with all employees involved in trunkline construction and operation indicate no one is aware of how or when the valve may have been opened. The conclusion is the event was a result of inadvertent human error.

As a result of this spill and the subsequent inspection, FEN is writing a standard operating procedure dealing with the construction, operation, and maintenance of buried trunklines. FEN will also construct a small earthen berm to contain any future spills from MU3 and prevent their entry to Squaw Creek.
