February 7, 2008

Donald C. Cook Nuclear Plant Units 1 and 2
STEAM GENERATOR TUBE INSPECTION REPORT
REQUEST FOR ADDITIONAL INFORMATION

STEAM GENERATOR TUBE INSPECTION REPORT
REQUEST FOR ADDITIONAL INFORMATION

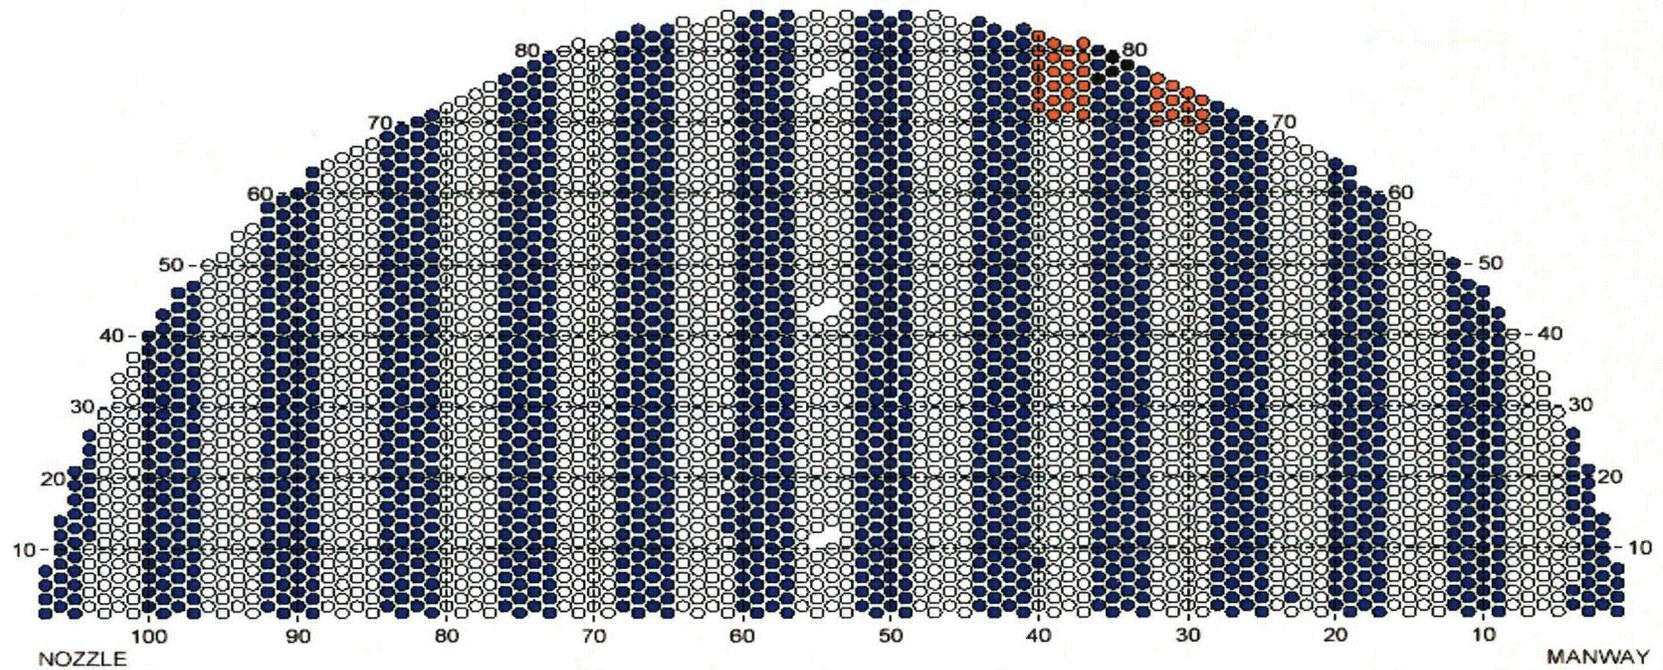
DC Cook Unit 1 SG 13 - Bobbin Coil Inspection

Tube R69C29 was not in the initial bobbin coil test plan, but was examined and detected as part of a bobbin coil expansion program (discussed below). Tubes R69C27 and R68C28 were in the original bobbin coil test plan; however, no indications of foreign objects/foreign object wear were identified by the bobbin coil probe.

During the U1C21 inspection, the base bobbin coil examination (blue pattern on Enclosure 1) detected indications of loose part wear affecting four tubes in the cold leg region of SG 13 within an inch of the top of the tubesheet. The four tubes involved were R79C35, R78C34, R77C35, and R76C36 (4 black tubes on Enclosure 1). There was no detection of a foreign object around these tubes from the eddy current examination. When the wear was first detected, the cold leg was not available for rotating coil eddy current examination. Since the bobbin coil had detected the indications, the examination was expanded (orange tubes) to fully bound the region with the

bobbin coil. This expansion detected a PLP indication in tube R69C29 at the top of the cold leg tubesheet and no additional indications.

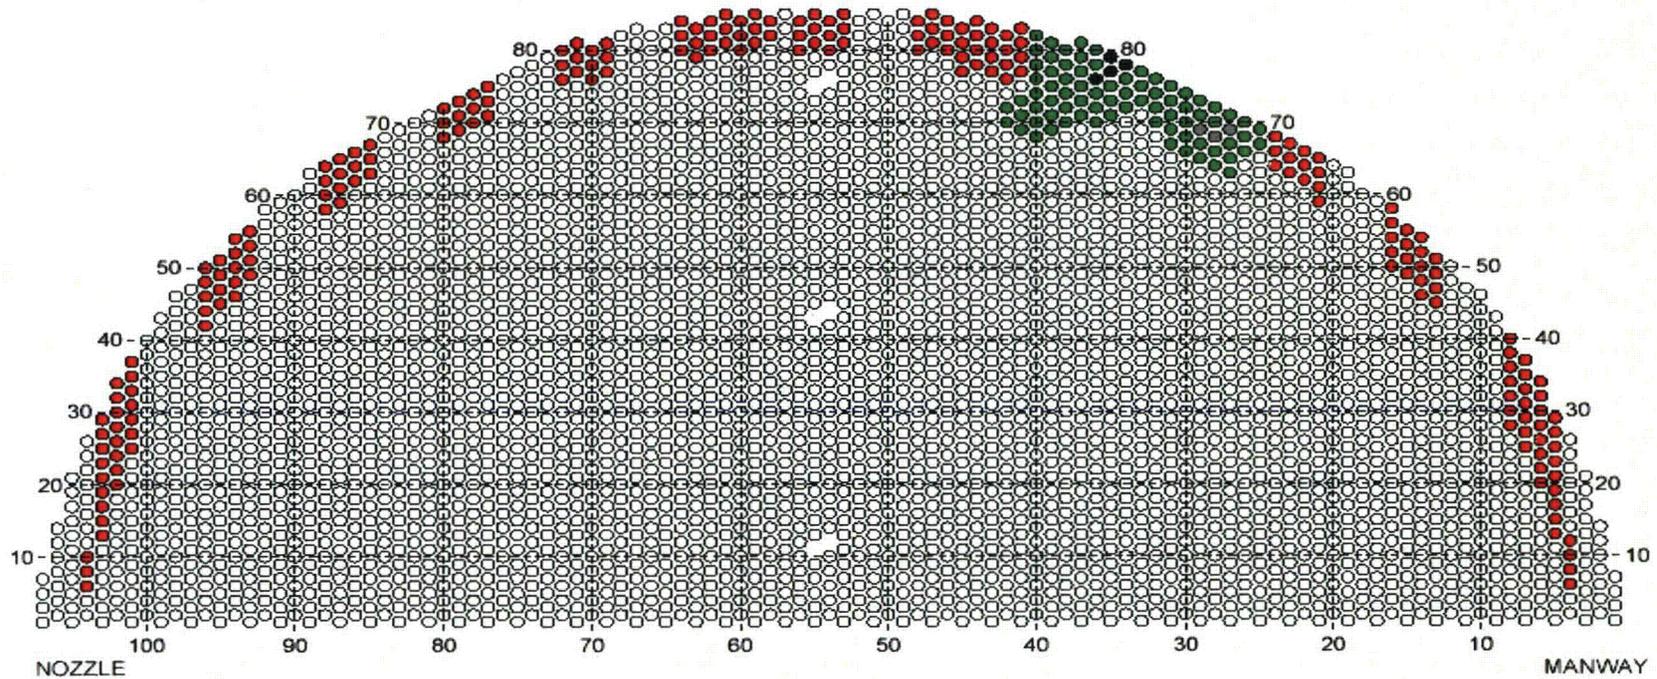
DC Cook Unit 1 SG 13 - Rotating Coil Expansions

Indications at tube R84C60 and R85C61 were identified during a rotating pancake coil (RPC) expansion program. Bobbin coil inspection of R84C60 did not identify the PLP signal and tube R85C61 was not in the bobbin coil inspection plan. Visual inspection subsequently determined that the PLP indications resulted from a sludge rock and no tube degradation was present.

To gain further insight into the initial indications and to investigate the PLP, a bounding rotating coil examination including the affected tubes and a border along a potential migration path of any potential loose parts was developed and executed once the cold leg was available for rotating coil examination (green tubes on Enclosure 2). This examination resulted in the detection of a second area of foreign object wear in the area of the PLP indication. This area involved tubes R69C29, R69C27, and R68C28 (grey tubes on Enclosure 2). Unlike the first area (R79C35, R78C34, R77C35, and R76C36), a loose part signal was detected in multiple tubes at this position (R70C28, R69C29, and R68C28) by the rotating coil.

The rotating coil examination was then further expanded around the periphery (red tubes on Enclosure 2) to address those cold leg periphery tubes that had not been previously inspected by the bobbin coil during U1C21. No other indications of foreign objects/foreign object wear were detected from these expansions.
