EA-08-046

SUBJECT: BYRON STATION, UNITS 1 AND 2 SPECIAL INSPECTION - DEGRADATION OF THE ESSENTIAL SERVICE WATER RISER PIPING TO THE COOLING TOWER BASIN 05000454/2007009(DRS) AND 05000455/2007009(DRS) AND PRELIMINARY WHITE FINDING

IR 05000454/2007009(DRS) and 05000455/2007009(DRS); 10/23/2007 - 02/14/2008; Byron Station, Units 1 and 2; Special Inspection to evaluate the facts and circumstances surrounding the degradation of the essential service water riser piping to the cooling tower basin.

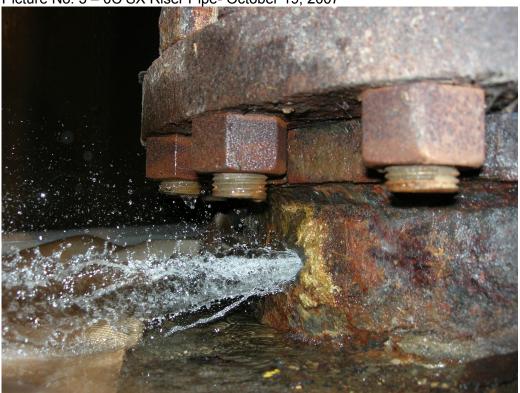
On October 19, 2007, during rust removal from the 0C essential service water riser pipe near valve 0SX163C, in preparation for pipe wall thickness measurements, a ½ inch diameter 10 gallon-per-minute leak occurred (Attachment 3, Picture No. 3). Because this section of pipe could not be isolated from other cells on the 0A essential service water cooling tower basin, the licensee declared the 0A tower of the ultimate heat sink inoperable, and shut down both Units due to entry into Technical Specification 3.7.9 (reference LER 2007-002-00). The riser pipe leak was caused by a loss of pipe wall thickness due to external corrosion induced by the wet environment surrounding the unprotected carbon steel pipe. The corrosion processes that caused this leak affected all eight similar locations on the essential service water riser pipes within vault enclosures and had occurred over many years. The NRC initiated a Special Inspection Team which consisted of Region III inspectors and a Region III Senior Reactor Analyst, with technical support from the Office of Nuclear Reactor Regulation staff. This team was chartered to evaluate the facts, circumstances, and licensee actions surrounding the degradation of the riser pipe.

Picture No. 3 - 0C SX Riser Pipe- October 19, 2007

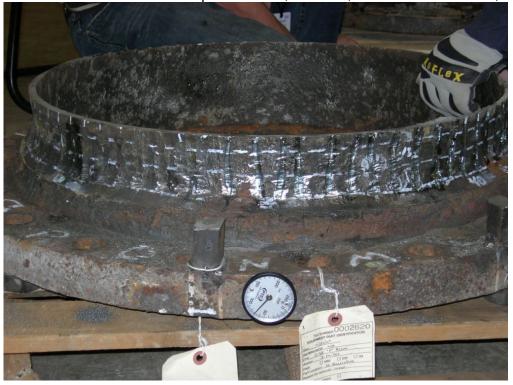
Picture No. 6 - 0F SX Riser Pipe Removed, Cleaned, with Grid- October 25, 2007

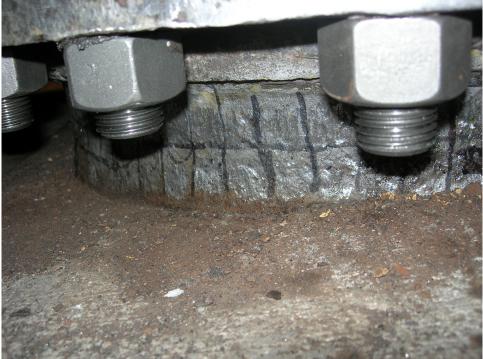
Picture No. 7 - 0D SX Riser Pipe- Cleaned with Grid - October 2007

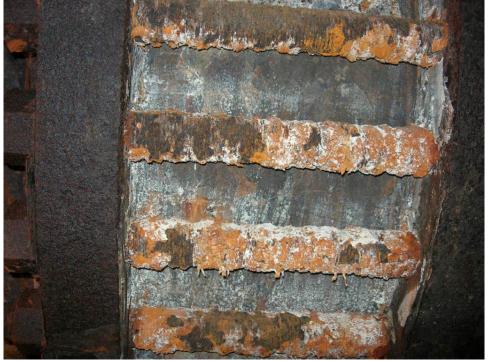
Picture No. 8- 0SX 138B Valve Bolting - October 2007

Green. The team identified a finding of very low safety significance and a Non-Cited Violation of 10 CFR Part 50, Appendix B, Criterion XVI, "Corrective Action," for the licensee's failure to identify severely corroded bolts (condition adverse to quality) on the 0B SX basin suction supply isolation valve 0SX138B. The cause of this finding was related to the Corrective Action Program Component (Item P.1(a) of IMC 305) for the cross-cutting area of Problem Identification and Resolution, because the licensee staff failed to adopt an appropriate threshold for identifying issues. Specifically, the failure of the licensee VT-2 examiner to identify these degraded bolts was related to an excessively high threshold for problem identification. The licensee entered this issue into the corrective action program and replaced the bolts on the lower half of this valve which were subjected to the most severe corrosion.
