Ministry of Economy,
Trade and Industry (METI)

Press Release Information	Nuclear and Industrial Safety Agency (NISA), Ministry of Economy, Trade and Industry (METI)
Consequences of "the Niigataken Chuetsu-oki Earthquake in 2007" at Kashiwazaki-Kariwa Nuclear Power Station, Tokyo Electric Power Company (the 5th report)

July 23, 2007

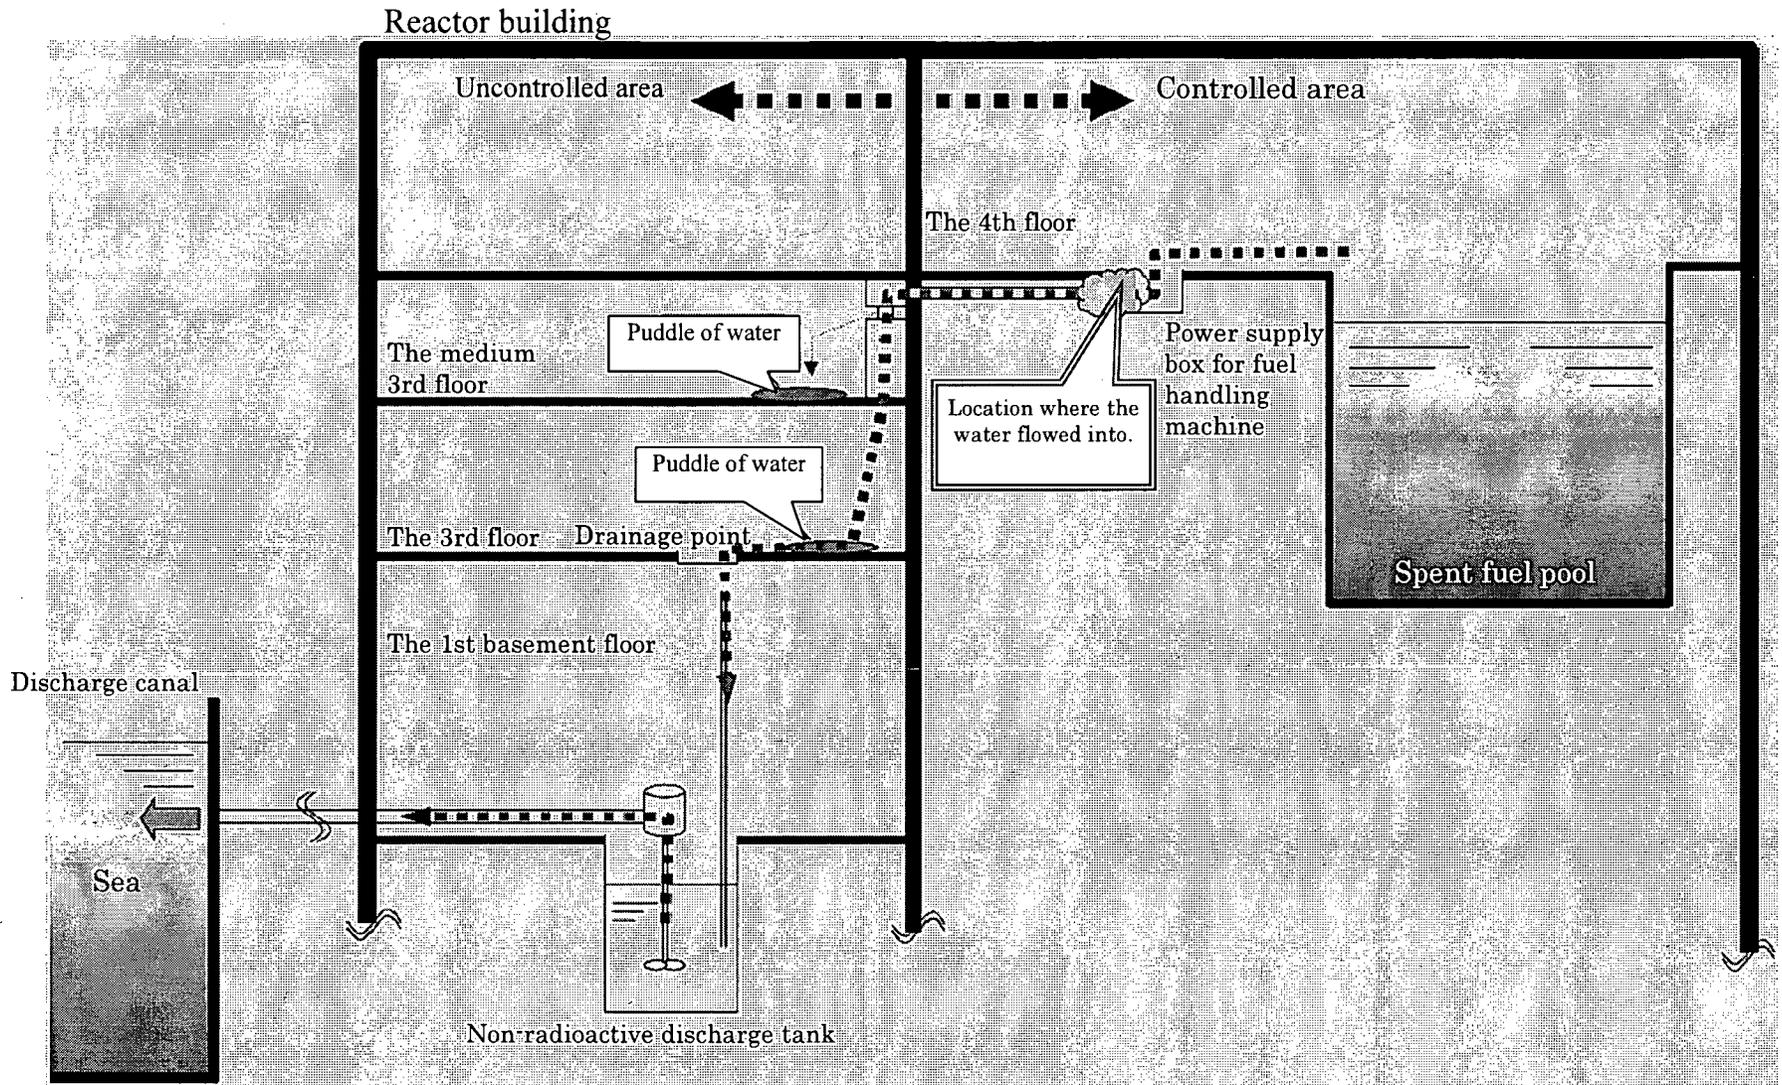
- 1) As for the water leakage in the uncontrolled area of Unit 6 (as announced on July 16), the water had splashed out of the spent fuel pool and flowed into the electric cable conduit and had dripped onto the medium 3rd floor from the area around the upper air conditioning system duct and the water had formed a puddle. Meanwhile, the water had dripped through the opening of the medium 3rd floor and had formed another puddle. It is estimated that the puddle water on the surface of the 3rd floor had flowed into the drain and had been discharged to the sea from the discharge canal. The work will be soon conducted to verify the validity of the estimated leak path (see the attached figure).

Schematic diagram of the water flow into the non-radioactive discharge tank and the water discharge to the sea at Unit 6
