SUBJECT:
Davis-Besse Nuclear Power Station
Docket Number 50-346, License Number NPF-3
Licensee Event Report 2007-002, Decay Heat Removal Discharge Piping Void Due to Inadequate Procedure for Venting Following Maintenance

1. FACILITY NAME Davis-Besse Nuclear Power Station				2. DOCKET NUMBER 05000346		3. PAGE 1 OF 6						
4. TITLE Decay Heat Removal Discharge Piping Void Due to Inadequate Procedure for Venting Following Maintenance

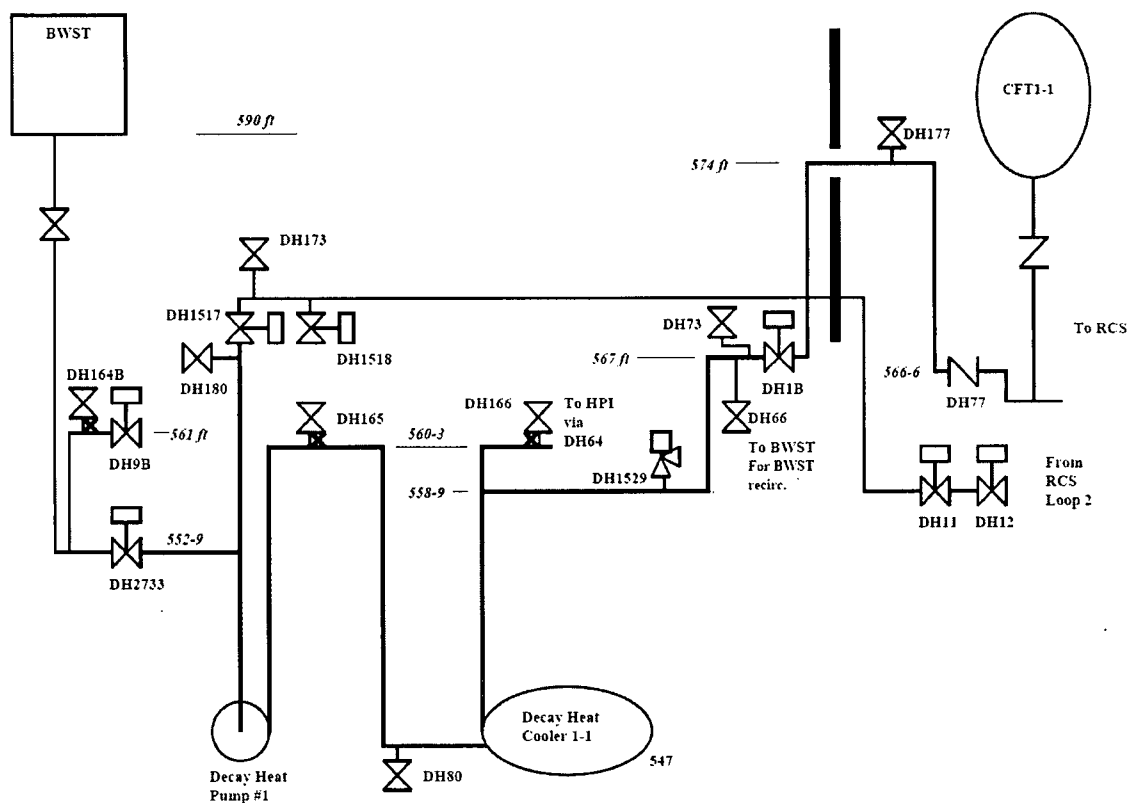
Figure 1

Neither the system operating procedure section for filling and venting Decay Heat Removal Train 1 following maintenance in Modes 1 to 3 nor the Operations Evolution Order contained instructions to vent from DH73, Decay Heat Pump 1 Discharge Line Leak Test Connection Valve, which was the high point of piping drained during the train outage. DH73 is located at elevation 567'-0" and venting from this location would have ensured the train was water solid to the upstream side of DH1B.

The initial size of the void was estimated to be approximately 15 cubic feet. This is based on the fact that when the void was created on October 31, 2007, valve DH1B (elevation 567' 0") was closed and the pipe was vented through valve DH166 (elevation 560' 3"), and there is approximately 26 feet of 10-inch pipe between these two elevations. Upon opening valve DH1B following maintenance, the void migrated to the true high point of the system, and expanded slightly (to approximately 17.4 cubic feet) due to the change in elevation. The void was well down stream of the branch connection for the HPI piggy back line and the connection for LPI recirculation to the BWST; therefore, no potential for voiding in the High Pressure Injection (HPI) piping existed. The quarterly LPI pump flow surveillance test, which utilized the recirculation line to the BWST, was performed without issue on November 1, 2007.

Decay Heat Removal System Simplified Elevation Diagram

DB-OP-06012, Decay Heat and Low Pressure Injection System Operating Procedure, will be revised by adding the requirement to vent from valves DH73 for train 1 and DH72 for train 2 to the procedure sections for filling and venting Decay Heat Removal Trains following maintenance in Modes 1 to 3.
