ATTN: Document Control Desk
United States Nuclear Regulatory Commission
Washington, D.C. 20555-0001**SUBJECT:**Davis-Besse Nuclear Power Station
Docket Number 50-346, License Number NPF-3
Licensee Event Report 2008-001, Pressure Boundary Leak Found During Decay Heat
Removal Drop Line Weld Overlay

1. FACILITY NAME Davis-Besse Nuclear Power Station					2. DOCKET NUMBER 05000346		3. PAGE 1 OF 6				
4. TITLE Pressure Boundary Leak Found During Decay Heat Removal Drop Line Weld Overlay

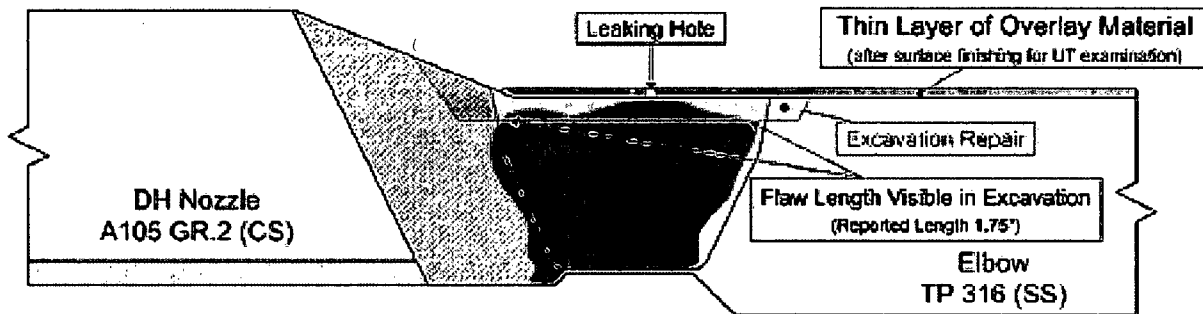
Figure 1: 12 Inch Decay Heat Drop Line Branch Connection Weld

Based upon an ODMI recommendation, the refueling canal was filled and the core was offloaded as originally scheduled. The leakage was measured as less than one drop per minute with at least 23 feet of borated water covering the top of the irradiated fuel assemblies seated within the reactor pressure vessel. Once the core was offloaded, work proceeded on repair of the weld. The first layer of the overlay was ground smooth to allow ultrasonic examination using the phased array technique. A recently developed manual phased array ultrasonic examination procedure was qualified such that it addressed the configuration of the hot leg to Decay Heat Removal Drop Line nozzle and dissimilar metal butt weld region in order to characterize the flaw. This qualification included detection and depth sizing of flaws in dissimilar metal butt welds and was demonstrated on samples containing implanted cracks. Utilizing an EPRI Performance Demonstration Initiative (PDI) mock-up, a detailed examination plan was developed to minimize the scan restrictions existing on the dissimilar metal weld region. The technique used a 32 x 32 element phased array search capable of generating angles from 0 to 84 degrees in one degree increments for circumferential flaws, and 0 to 69 degrees for axial flaws (limited by physical restraints of the wedge). The search output is raster scanned to the extent that the configuration of the dissimilar metal weld geometry allows. The phased array examination determined that the flaw was an axial flaw approximately 1.75 inches long, wholly contained in the dissimilar metal butt weld and had a profile consistent with other stress corrosion cracking axial flaws in alloy 82/182 weld material that have been confirmed in other plants. No other flaws were noted during this initial ultrasonic examination of the decay heat nozzle weld. Refer to Figure 1 for a diagram of the weld and flaw.

At the completion of the ultrasonic examination, a cavity two inches wide, 2.5 inches long and approximately 0.375 inches deep was ground into the weld and adjacent base material in order to prepare the area for evaluation and repair. The UT Examination of the area and the excavated cavity confirmed that the flaw was axially oriented and allowed the configuration of the dissimilar metal butt weld region to be more accurately depicted.

The axial flaw was located in the alloy 82/182 portion of the dissimilar metal weld. The thickness of the alloy 82/182 portion of the dissimilar metal weld is approximately 1.25 inches. The Decay Heat Removal Drop Line had been in service for 19.25 effective full power years (EFPY) at a temperature of 606.4 degrees Fahrenheit.

The probable cause of the axial flaw in the hot leg to decay heat removal nozzle dissimilar metal butt weld was determined to be the result of PWSCC that resulted in the axial flaw progressing through-wall, and resulted with water seeping during the application of the structural weld overlay. The stress corrosion failure mode is supported by ultrasonic examination results which confirm a similar profile and characteristics to stress corrosion cracking at other plants established by metallurgical examination.

Corrective actions taken to repair the leak included excavation of a cavity, peening the area of the flaw, seal welding, completion of the planned full structural weld overlay, and an acceptable ultrasonic examination. The implementation of the structural weld overlay provided a new RCS pressure boundary, an acceptable method of preventing future PWSCC, and an acceptable contour for ultrasonic examination.
