April 16, 2008

UNITED STATES  
NUCLEAR REGULATORY COMMISSION  
OFFICE OF NUCLEAR MATERIAL SAFETY AND SAFEGUARDS  
WASHINGTON, D.C. 20555

NRC INFORMATION NOTICE 2008-08: MAINTENANCE PROCEDURES COMPROMISE  
DOUBLE-CONTINGENCY OF UO<sub>2</sub> POWDER-  
HANDLING EQUIPMENT AT FUEL CYCLE  
FACILITY

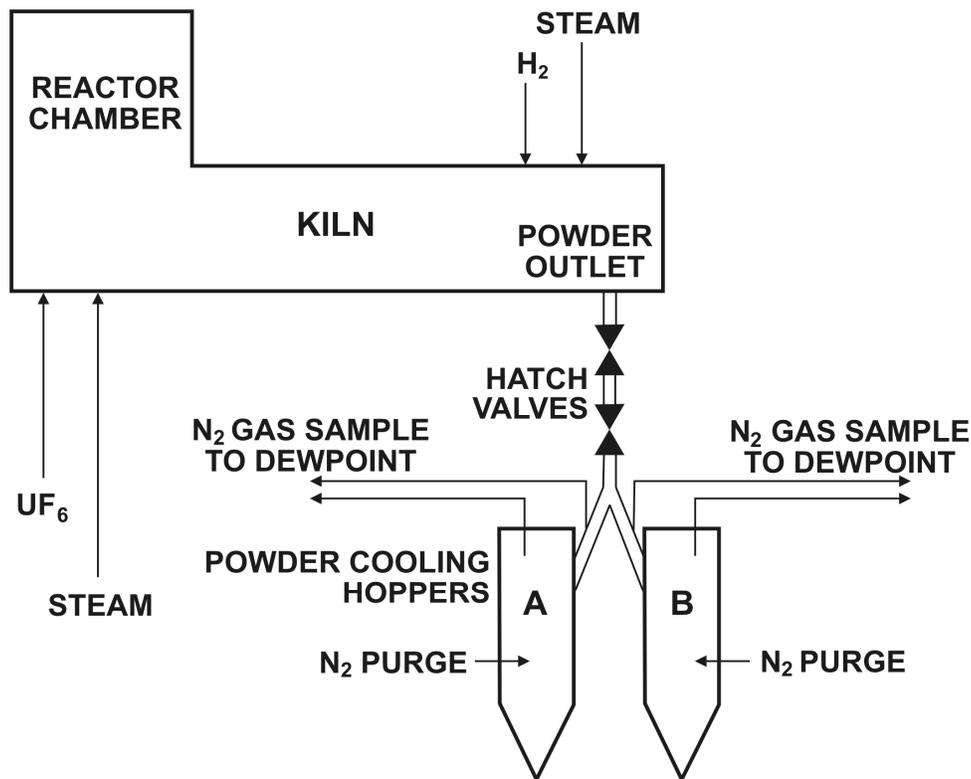
**Figure 1**  
**Conversion Reactor/Kiln and Cooling-Hopper Equipment Arrangement**

The licensee was performing maintenance consisting of rebuilding the conversion reactor/kiln on one of the dry-conversion lines. The maintenance included replacing the two in-line hatch valves leading to the cooling-hoppers. During the maintenance, one of the two hatch valves was incorrectly connected to its actuator, which resulted in the valve not being able to fully close. After completion of the maintenance, the licensee performed startup testing of the rebuilt equipment, which included sending steam to the reactor/kiln and cycling the hatch valves, to ensure that both hatch valves were properly seating. Hatch valve cycling consists of opening and closing one valve at a time and then pressure checking between the valves, while both are closed, to ensure that there is no direct path for steam to enter the hoppers. Pressure conditions between the two closed hatch valves could not be achieved and the licensee halted the start-up testing. To troubleshoot the condition, the licensee placed the equipment in hot-maintenance standby, which included shutting off the steam to the reactor/kiln.

During the specific troubleshooting of the condition, licensee maintenance personnel secure nitrogen flow to the cooling-hoppers to reduce the likelihood of airborne contamination. Licensee personnel anticipated that moisture sensors would trip the appropriate alarms and interlocks because of the intrusion of ambient air when the nitrogen was shut off. Maintenance personnel informed the dry-conversion area control room of the nitrogen flow being secured. As the troubleshooting progressed, the moisture sensors alarmed and then interlocked, which triggered the steam/UF<sub>6</sub> cutoff. Licensee operators acknowledged the moisture alarm, but failed to notice the interlock status.

Dry-conversion process operators beginning a subsequent shift in the facility noticed the activated cooling-hopper moisture interlock and observed that cooling-hopper A contained approximately 36 kilograms of UO<sub>2</sub> powder. Licensee management, unaware that the interlock had occurred during troubleshooting, decided that the moisture interlock possibly resulted from steam introduced during startup testing. Because the cooling-hoppers are a nonfavorable geometry and the amount of uranium involved appeared to be over the licensee's 31 kilogram safety limit for uncontrolled powder, licensee staff initiated an alert.

Subsequently, the powder in cooling-hopper A was determined to be dry. The licensee investigation concluded that the moisture detector tripped the interlock because of ambient air intrusion during troubleshooting, and that the maintenance staff had not passed on the information because they had not noticed the interlock status.

Because the licensee criticality safety staff thought that no fissile material would be present in equipment during maintenance, this staff did not normally review maintenance procedures. NRC expects licensees to provide for double-contingency protection during all phases of operations at their facilities, including maintenance. To this end, fuel cycle licensee criticality safety staff members are expected to be familiar with the conduct of process equipment maintenance, in particular, how maintenance procedures affect criticality-related controls.
