Subject: LER 2008-001-00- Manual Reactor SCRAM Due to Loss of Main Electrical
Output Transformer Cooling

Grand Gulf Nuclear Station, Unit 1
Docket No. 50-416
License No. NPF-29

4. TITLE Manual Reactor SCRAM Due to Loss of Main Electrical Output Transformer Cooling

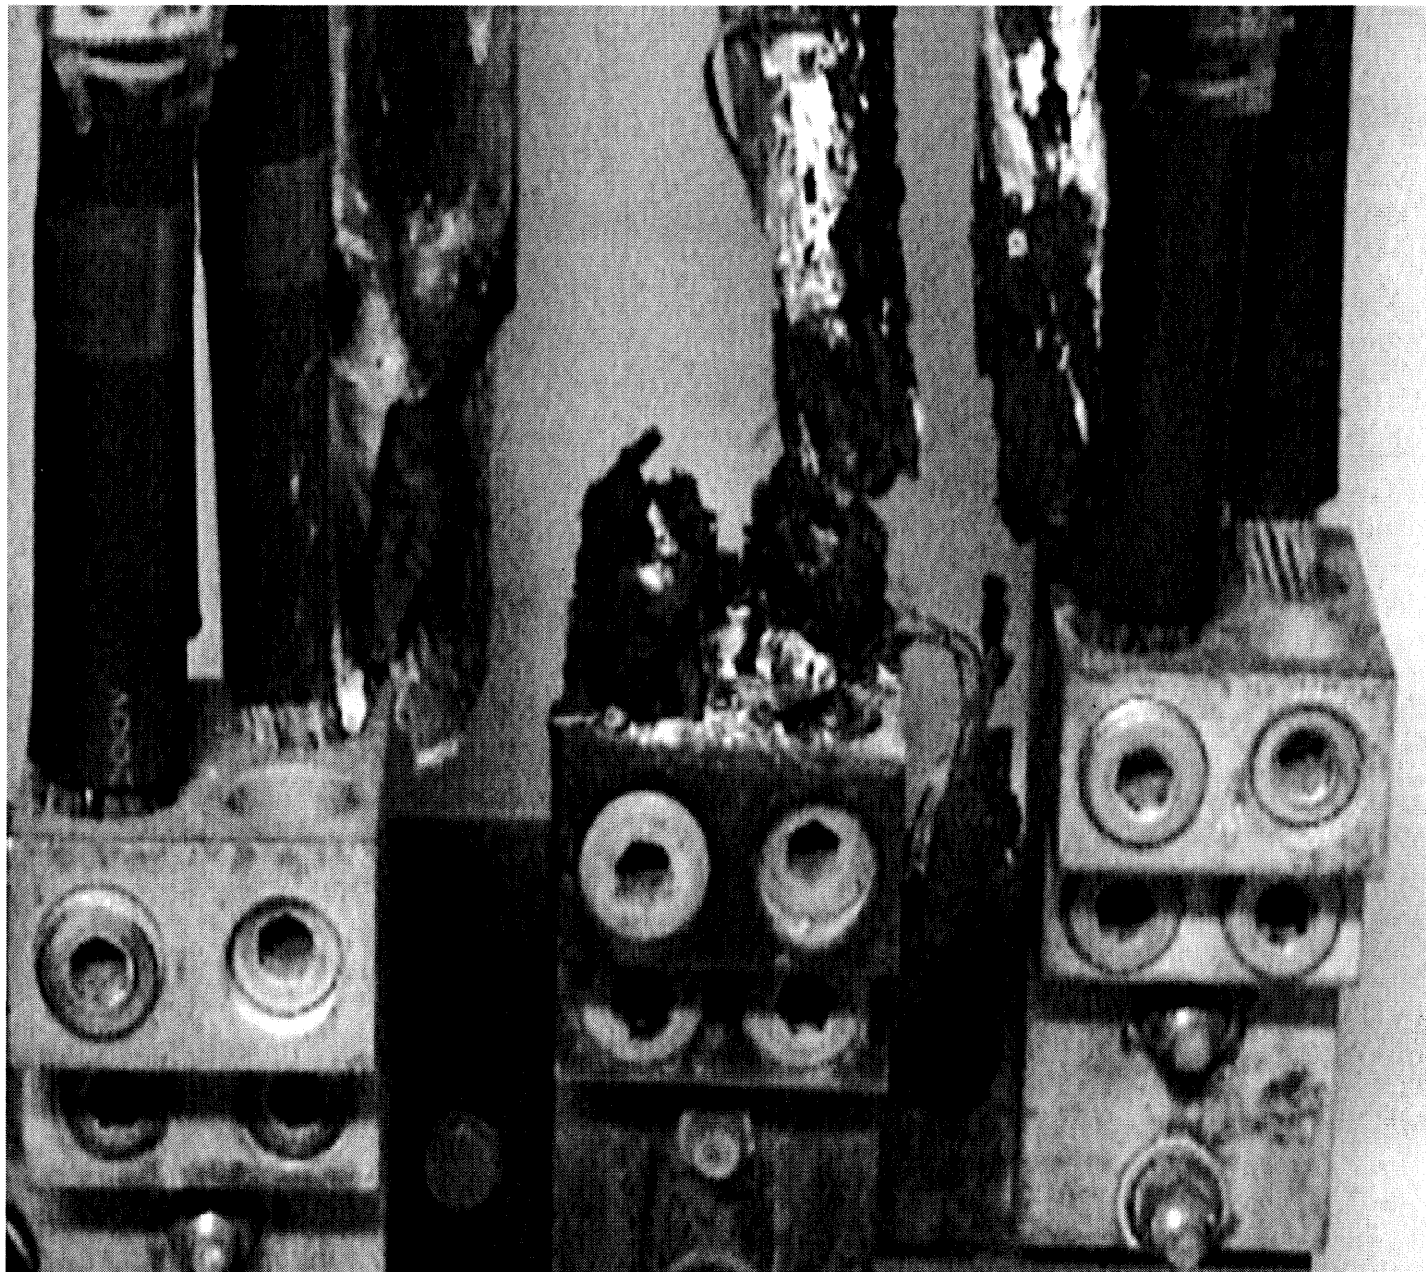
Figure 1 – As Found Condition

The cause of this event was the loss of cooling to the Main Transformers caused by loss of Auxiliary Power to the Main Transformer cooling system. Inspection of the complete circuit for Main Transformer Auxiliary Power showed that the "B" phase power cables were found to be burned in two at the transfer switch panel. The cause of the "B" phase power cable failure is attributed to failure of an electrical compression connection on a lug connection. This particular cable and connection has been inservice since plant start-up. Potential root causes were determined to be use of a compression connection for high current applications versus the preferred crimp type connection and an inadequate preventive maintenance strategy to provide early detection. Corrective actions included an inspection of the power panel and replacement of all damaged cabling.

The cause of this event was the loss of cooling to the Main Transformers caused by loss of Auxiliary power to the Main Transformer cooling system. Inspection of the complete circuit for Main Transformer Auxiliary Power showed that the “B” phase power cables were found to be burned in two in panel 1SMT1 (transfer switch panel). The cause of the “B” phase power cable failure is attributed to failure of an electrical compression connection on a lug connection; the connection was manufactured by BURNDY®, Model No. D1281. The root cause of the power cable failure could not be conclusively determined by the initial investigation. This particular cable and connection has been inservice since plant start-up. One potential root cause was determined to be use of a compression connection for high current applications versus the preferred crimp type connection. Another potential root cause was there was an inadequate preventive maintenance strategy to provide early detection. Figure 1 provides a picture of the failed connection.

Immediate Corrective Actions – Completed inspection of the 1SMT1 Transfer Switch Panel. All damaged cabling has been replaced. Inspection results indicate that no damage occurred to the affected transformers and all equipment responses were as designed and expected.
