St. Lucie Pressurizer Nozzle DM Weld Examination Project

Internal Office Report

St. Lucie Pressurizer DM weld examinations

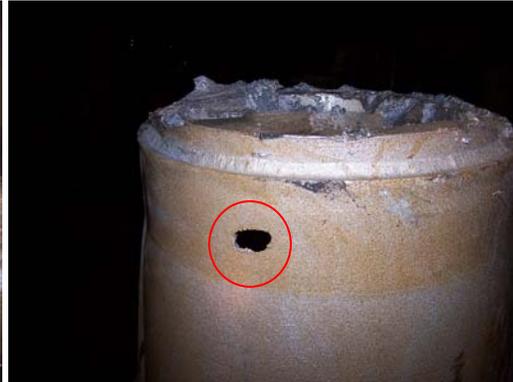
Flame cut hole in the DM weld

All six nozzle DM welds on the former St. Lucie Combustion Engineering Pressurizer vessel were successfully examined from both the OD and ID with liquid dye penetrant, and were volumetrically examined by the Phased-Array UT method, using Structural Integrity Associates PDI qualified procedure SI-UT-130. The only limitations to these examinations were on the Surge nozzle, where initial attempts to remove the end plug by flame cutting had resulted in extensive damage to the ID surface and in one area had resulted in a hole through the middle of the DM weld.

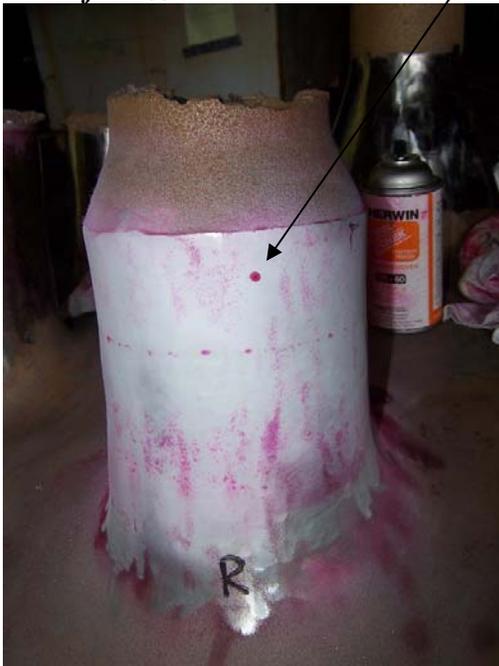
On Tuesday, we set up and performed liquid dye penetrant (PT) examinations of the OD surface of each DM welds. There were two small rounded indications noted during the OD PT exams. One was on the Relief nozzle, in the DM weld surface area. And the other was on the “C” Safety nozzle, also in the DM weld surface.

Relief Nozzle OD PT indication

The OD surface PT examinations of these six nozzle welds resulted in two recordable indications. One small rounded indication was recorded in the Relief nozzle DM weld crown surface. One small rounded indication was recorded in the “C” Safety nozzle DM weld crown surface. Both of these indications were indicative of porosity-type indications, which may have been uncovered during the bead blasting and flapping processes. Further surface preparations were not performed in the areas of these indications to see if they could be removed.

The two rounded indications recorded during the OD PT examinations are not unusual, during normal ISI surface examinations. Additional grinding would normally be prescribed to attempt to remove these indications. Surface Eddy Current examination could also be utilized to determine if these indications become linear underneath the surface.

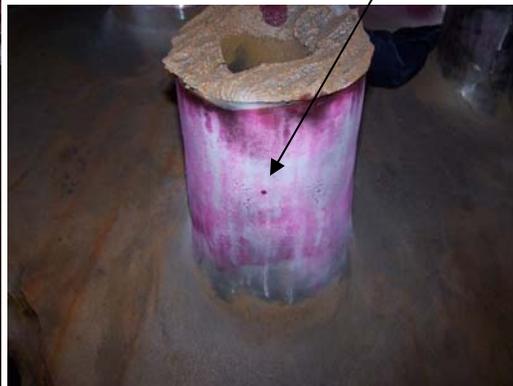
“C” Safety nozzle OD PT indication

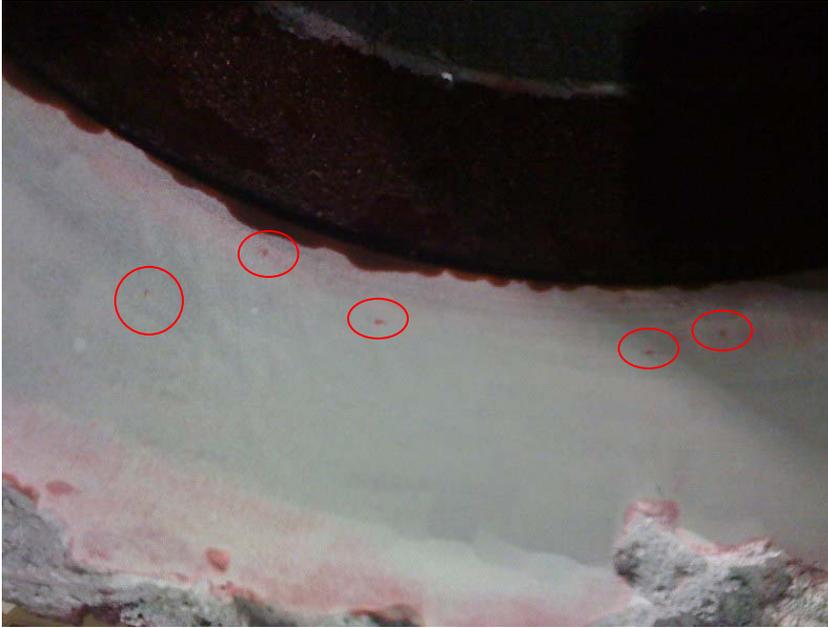
Faint ID PT indications on the Surge nozzle

The ID surface PT examinations of the nozzles resulted in multiple, well defined, aligned surface indications being recorded in the weld root area of the "A" and "C" Safety nozzles and the Spray nozzle. The "B" Safety nozzle and Surge nozzle each showed a few faint indications in the weld root area, which were not as well defined, but were recordable. The Relief nozzle did not reveal any ID surface indications. As with the OD surface indications that were noted, all of these ID connected indications could have been uncovered during the surface preparation activities. Further surface preparations were not attempted in the areas of any of these ID indications to see if they could be removed.
