St. Lucie Pressurizer Nozzle DM Weld Examination Project

Internal Office Report

St. Lucie Pressurizer DM weld examinations

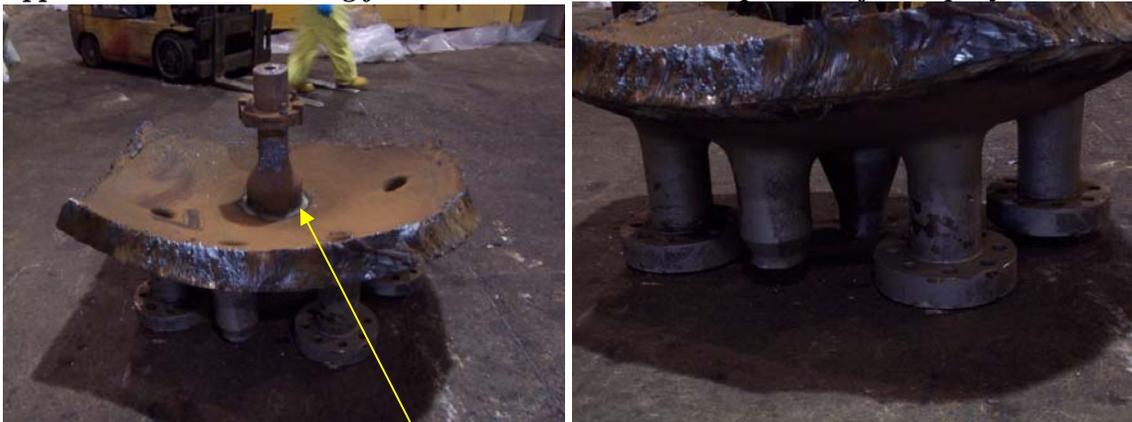
Upper Head Piece showing five nozzles and the internal portion of the Spray nozzle

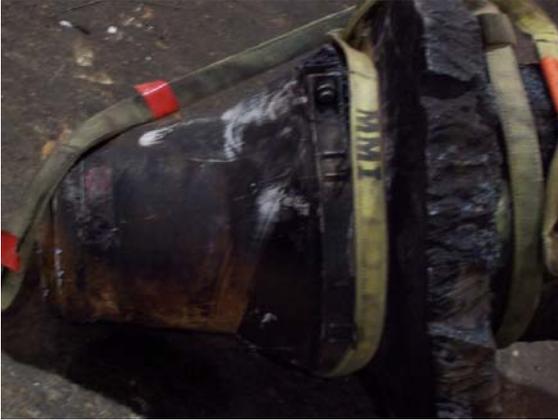
Lower head containing the Surge nozzle

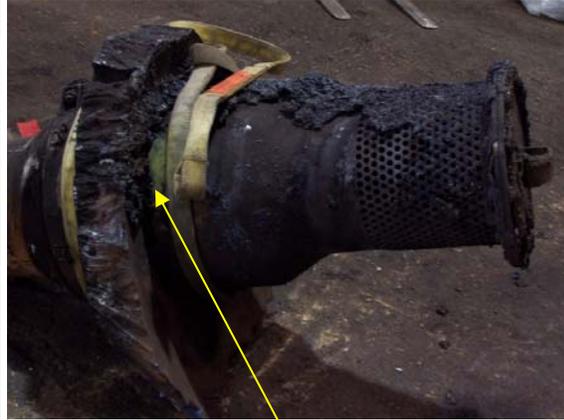
Internal portion of Surge nozzle

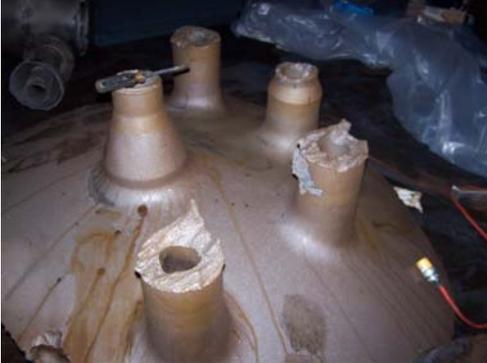
Upper Head after initial prep work

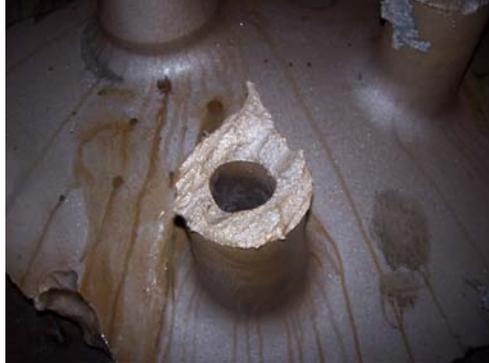
Safety nozzle after flange removal

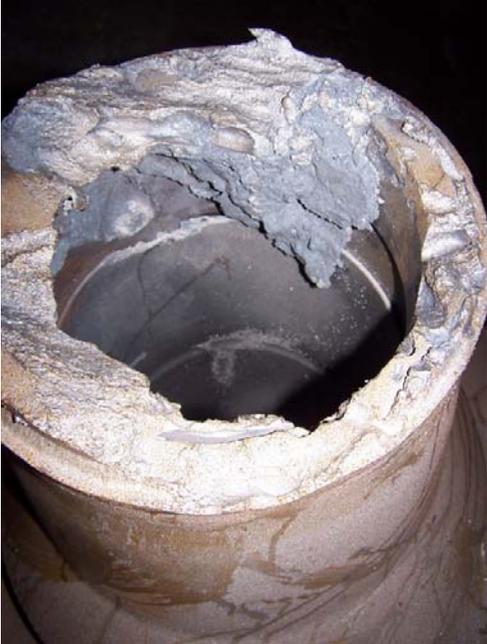
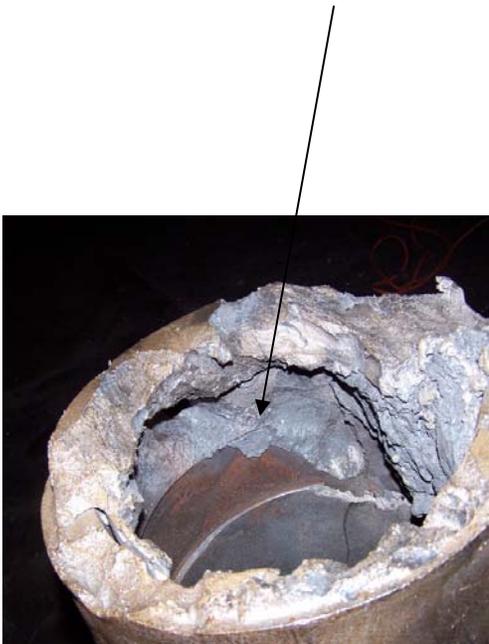
An assessment of the Surge nozzle, after complete plug removal showed that a great deal of the ID of the weld had been damaged by flame cutting.

Surge nozzle after initial prep work (note ID damage caused by flame cutting)

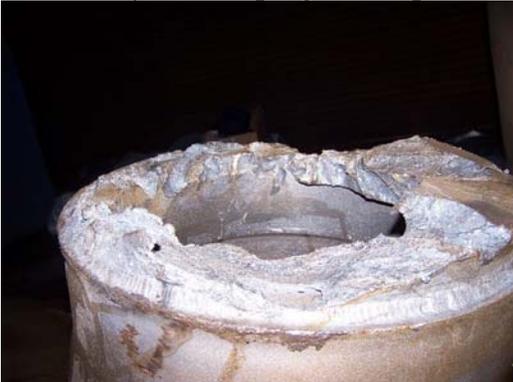
Portions of the end plug still in place

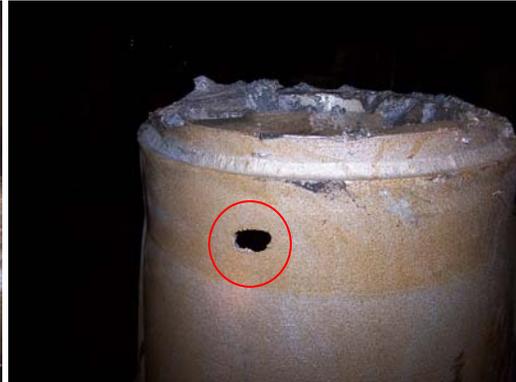
Flame cut hole in the DM weld

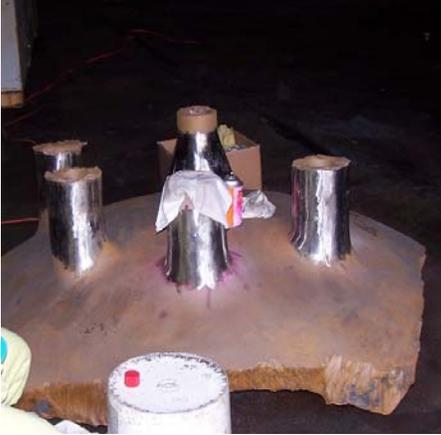
Upper head after flapping

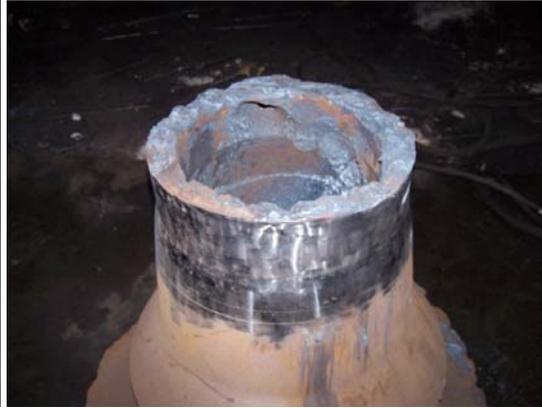
Surge nozzle after flapping and plug removal

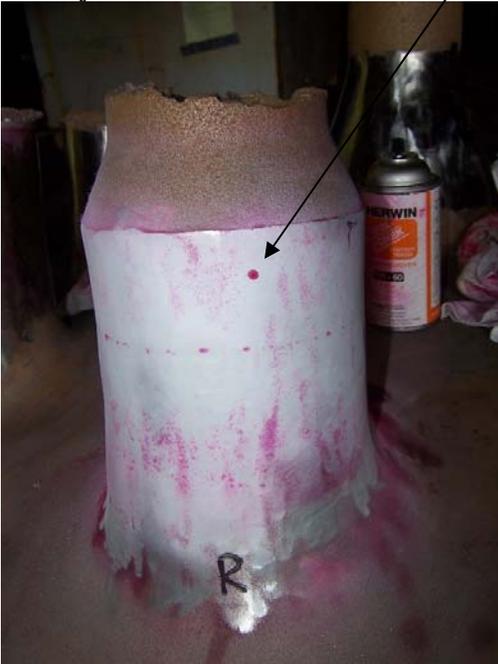
On Tuesday, we set up and performed liquid dye penetrant (PT) examinations of the OD surface of each DM welds. There were two small rounded indications noted during the OD PT exams. One was on the Relief nozzle, in the DM weld surface area. And the other was on the “C” Safety nozzle, also in the DM weld surface.

Relief Nozzle OD PT indication

The OD surface PT examinations of these six nozzle welds resulted in two recordable indications. One small rounded indication was recorded in the Relief nozzle DM weld crown surface. One small rounded indication was recorded in the “C” Safety nozzle DM weld crown surface. Both of these indications were indicative of porosity-type indications, which may have been uncovered during the bead blasting and flapping processes. Further surface preparations were not performed in the areas of these indications to see if they could be removed.

The two rounded indications recorded during the OD PT examinations are not unusual, during normal ISI surface examinations. Additional grinding would normally be prescribed to attempt to remove these indications. Surface Eddy Current examination could also be utilized to determine if these indications become linear underneath the surface.

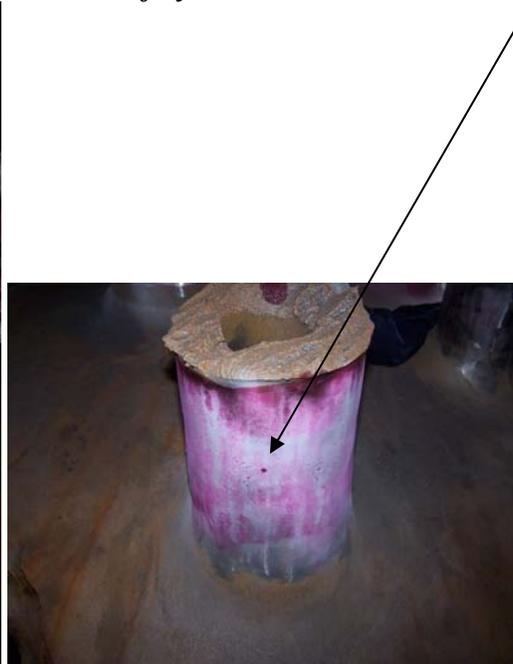
“C” Safety nozzle OD PT indication

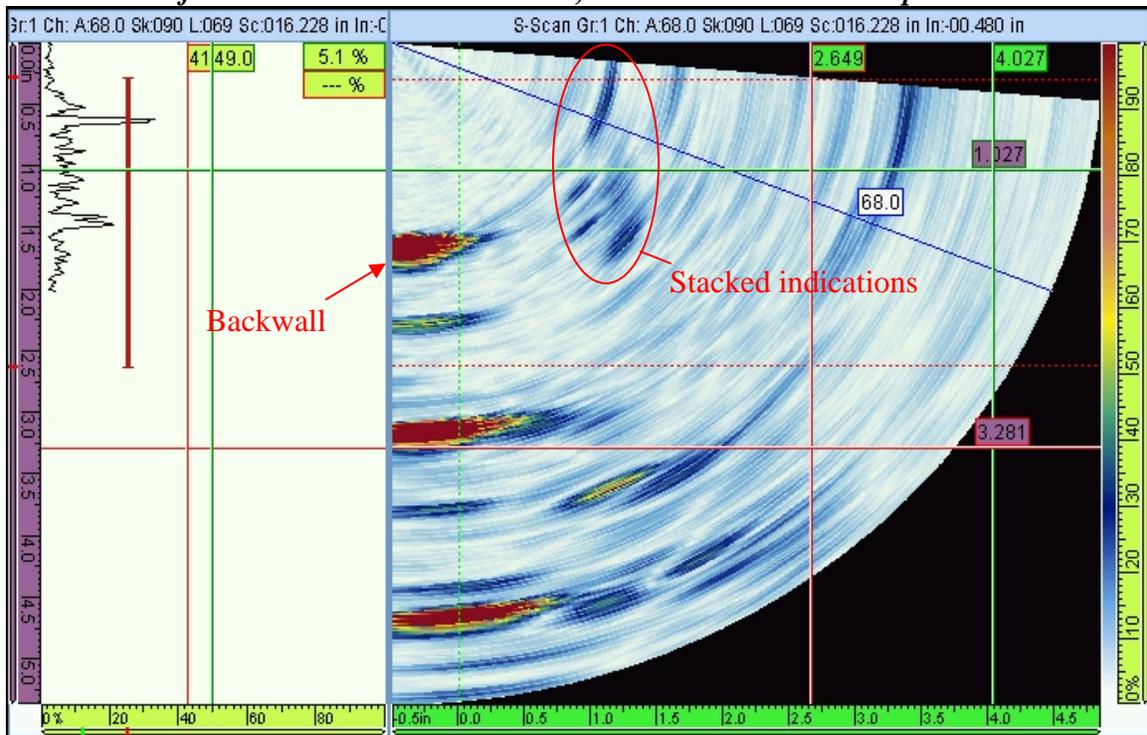
Tuesday afternoon, we began Phased-Array UT examination on the “A” Safety nozzle DM weld, using longitudinal ultrasonic sound beams projected from 0° to 80° angles. We immediately noted a large number of planar reflectors in the weld, which were stacked on top of each other and appeared to extend from the ID surface of the weld up to approximately 0.325” from the OD surface of the weld, at the deepest point. These reflectors were numerous and were present 360° around the circumference of the weld. When scanning across the tops of these indications, the UT sound beams that were projected normal to the surface (straight beams) did not pick up the indications, as you would expect them to if the indications were caused by internal inclusions. Under normal field examination conditions, these types of indications would have to be recorded and evaluated as one continuous linear planer flaw, seen 360° around the weld.

Screen shot of these stacked UT indications, as seen at the 3 o'clock position

The UT indications recorded on the three Safety nozzles contained multiple planar reflectors, which appear to be vertically stacked and extend from the ID surface to a significant through-wall depth. These indications are indicative of corrosion cracking, but could also be attributed to multiple stacked inclusions in the weld material, left over from construction. Performing automated UT on these three nozzle welds would allow for better flaw mapping and analysis. However, under normal field NDE conditions, these three welds would certainly be reported as containing 360° linear planar flaws of significant through-wall depth, which would require immediate repair.

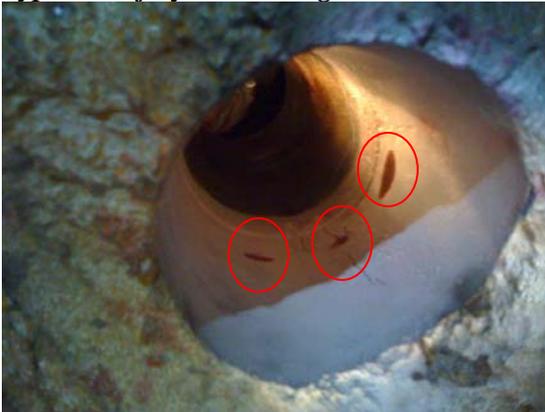
Typical Safety nozzle aligned ID PT indications

The ID surface PT examinations of the nozzles resulted in multiple, well defined, aligned surface indications being recorded in the weld root area of the “A” and “C” Safety nozzles and the Spray nozzle. The “B” Safety nozzle and Surge nozzle each showed a few faint indications in the weld root area, which were not as well defined, but were recordable. The Relief nozzle did not reveal any ID surface indications. As with the OD surface indications that were noted, all of these ID connected indications could have been uncovered during the surface preparation activities. Further surface preparations were not attempted in the areas of any of these ID indications to see if they could be removed.

The aligned ID PT indications noted on several of these nozzles could also be indicative of corrosion cracking. During many recent PT examinations of Reactor Upper Head penetration welds, PWSCC flaws were initially recorded as small aligned “snake bite” indications in the surface of the weld, which upon further surface grinding revealed linear cracking. However, it is also possible that the initial surface preparation of these welds uncovered inclusions in the weld material, which may have been removed upon further surface preparation. Surface Eddy Current examination could also be used to determine whether or not these indications are linked.

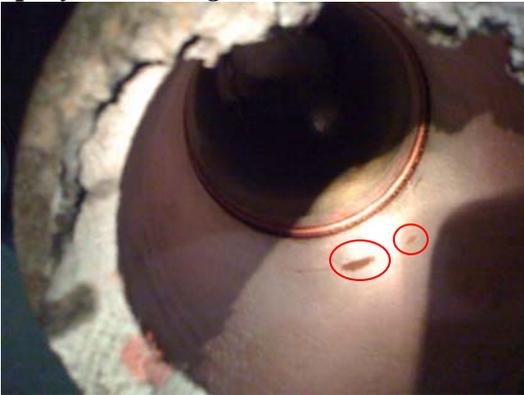
Spray nozzle aligned ID PT indications

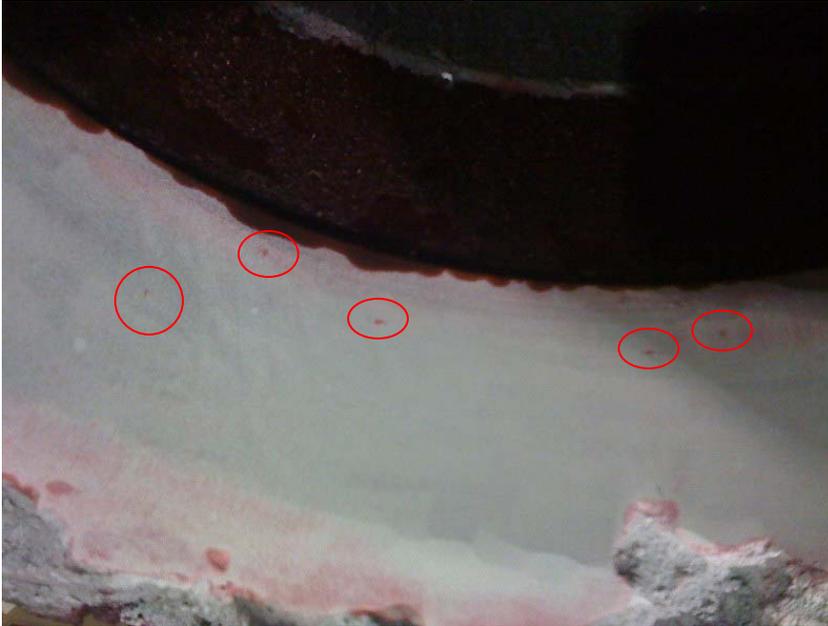
Faint ID PT indications on the Surge nozzle
