MRP Materials Reliability Program _____ MRP 2008-014
(via email)

Reference: MRP 2008-012 “Examination Results on Nozzles from removed St Lucie Pressurizer with attachment St. Lucie Pressurizer Nozzle DM Weld Examination Project Internal Office Report”

“A” Pressurizer Safety Nozzle Dissimilar Metal Weld
Circumferential Indication Profile

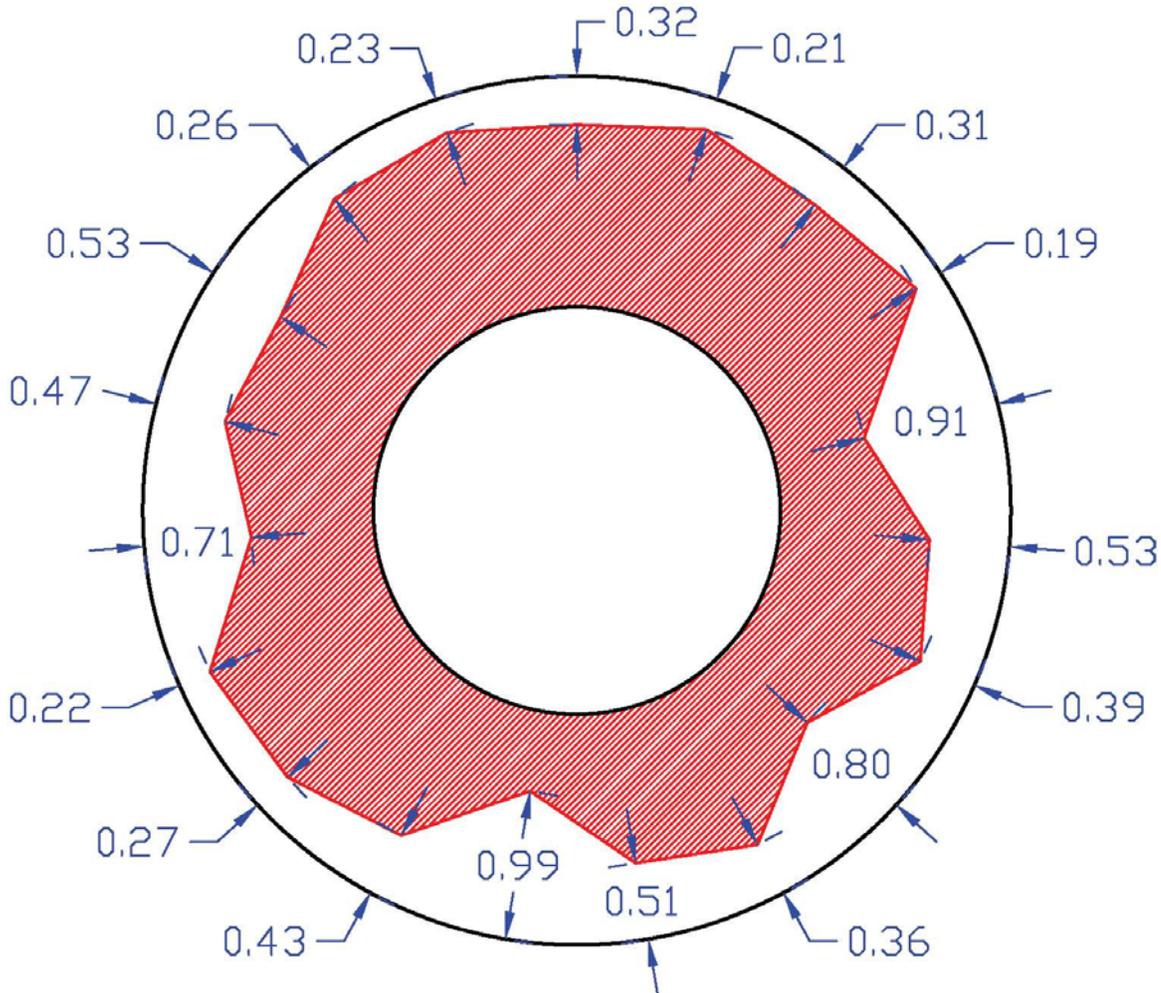
The graphic below represents a normalized side-view profile of the “A” Safety Nozzle DM Weld indication, based on ultrasonic depth measurements recorded at 1.0 inch increments around the circumference of the nozzle. The numbers, included below, represent the remaining ligament of material above the indication. The additional pages included with this graphic contain screen captures of each ultrasonic measurement location, as well as additional information that was used to derive the result.

The percentage of degraded material according to this graphic is estimated to be 64% of the total wall thickness. It should be noted, however, that this profile was created by taking 19 individual depth measurements and extrapolating a straight line in between them, which is not fully representative of what was noted during the actual field examination. In order to obtain a more accurate three-dimensional representation of the indication, or indications, it is recommended that an automated ultrasonic system be employed to take continuous measurements of the entire circumference of the weld.

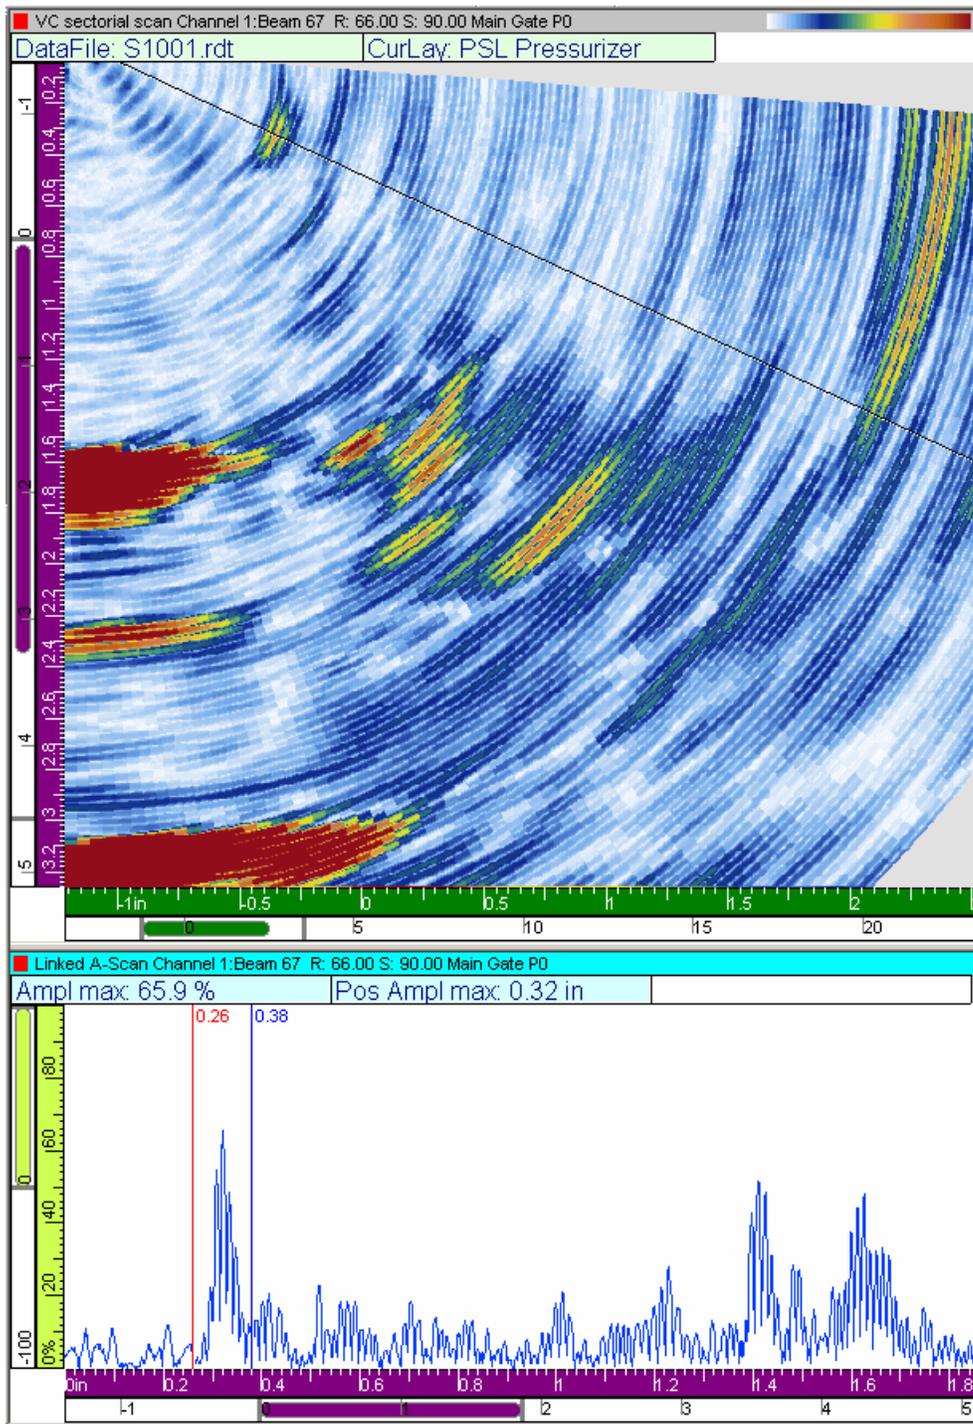
Location: At the “0” stamp (circumferential reference point)

Indication through-wall depth at this location: 1.38 inches

Estimated remaining ligament above the indication: 0.32 inches

Angle used for measurement: 67 degrees

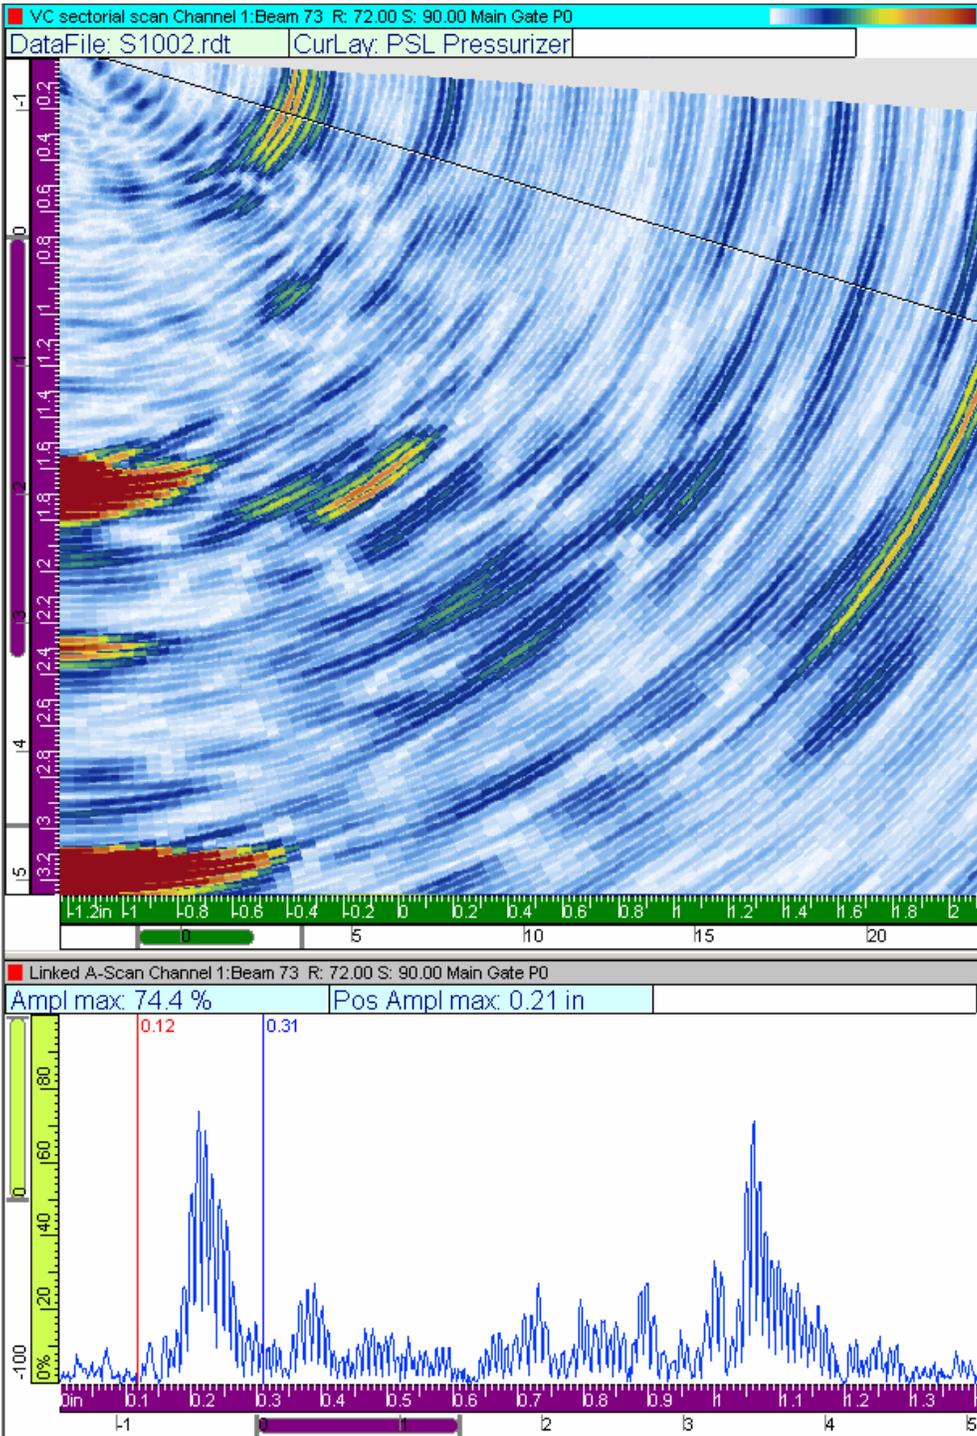
Location: 1 inch clockwise from “0” stamp

Indication through-wall depth at this location: 1.49 inches

Estimated remaining ligament above the indication: 0.21 inches

Angle used for measurement: 73 degrees

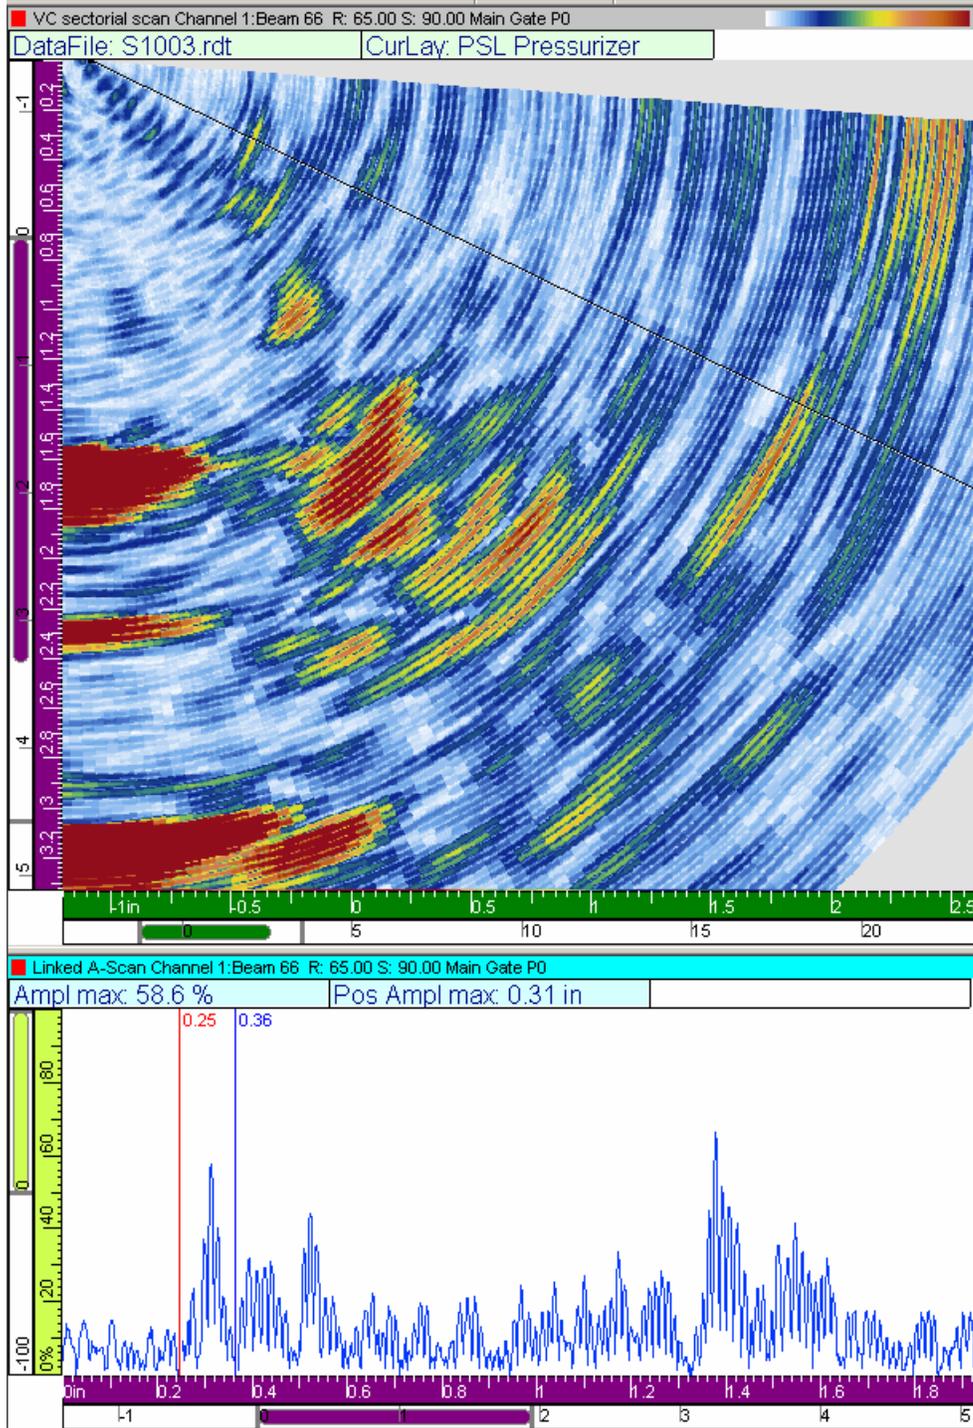
Location: 2 inches clockwise from “0” stamp

Indication through-wall depth at this location: 1.39 inches

Estimated remaining ligament above the indication: 0.31 inches

Angle used for measurement: 66 degrees

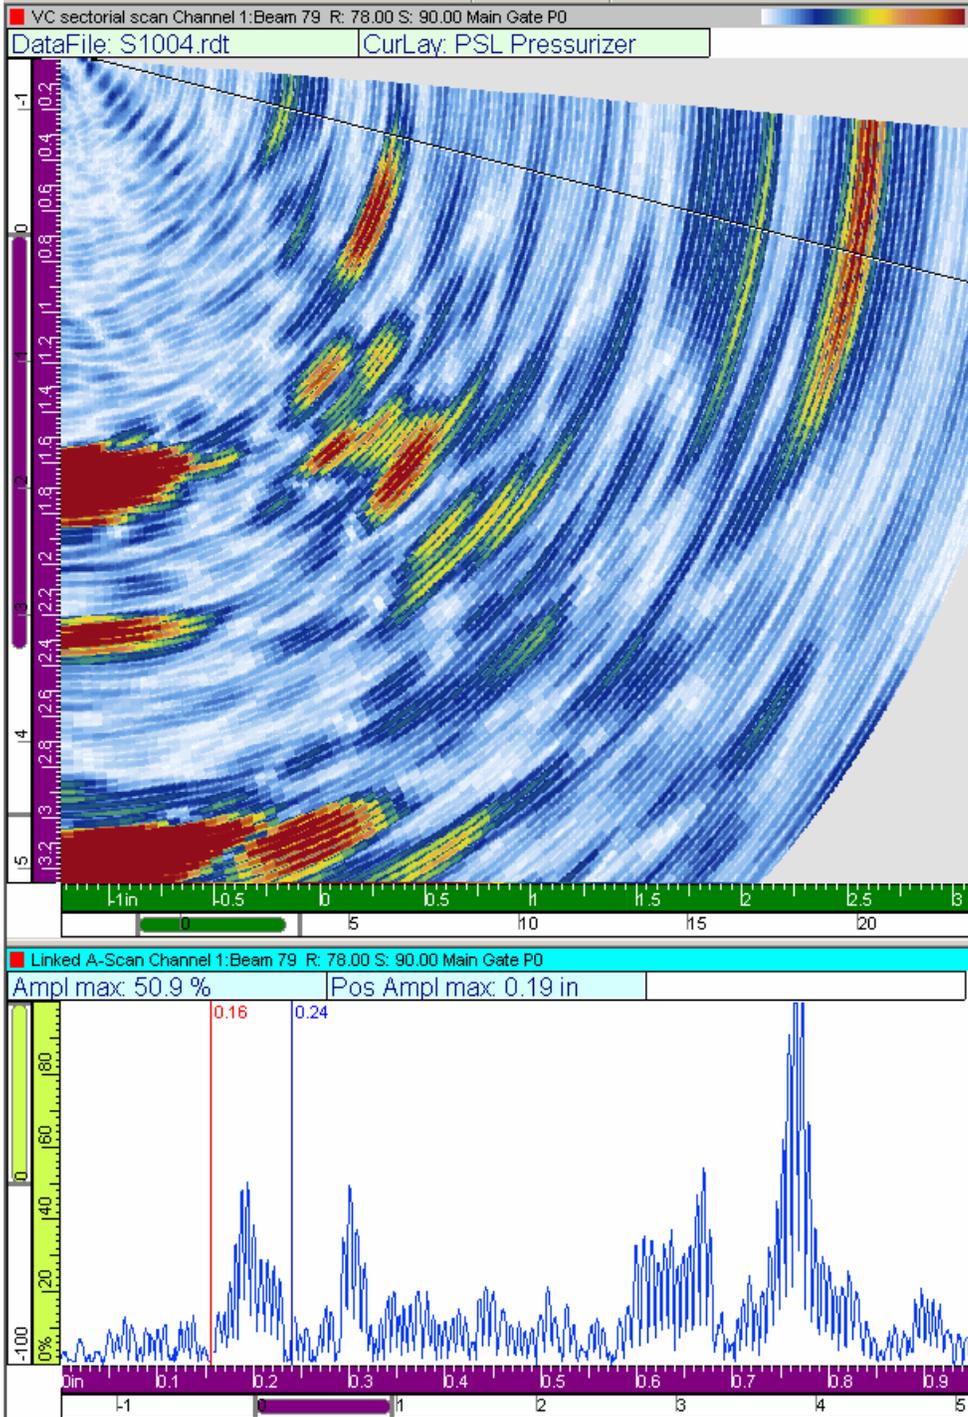
Location: 3 inches clockwise from “0” stamp

Indication through-wall depth at this location: 1.51 inches

Estimated remaining ligament above the indication: 0.19 inches

Angle used for measurement: 79 degrees

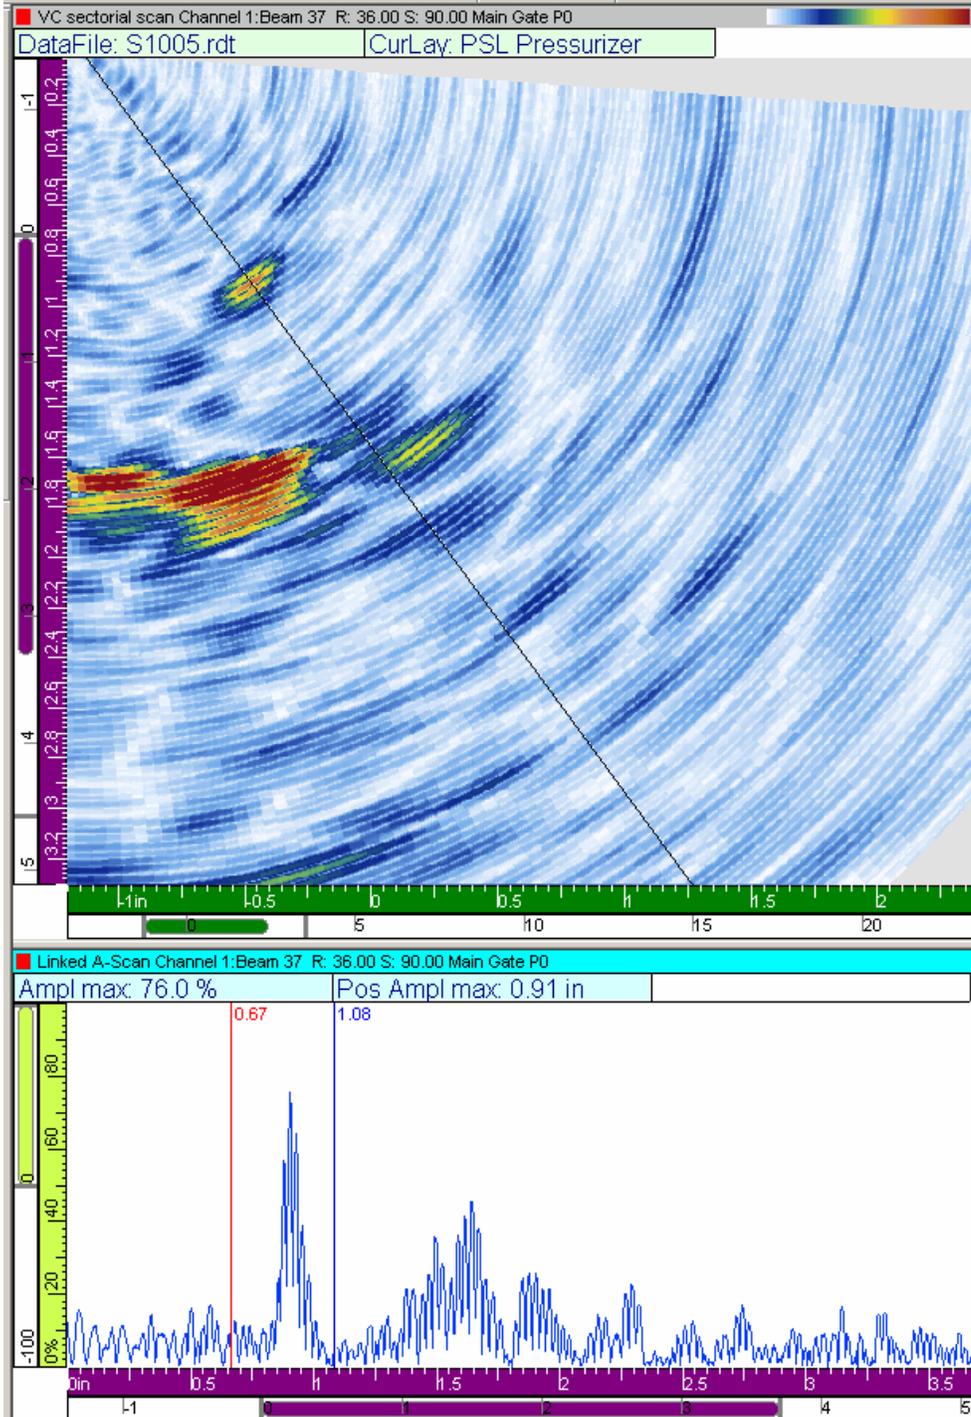
Location: 4 inches clockwise from “0” stamp

Indication through-wall depth at this location: 0.79 inches

Estimated remaining ligament above the indication: 0.91 inches

Angle used for measurement: 37 degrees

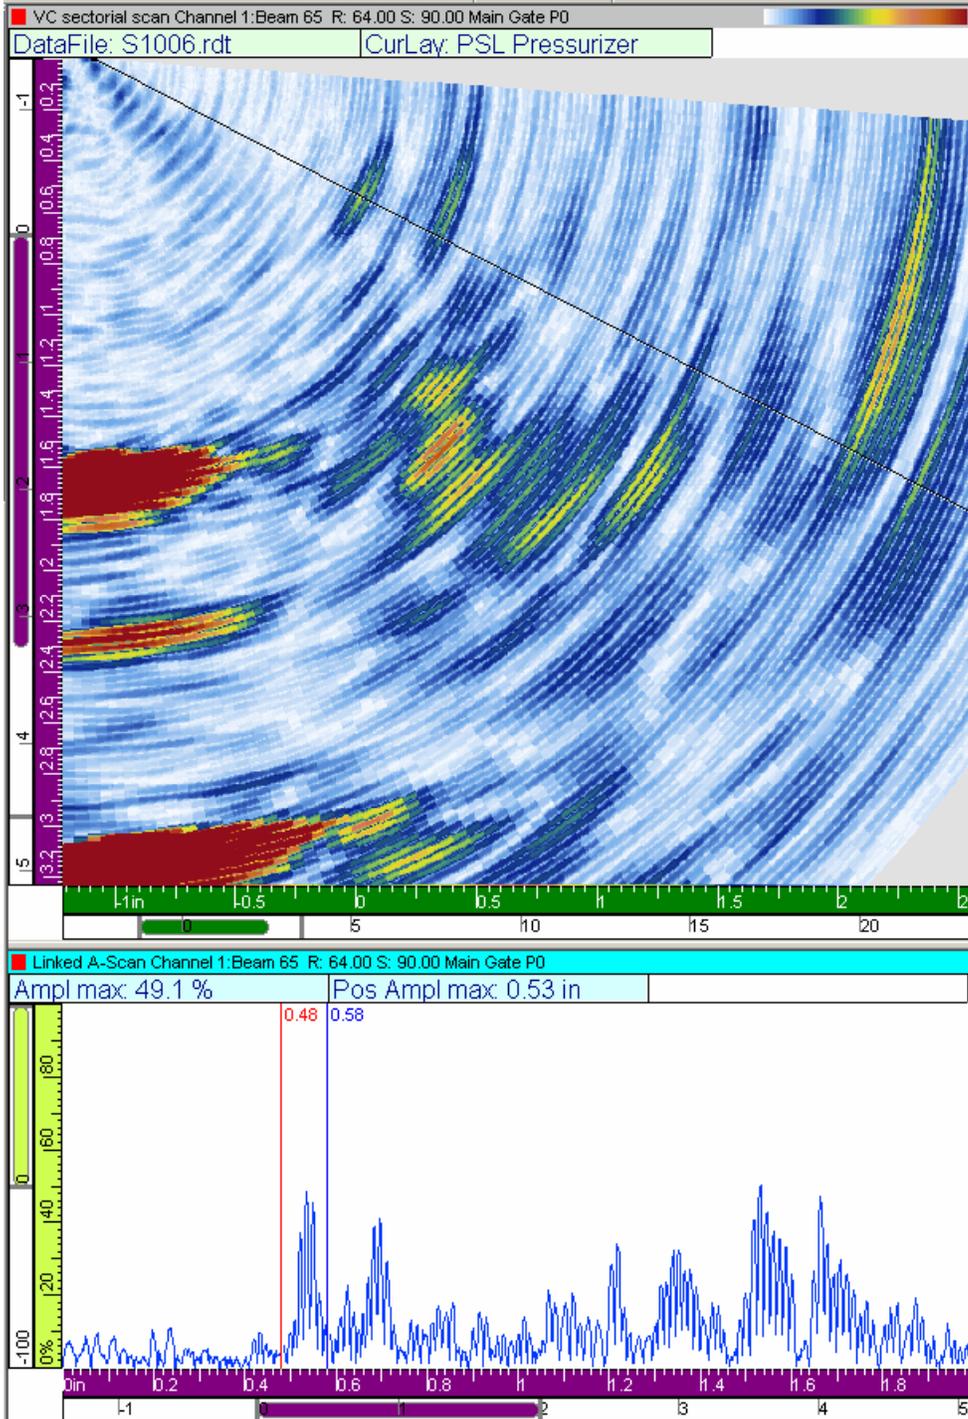
Location: 5 inches clockwise from “0” stamp

Indication through-wall depth at this location: 1.17 inches

Estimated remaining ligament above the indication: 0.53 inches

Angle used for measurement: 65 degrees

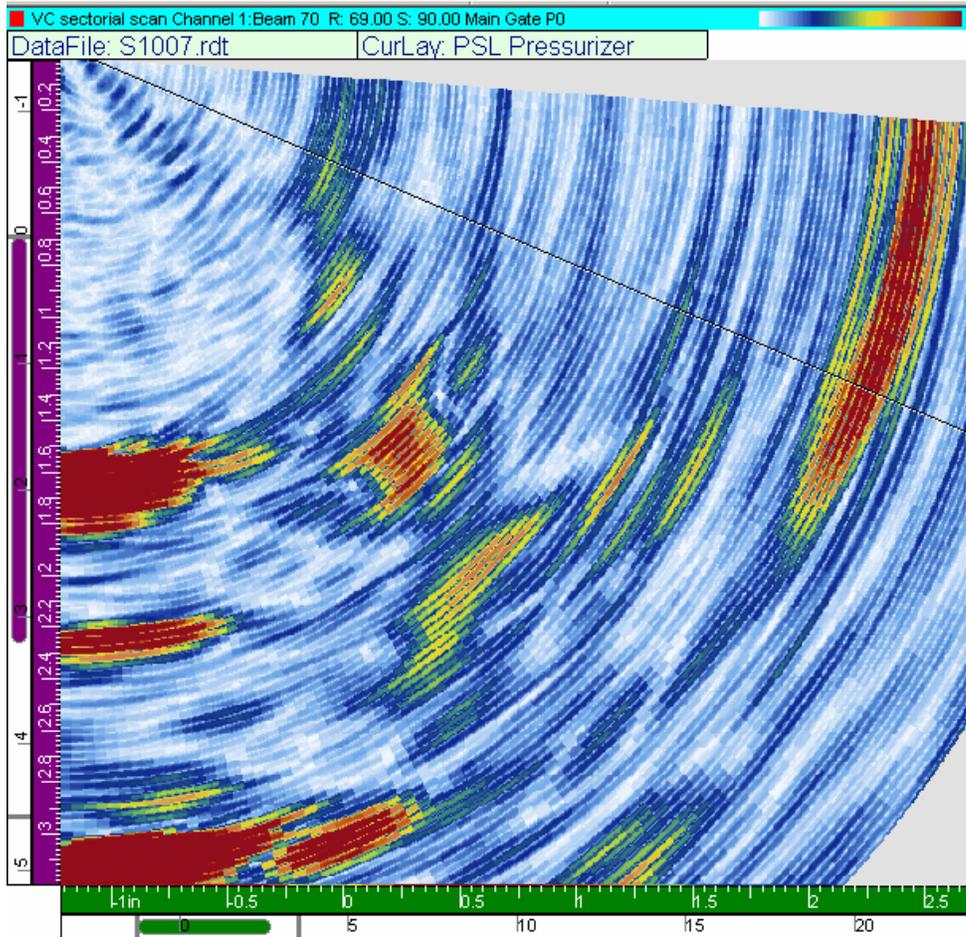
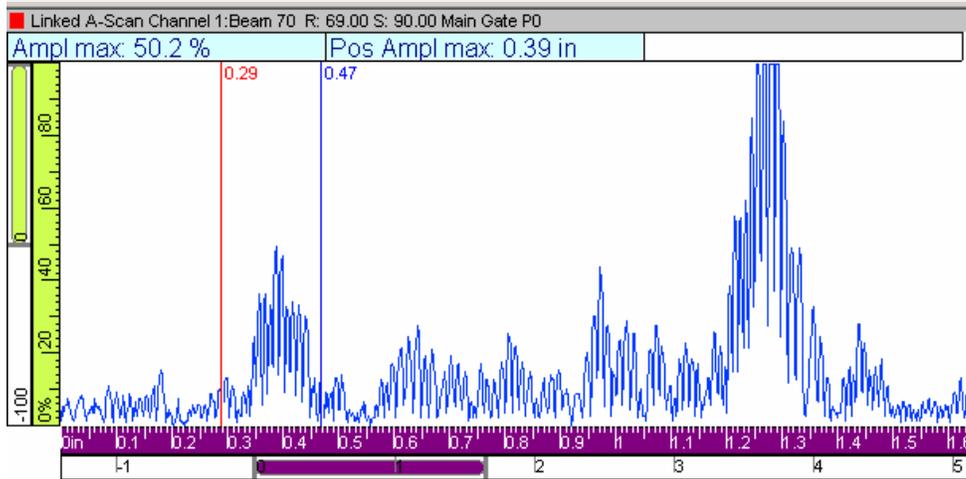
Location: 6 inches clockwise from “0” stamp

Indication through-wall depth at this location: 1.31 inches

Estimated remaining ligament above the indication: 0.39 inches

Angle used for measurement: 70 degrees

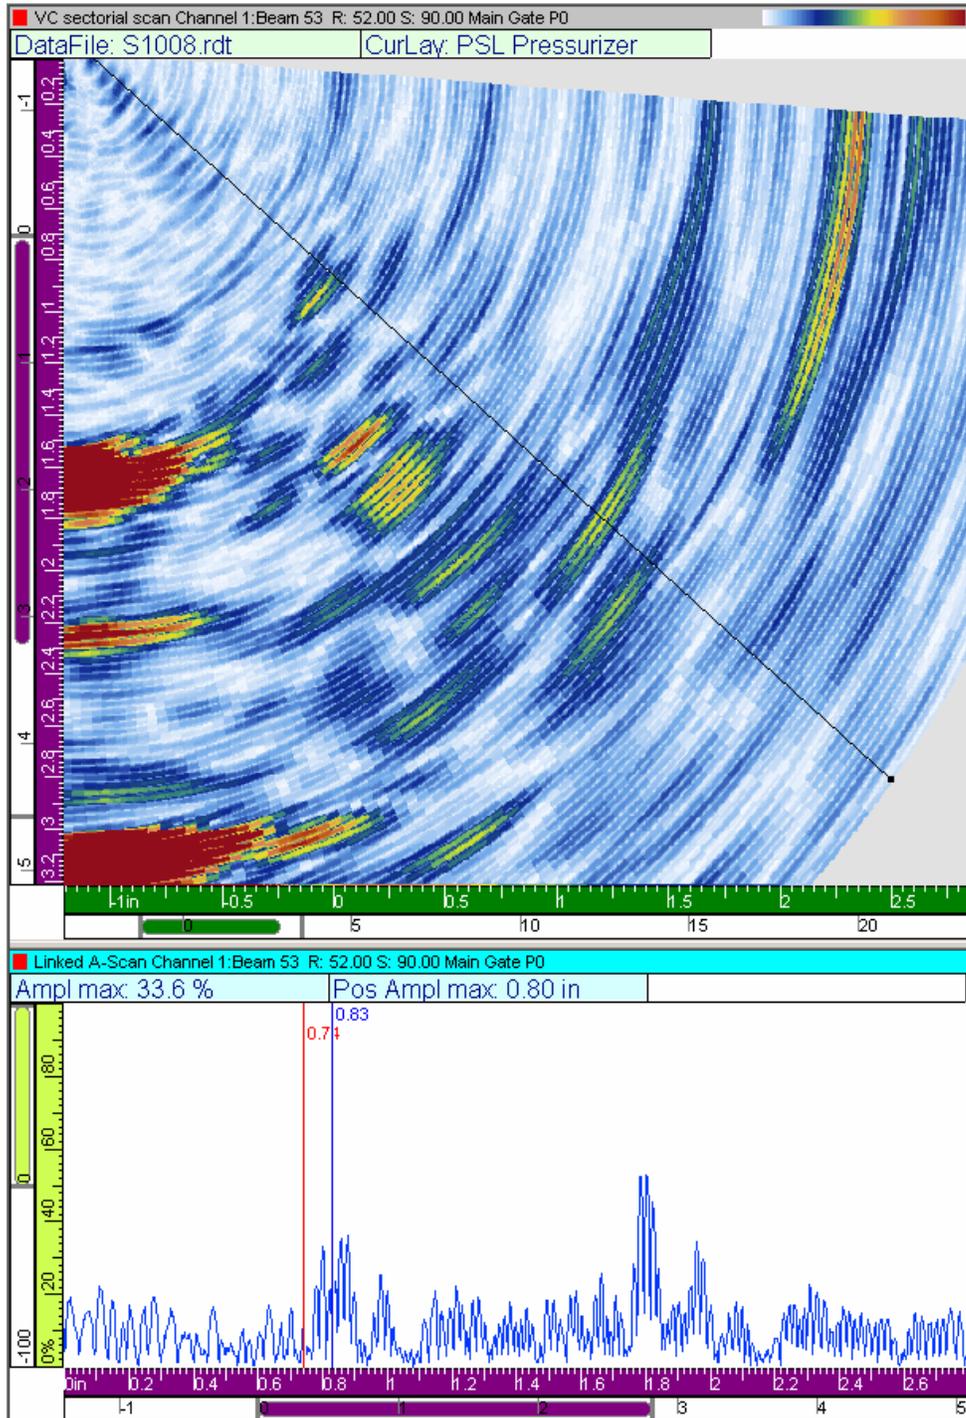
Location: 7 inches clockwise from “0” stamp

Indication through-wall depth at this location: 0.9 inches

Estimated remaining ligament above the indication: 0.80 inches

Angle used for measurement: 53 degrees

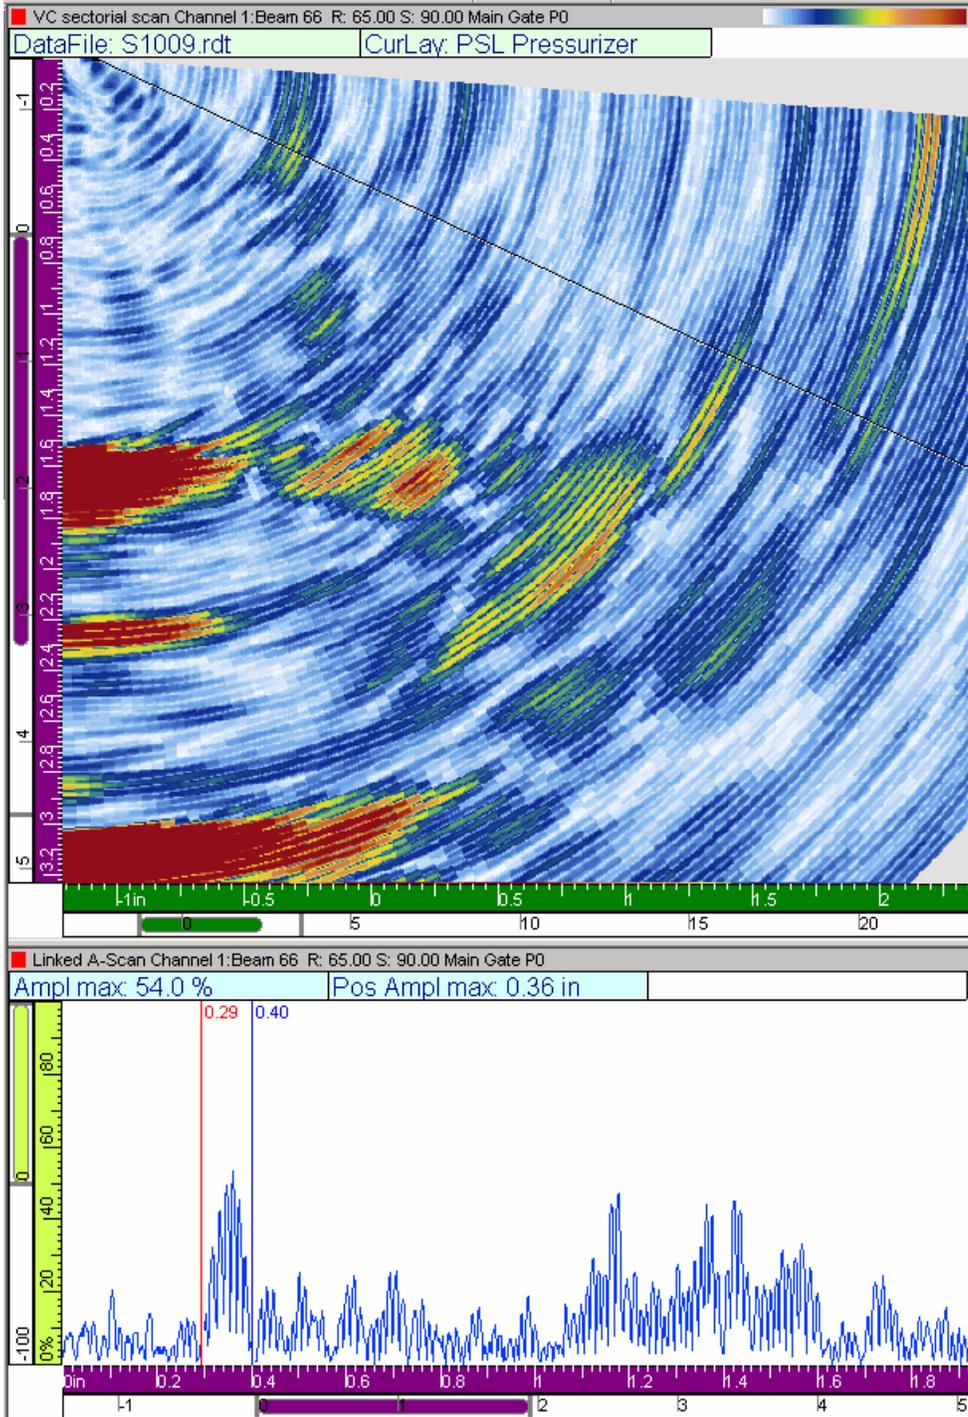
Location: 8 inches clockwise from “0” stamp

Indication through-wall depth at this location: 1.34 inches

Estimated remaining ligament above the indication: 0.36 inches

Angle used for measurement: 66 degrees

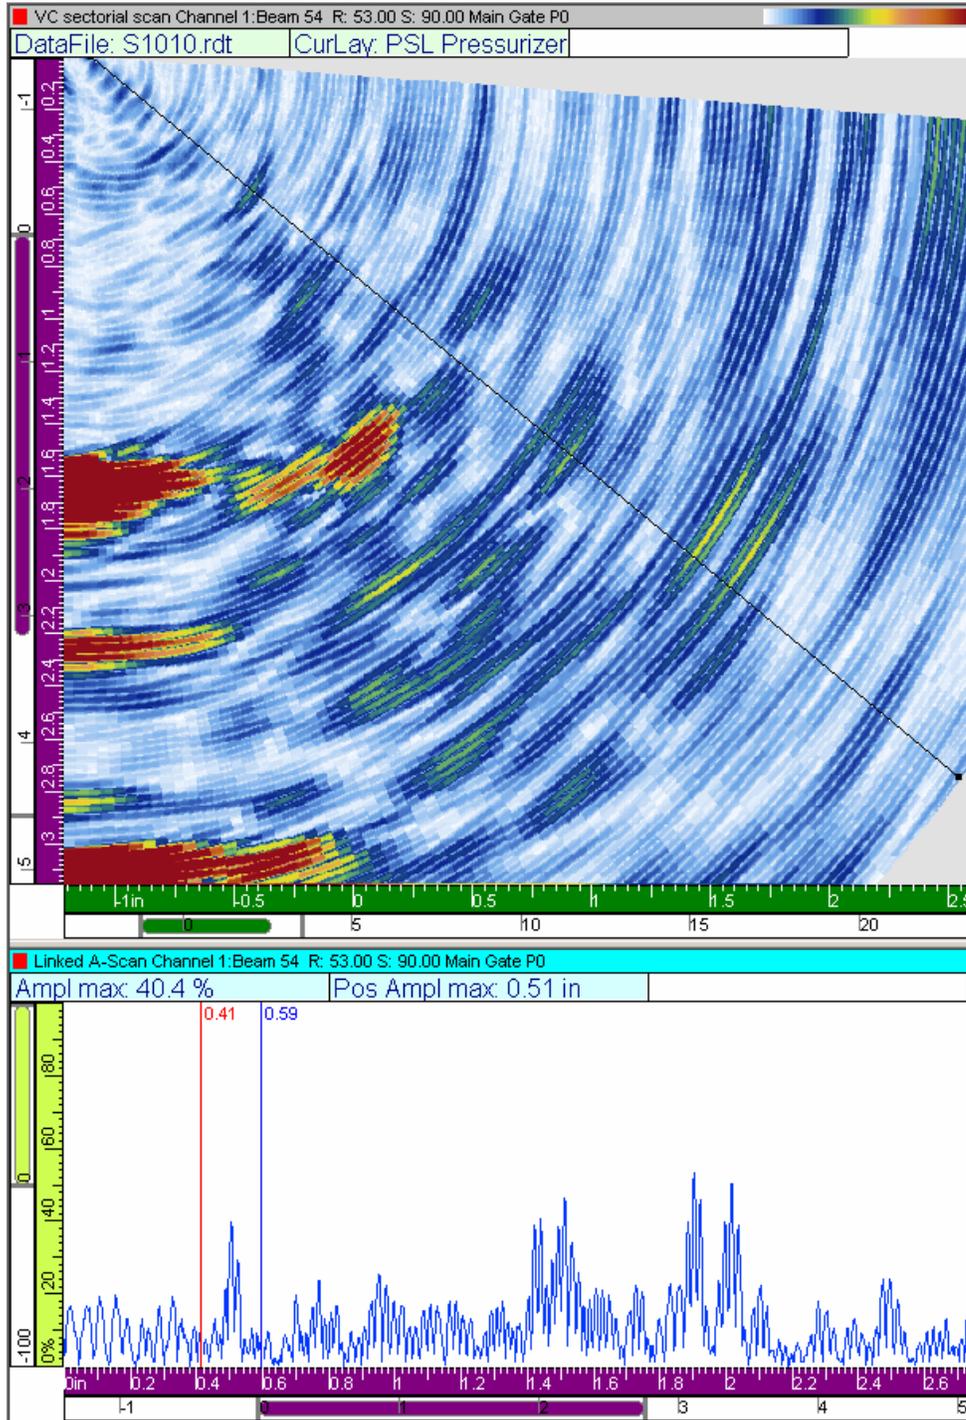
Location: 9 inches clockwise from “0” stamp

Indication through-wall depth at this location: 1.19 inches

Estimated remaining ligament above the indication: 0.51 inches

Angle used for measurement: 54 degrees

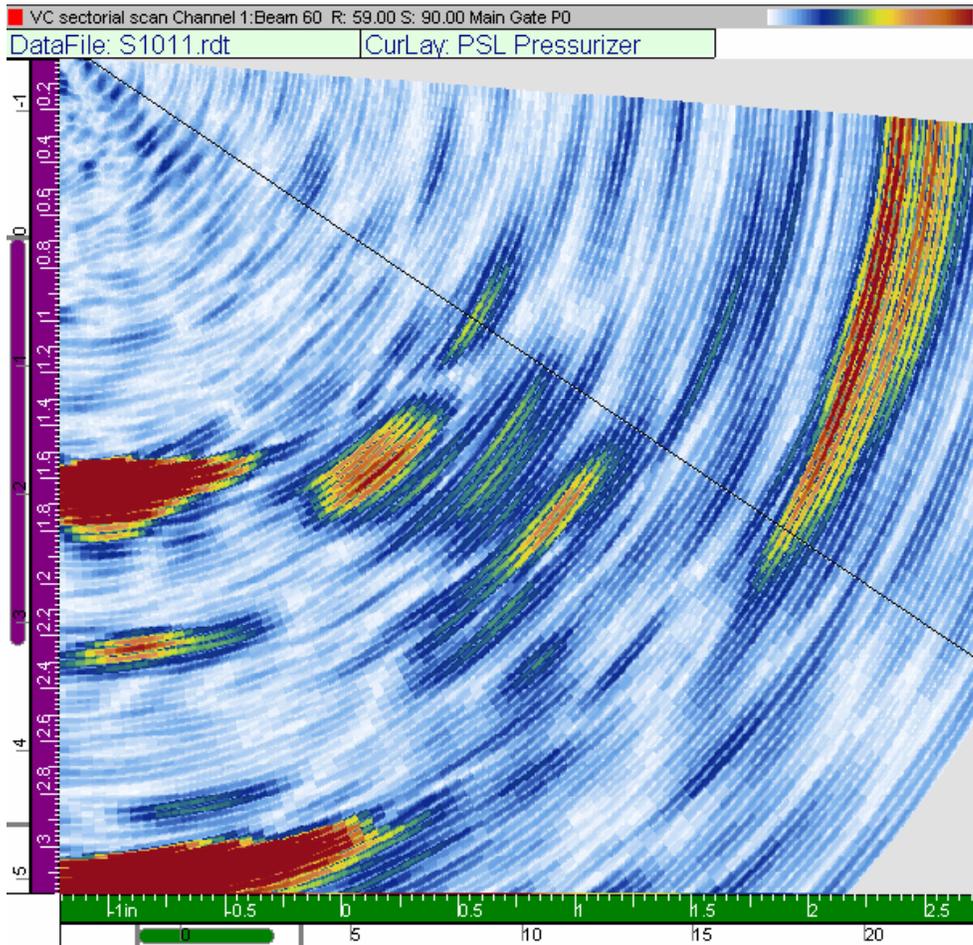
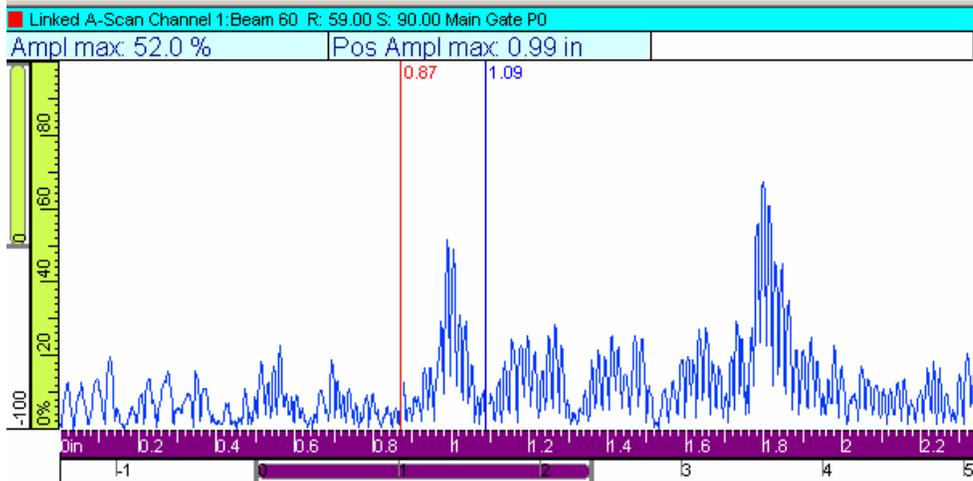
Location: 10 inches clockwise from “0” stamp

Indication through-wall depth at this location: 0.71 inches

Estimated remaining ligament above the indication: 0.99 inches

Angle used for measurement: 60 degrees

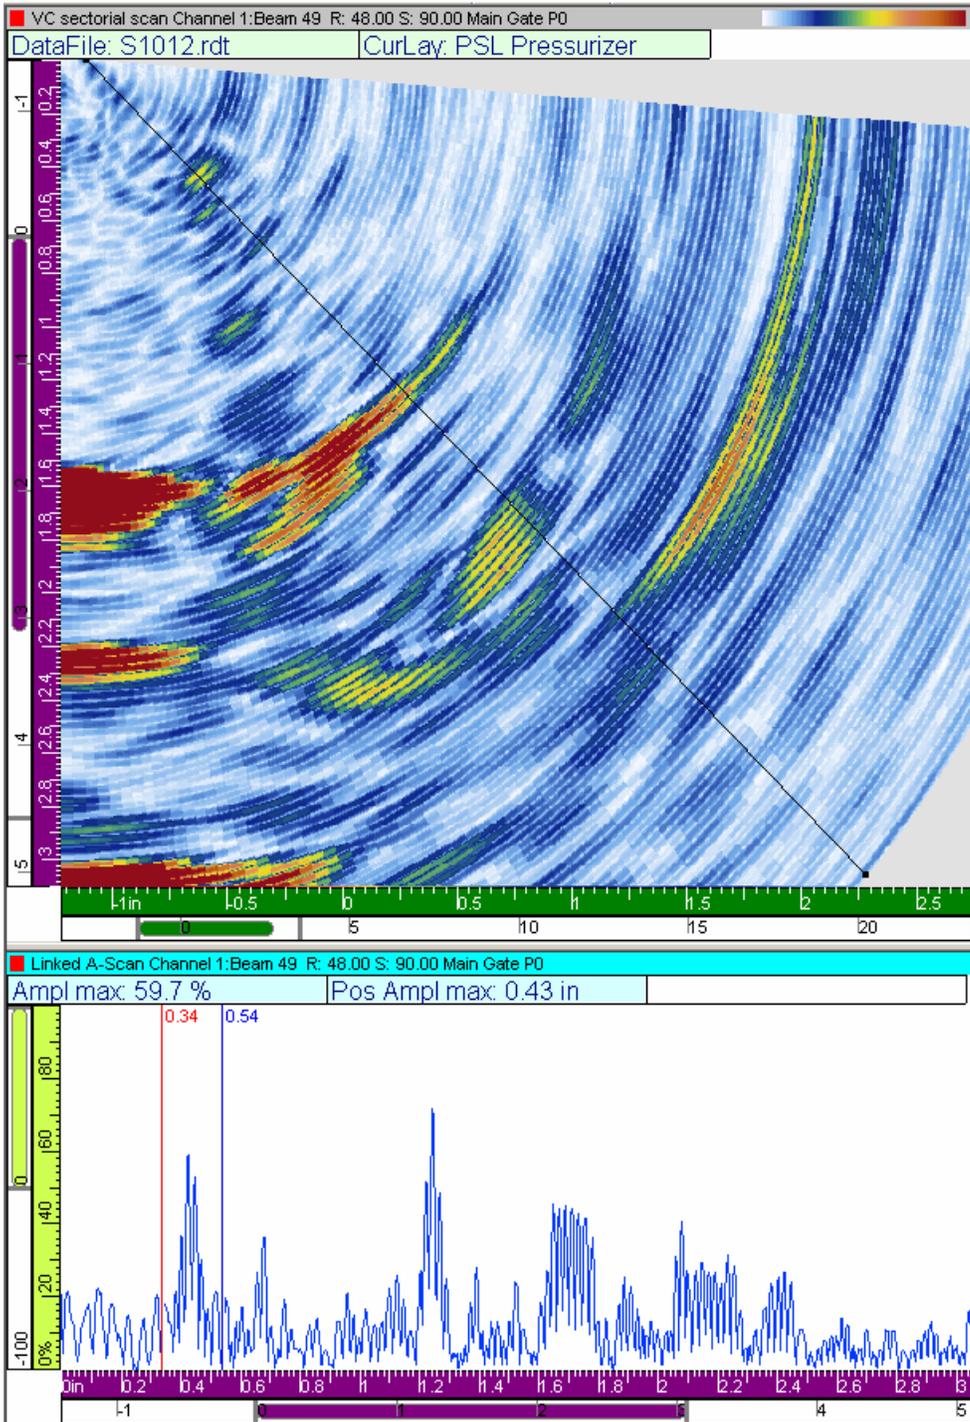
Location: 11 inches clockwise from “0” stamp

Indication through-wall depth at this location: 1.27 inches

Estimated remaining ligament above the indication: 0.43 inches

Angle used for measurement: 49 degrees

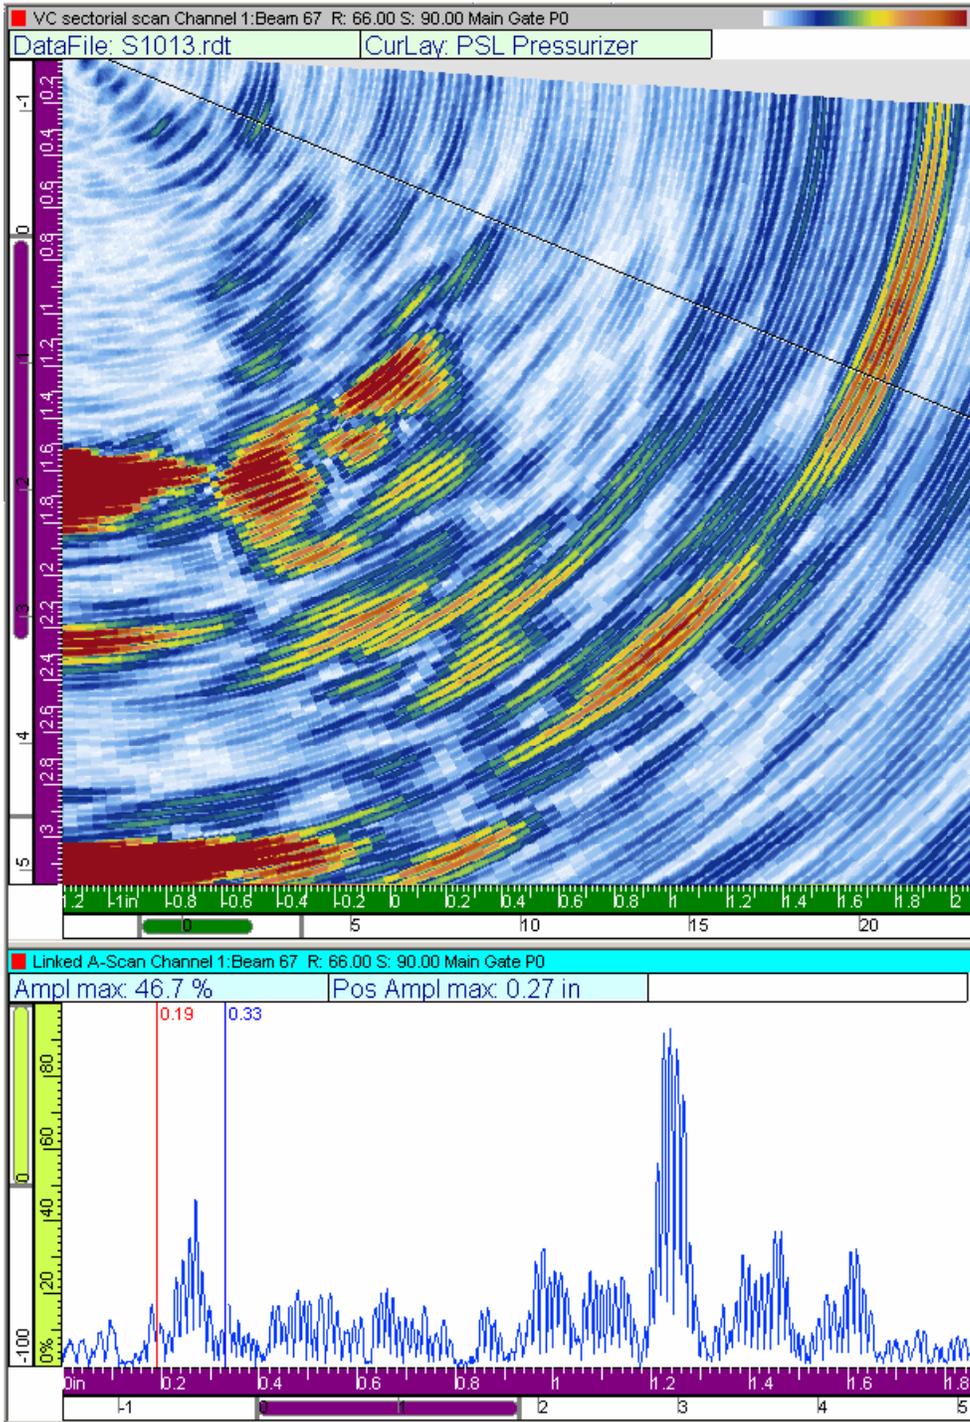
Location: 12 inches clockwise from “0” stamp

Indication through-wall depth at this location: 1.43 inches

Estimated remaining ligament above the indication: 0.27 inches

Angle used for measurement: 67 degrees

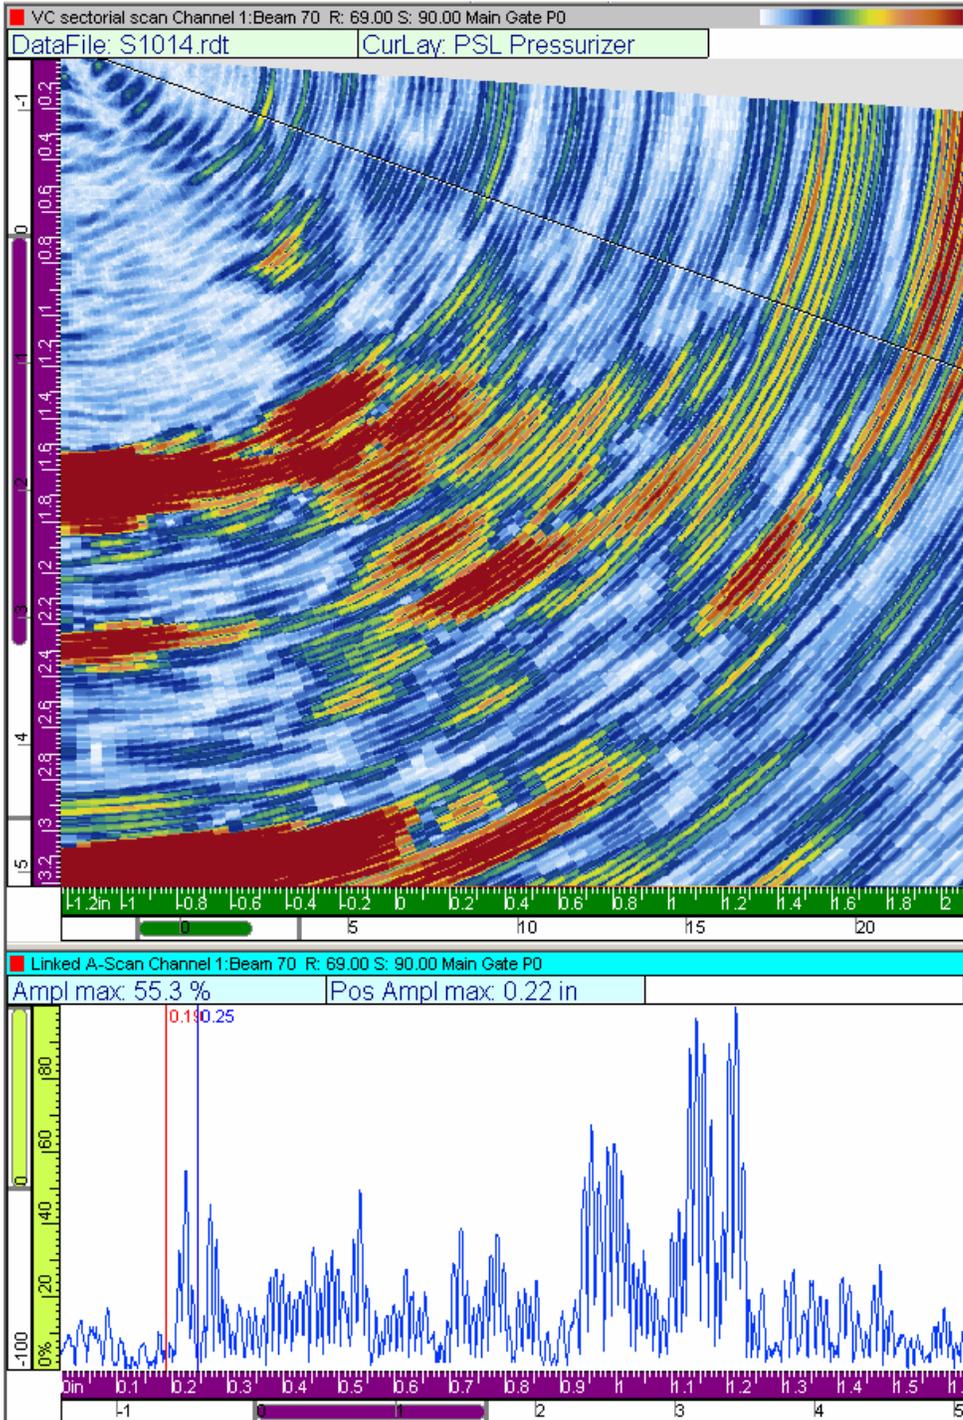
Location: 13 inches clockwise from “0” stamp

Indication through-wall depth at this location: 1.48 inches

Estimated remaining ligament above the indication: 0.22 inches

Angle used for measurement: 70 degrees

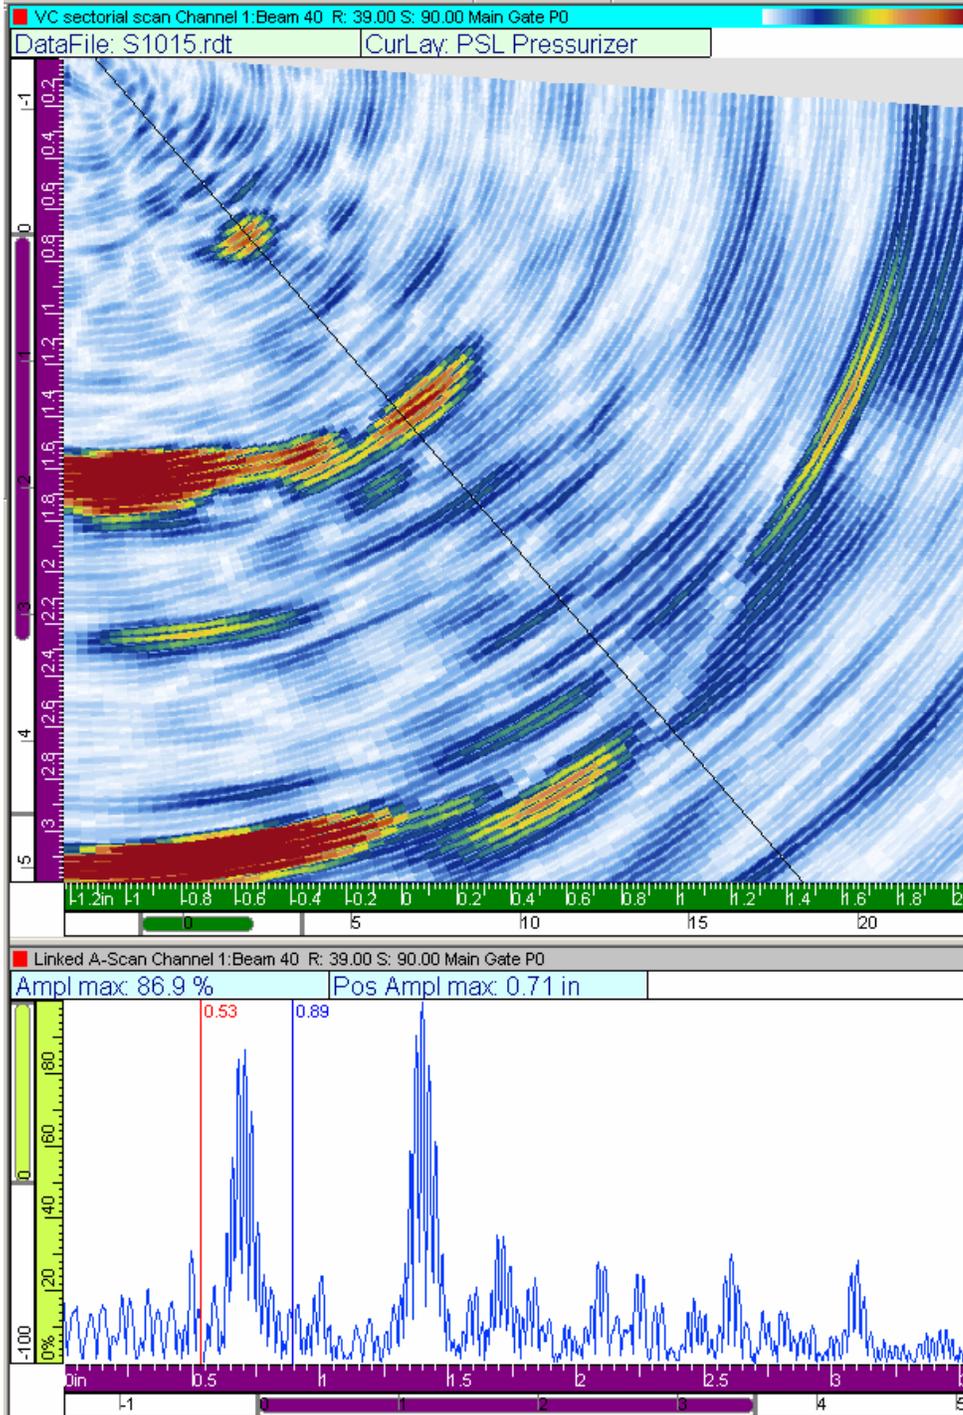
Location: 14 inches clockwise from “0” stamp

Indication through-wall depth at this location: 0.99 inches

Estimated remaining ligament above the indication: 0.71 inches

Angle used for measurement: 40 degrees
