MRP Materials Reliability Program _____ MRP 2008-014
(via email)

Reference: MRP 2008-012 “Examination Results on Nozzles from removed St Lucie Pressurizer with attachment St. Lucie Pressurizer Nozzle DM Weld Examination Project Internal Office Report”

“A” Pressurizer Safety Nozzle Dissimilar Metal Weld
Circumferential Indication Profile

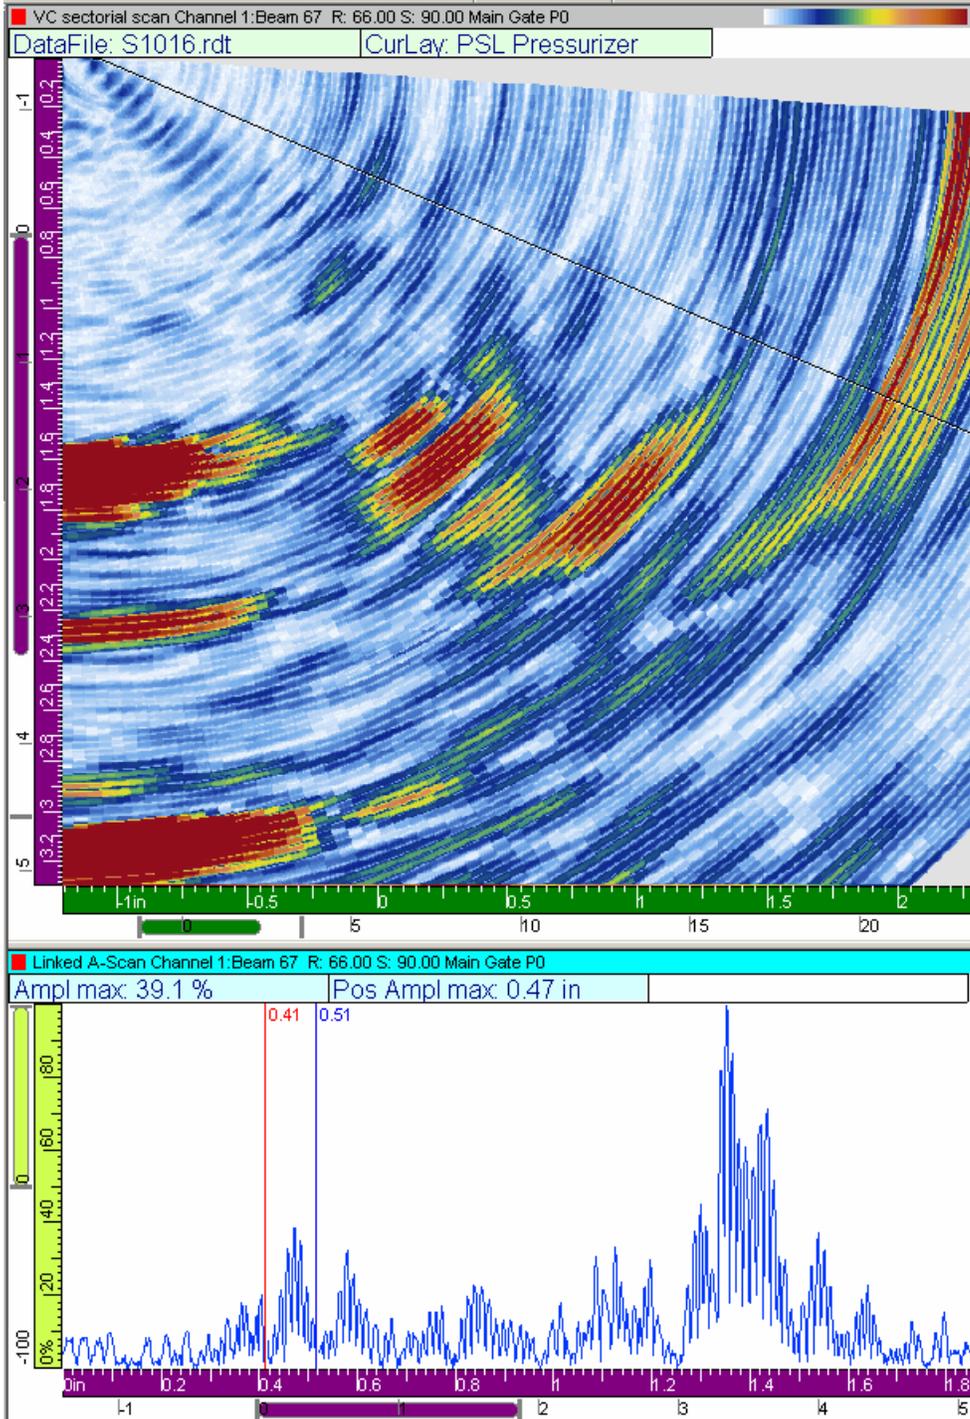
Location: 15 inches clockwise from “0” stamp

Indication through-wall depth at this location: 1.23 inches

Estimated remaining ligament above the indication: 0.47 inches

Angle used for measurement: 67 degrees

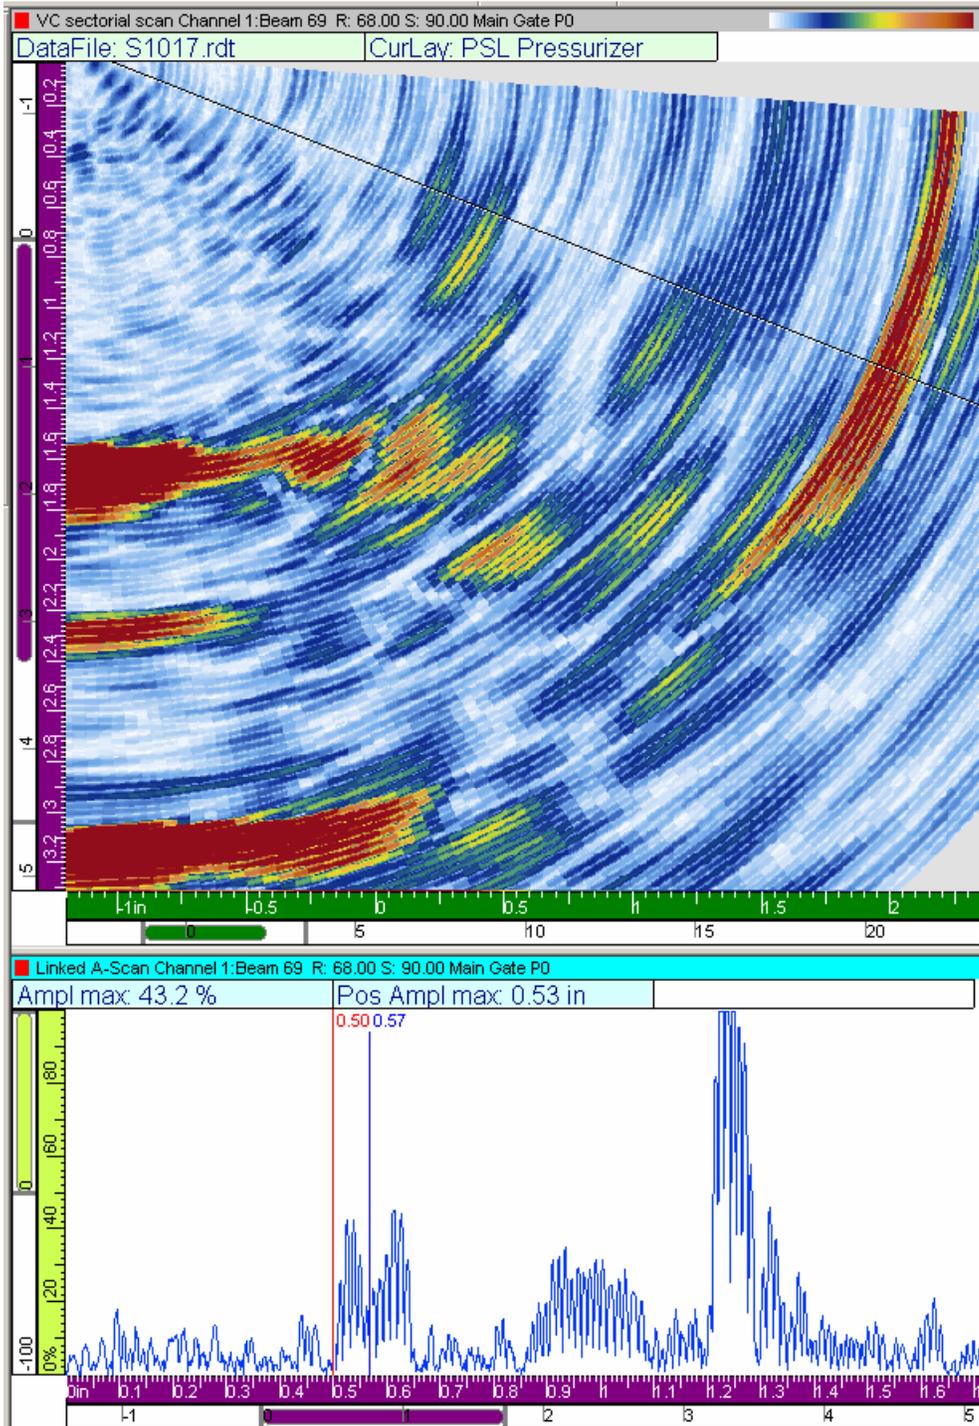
Location: 16 inches clockwise from "0" stamp

Indication through-wall depth at this location: 1.17 inches

Estimated remaining ligament above the indication: 0.53 inches

Angle used for measurement: 69 degrees

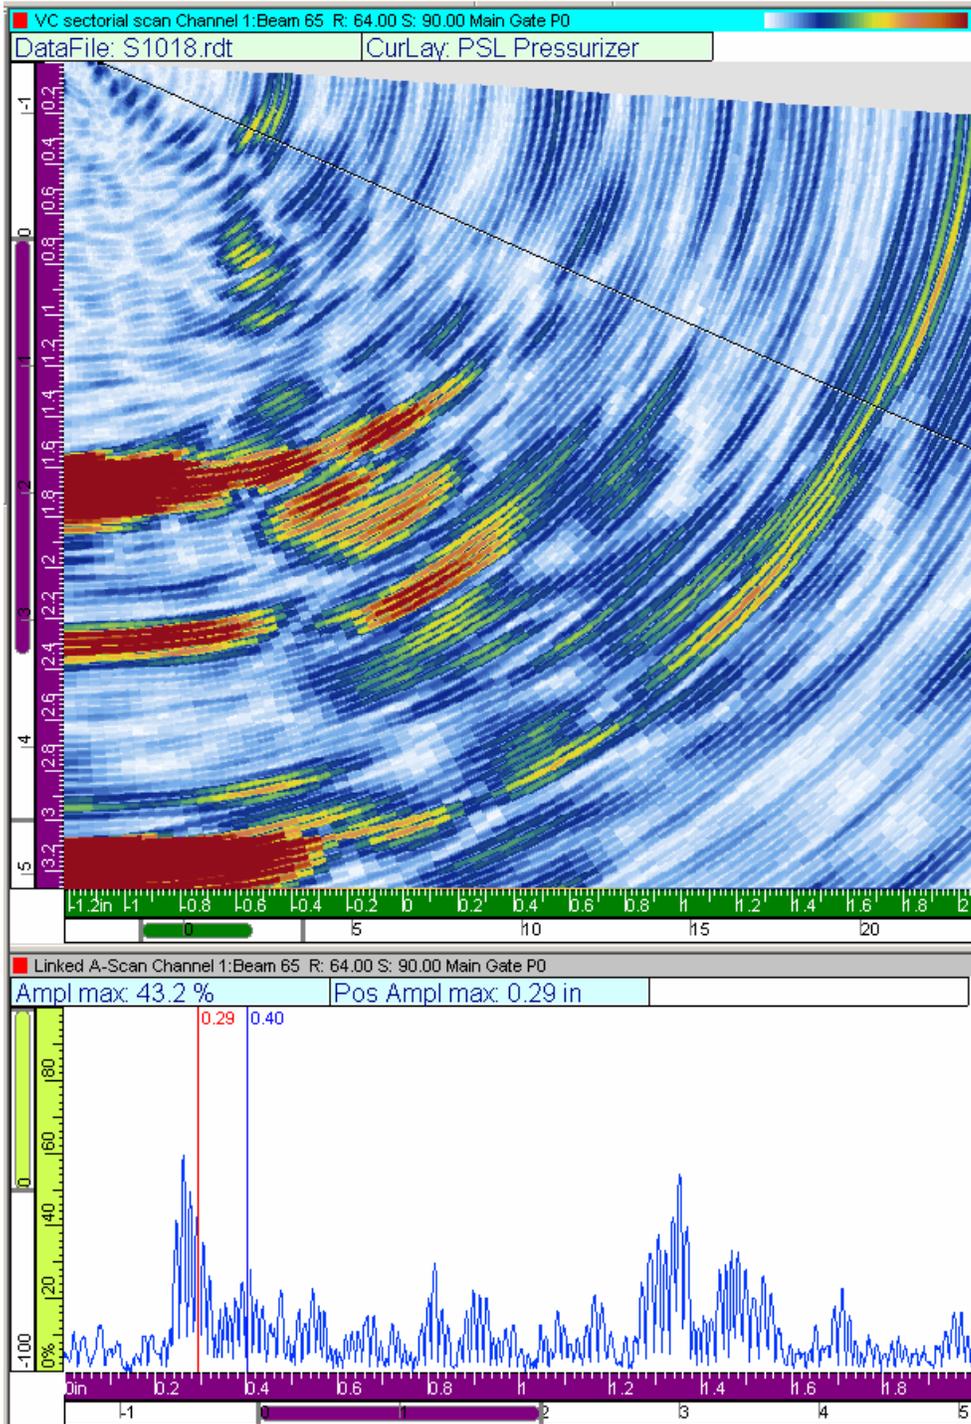
Location: 17 inches clockwise from “0” stamp

Indication through-wall depth at this location: 1.41 inches

Estimated remaining ligament above the indication: 0.29 inches

Angle used for measurement: 65 degrees

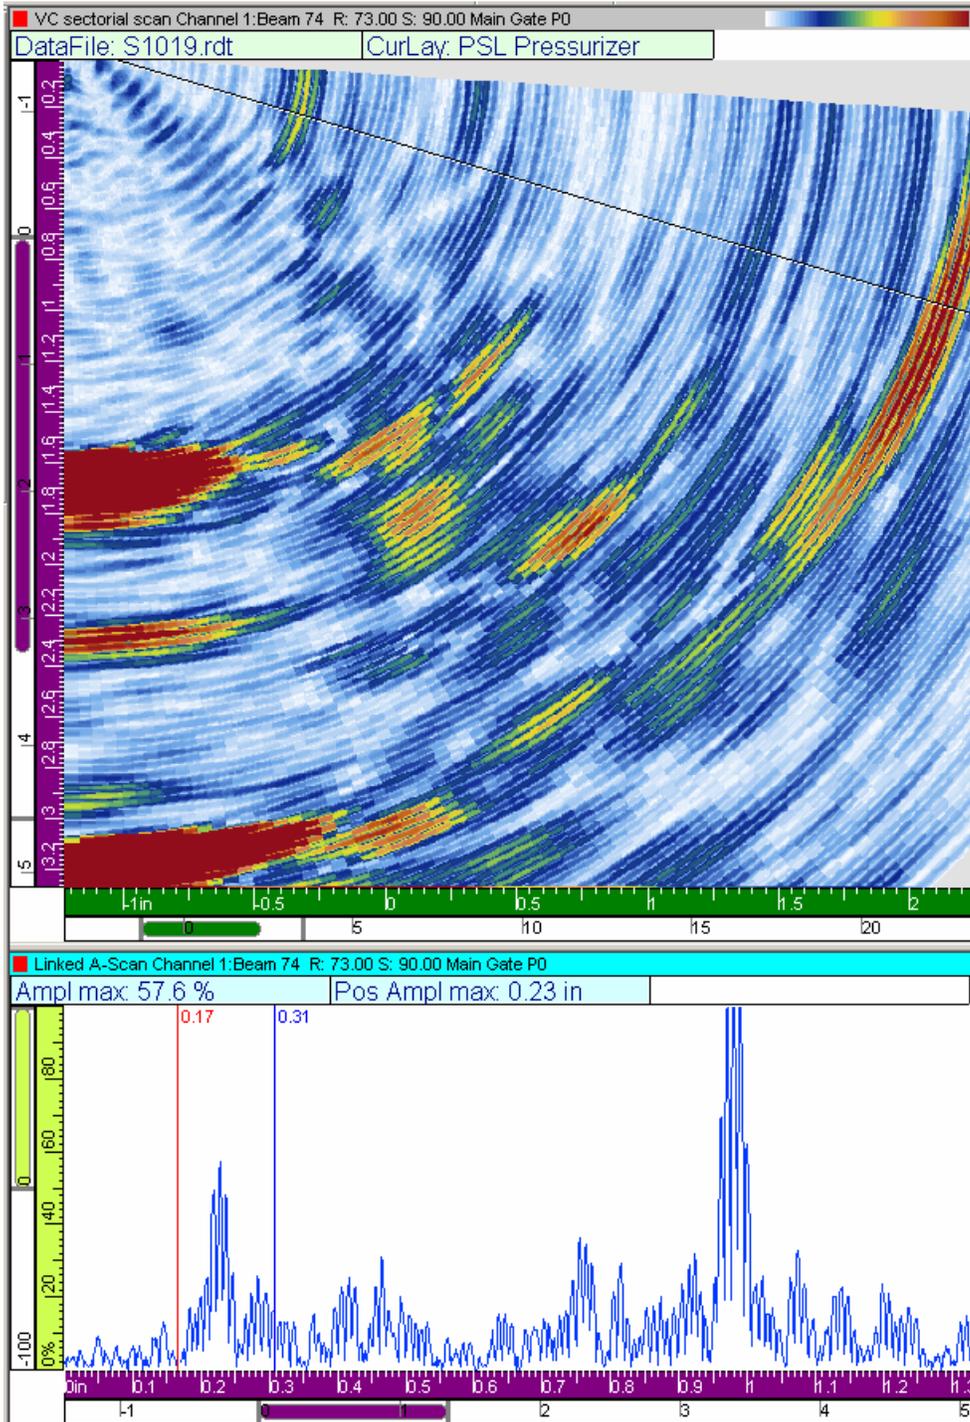
Location: 18 inches clockwise from “0” stamp

Indication through-wall depth at this location: 1.47 inches

Estimated remaining ligament above the indication: 0.23 inches

Angle used for measurement: 74 degrees
