RE: Incident Involving Nuclear Density Gauge
NRC Material License No. 24-20039-01
NRC Event No. 43978

Please be advised that we had an incident with a Humboldt Model 5001 Moisture Density Gauge (Serial No. 1564) on February 11, 2008. We are enclosing the following documents which describe the incident.

R. M. Wester and Associates, Inc.
Humboldt 2100 Accident Site
Soil Analysis Report
Maryland Heights, MO
February 13, 2008

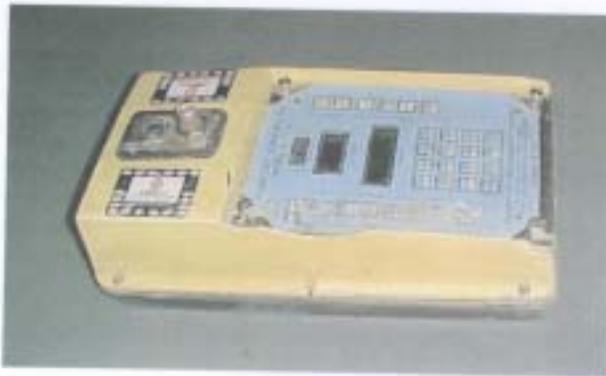
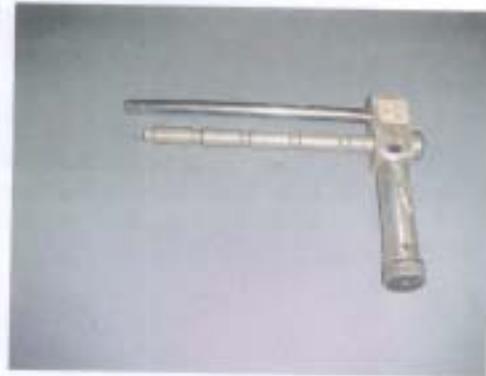
The Humboldt moisture/density gauge was examined in detail. The manipulator rod and positioning rods were sheared off and there was some damage to the housing as shown in the picture on the next page. The shutter was stuck in the half open position. Due to the high radiation levels(up to 70 mR/hr on contact) the device had to be packaged with additional lead shielding before transporting back to our laboratory.

At our laboratory the soil samples were analyzed for contamination by Cesium-137 and Americium-241. No contamination was indicated. A leak test was performed on the Humboldt moisture/density gauge. After leak test indicated that there was no contamination of Cs-137 or Am-241 on the device the shutter was manual closed at our laboratory.

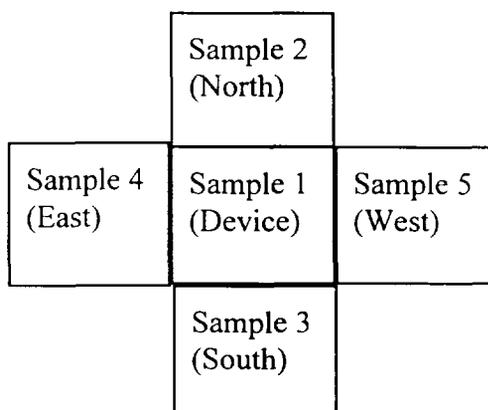
Soil samples were taken at the location of the damaged device and at the cardinal points as shown in the diagram below:

There is no indication of Americium-241 or Cesium-137 contamination in the soil.

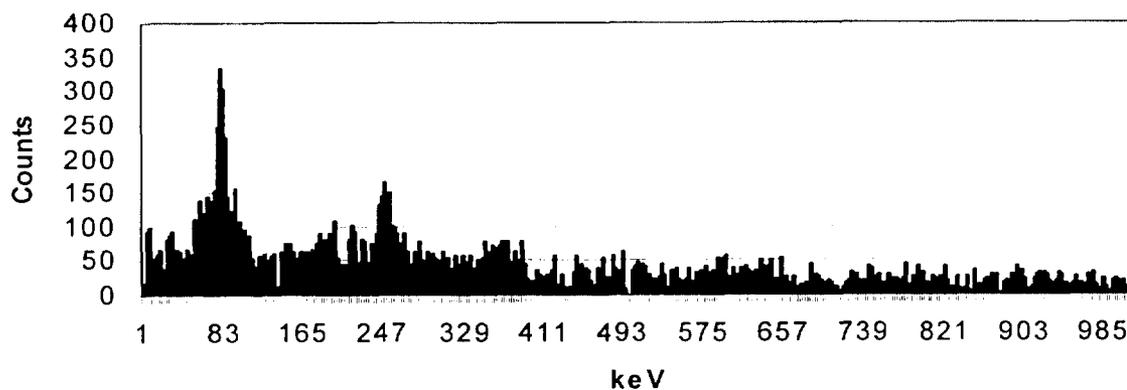
SCI Soil Combined Soil Samples

The spectra combined from all the soil samples after a 50 minute run time gives a typical NORM(Naturally Occurring Radioactive Material) spectra containing isotopes of the Thorium-232 and Uranium-238 decay chains.
