U. S. ATOMIC ENERGY COMMISSION
DIRECTORATE OF REGULATORY OPERATIONS

RO Inspection Report No.: 70-82/73-05 and 40-672/73-02

Licensee: Nuclear Metals, Incorporated

Type of Inspection: Routine, Unannounced

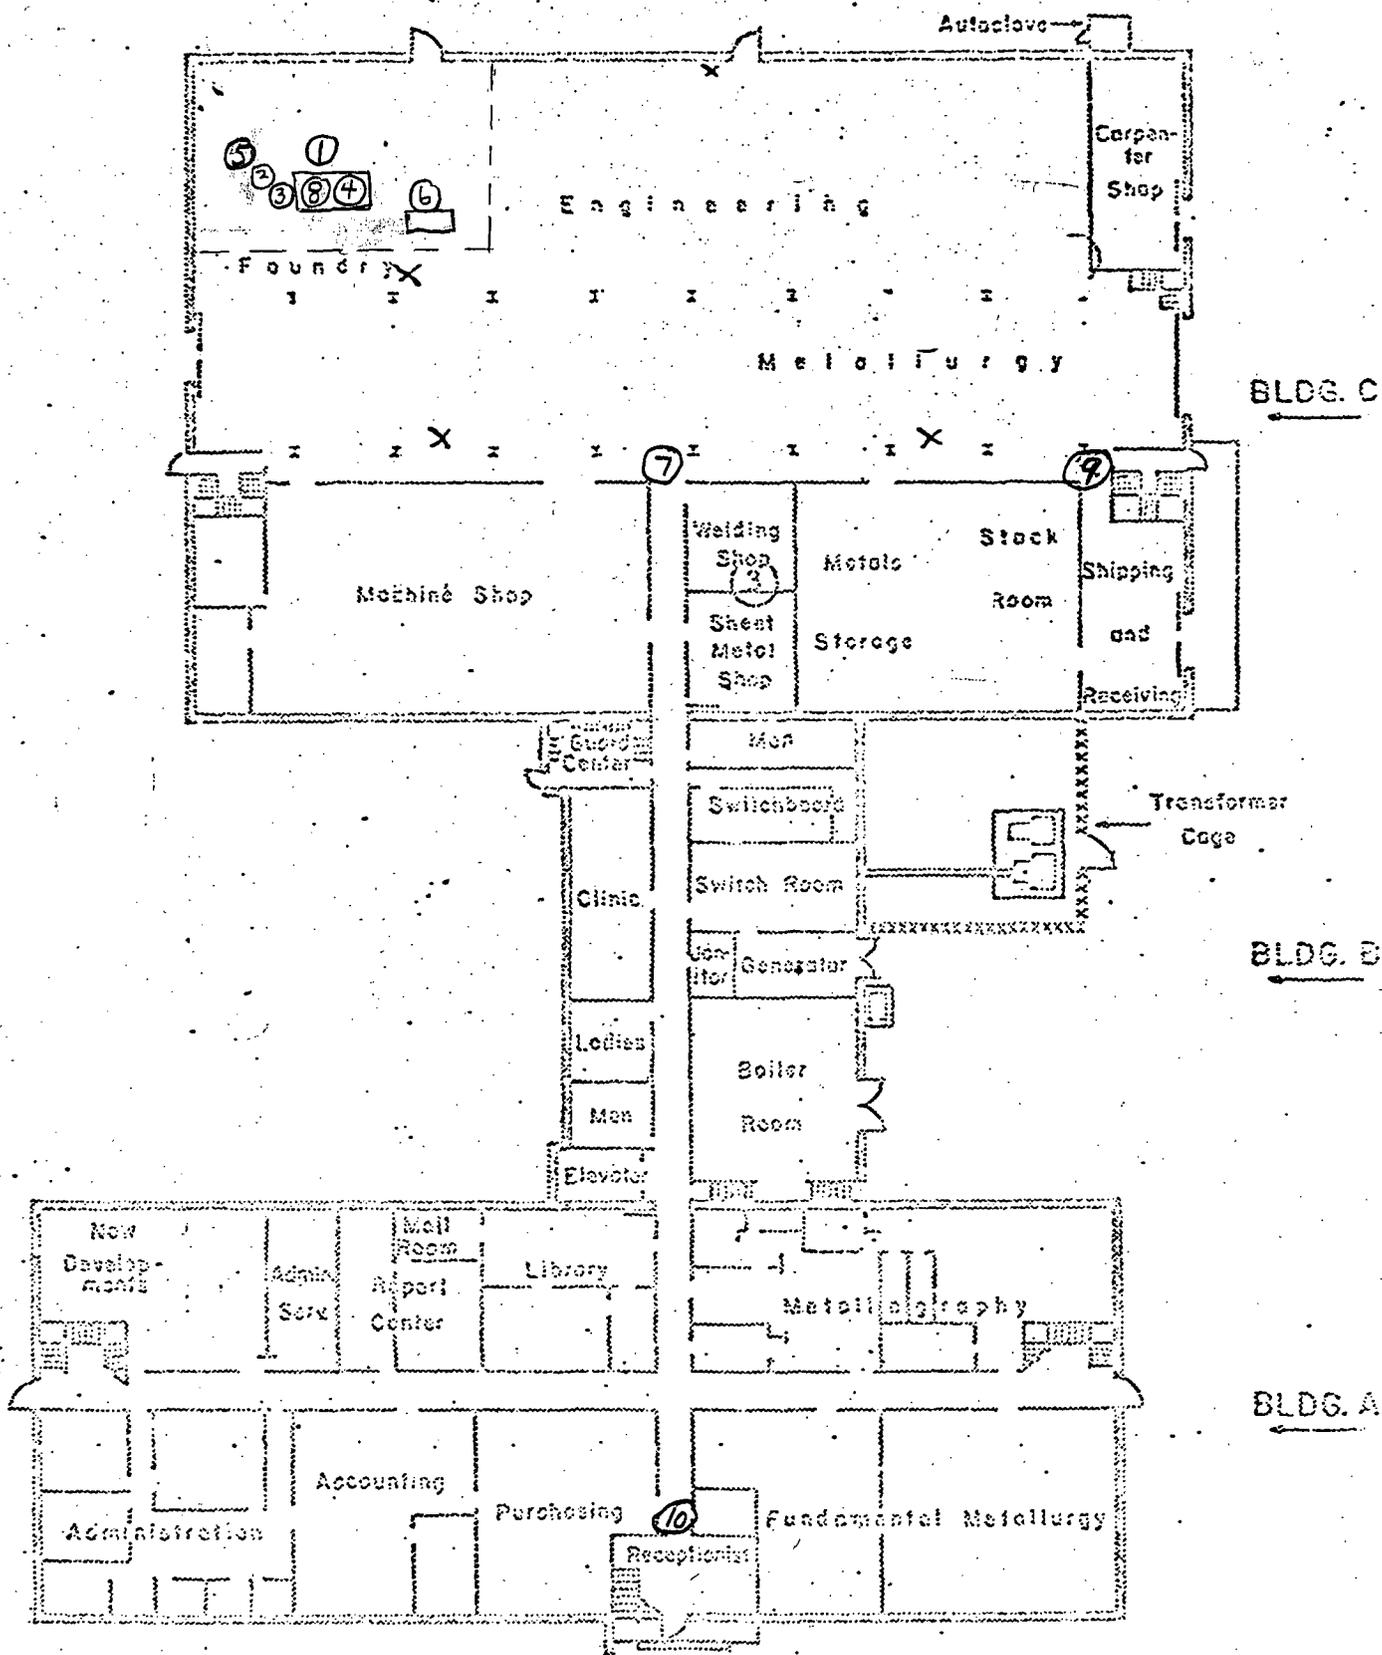
- a. Records were examined for the period from April 1 to December 15, 1973 and showed that wipes were taken monthly at 14 locations in the plant area. The wipes were counted only for alpha contamination. The maximum wipe showed 28.5 d/m alpha/100cm². It was taken on the floor near the large door in the foundry area.
- b. The inspector took wipes at ten locations as indicated in Table I. The wipes were counted on January 2, 1974 using an Eberline Model SAC-4 for alpha counting and Eberline Model LCS-1 with Eberline Model RD-14 Beta Detector for beta counting. Figure 1 shows the location of the wipes by number.

<u>SMEAR NUMBER</u>	<u>LOCATION</u>	<u>d/m alpha</u>	<u>d/m beta-gamma</u>
1	Floor near tower (Foundry)	78	10,105
2	Inside side wall crucible hood (Foundry)	270	11,224
3	Step to tower (Foundry)	78	17,559
4	Floor of tower hood (Foundry)	189	5 mR/hr ⁽¹⁾
5	Inside paint hood, side wall (Foundry)	34	705
6	Floor near hack saw (Foundry)	25	4,256
7	Floor near exit to hall (Main shop area)	6	686
8	Tower counter top (Foundry)	40	5,331
9	Floor near entrance to shipping and receiving area(Main Shop Area)	6	335
10	Floor in hall at reception room	9	148
