RO Inspection Report No.: 70-82/73-05 and 40-672/73-02

Licensee: Nuclear Metals, Incorporated

Type of Licensee: Fuel Fabricator and Product Manufacturer

## SUMMARY OF FINDINGS

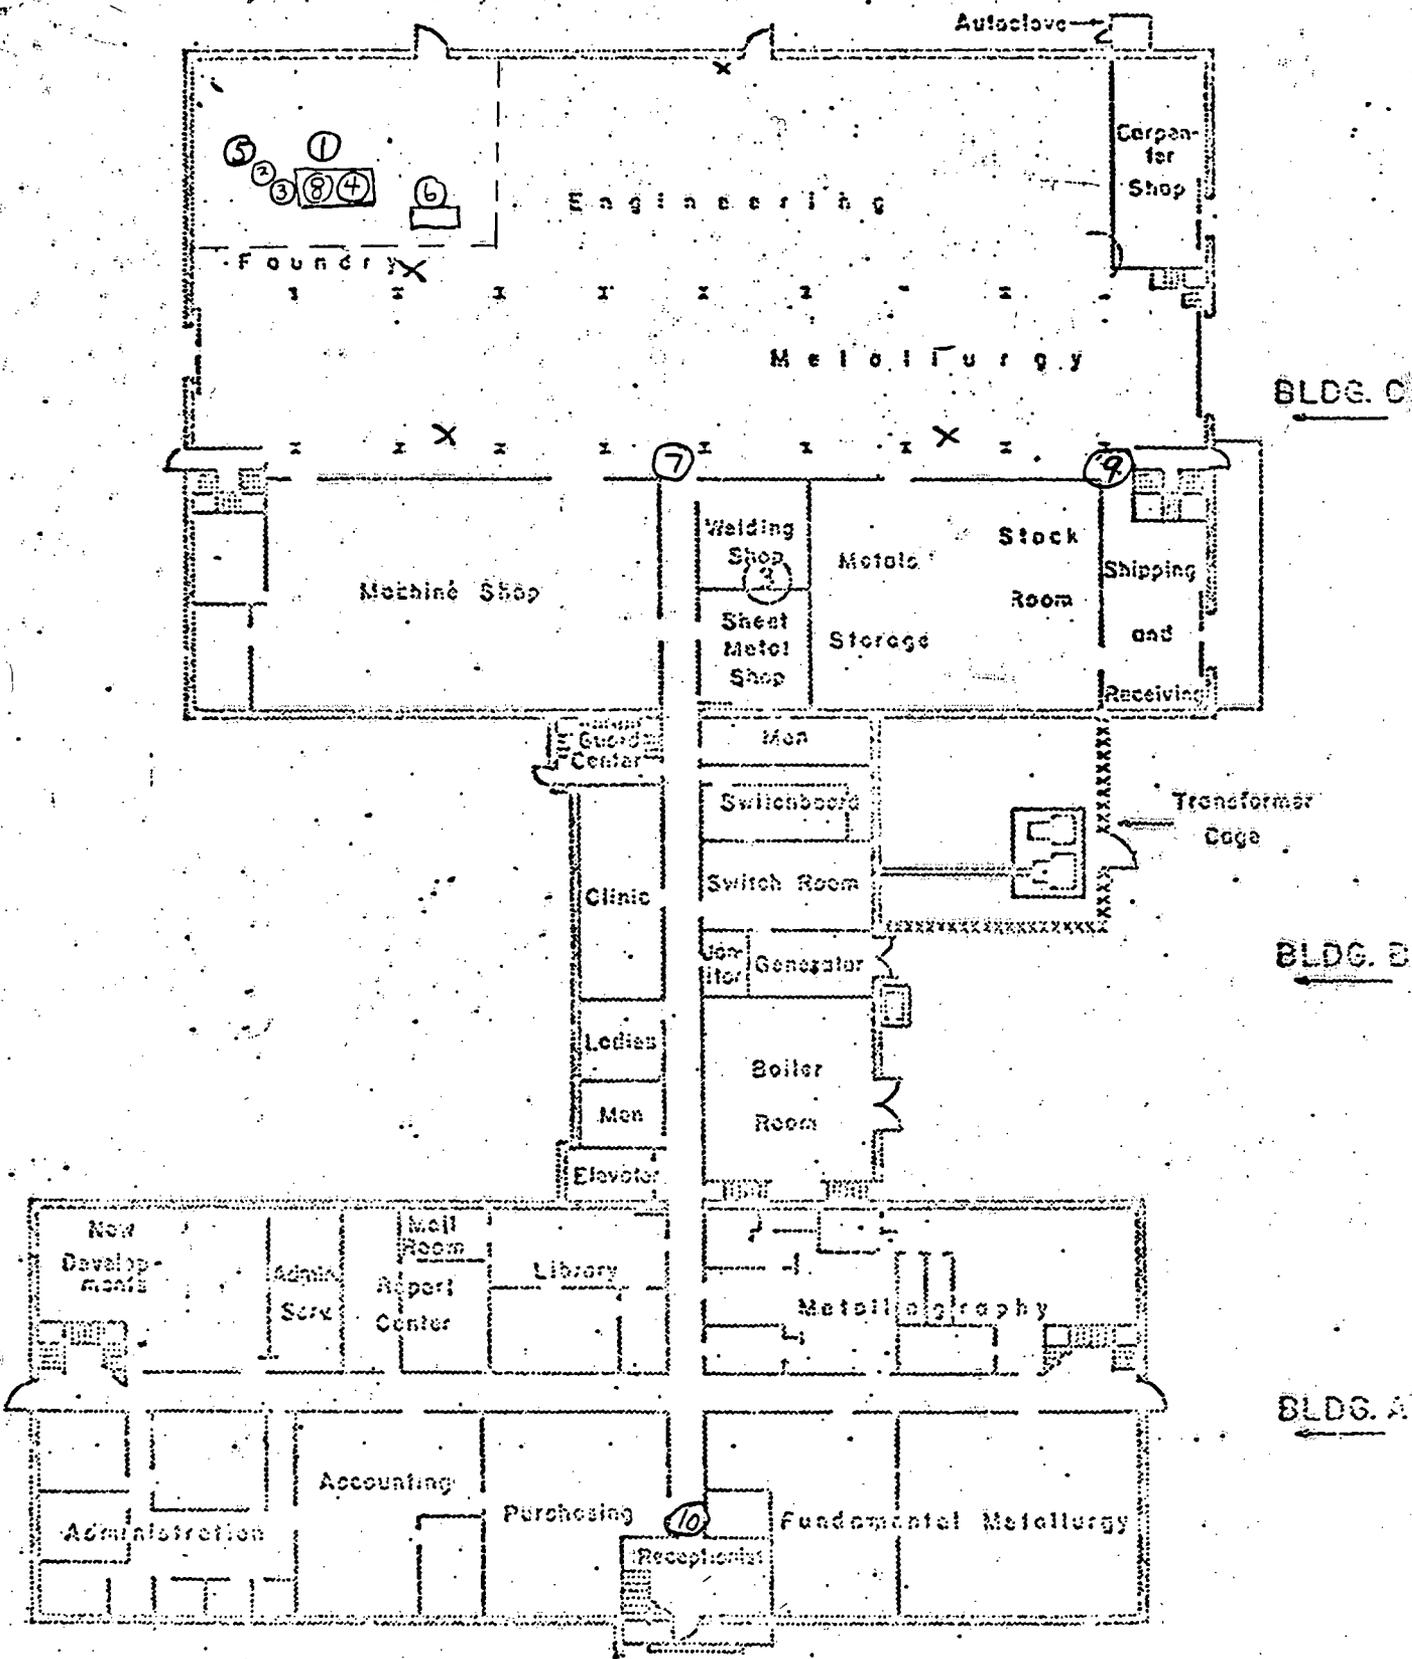
○ Location of wipers

- a. Records were examined for the period from April 1 to December 15, 1973 and showed that wipes were taken monthly at 14 locations in the plant area. The wipes were counted only for alpha contamination. The maximum wipe showed 28.5 d/m alpha/100cm<sup>2</sup>. It was taken on the floor near the large door in the foundry area.
- b. The inspector took wipes at ten locations as indicated in Table 1. The wipes were counted on January 2, 1974 using an Eberline Model SAC-4 for alpha counting and Eberline Model LCS-1 with Eberline Model RD-14 Beta Detector for beta counting. Figure 1 shows the location of the wipes by number.

<u>SMEAR NUMBER</u>	<u>LOCATION</u>	<u>d/m alpha</u>	<u>d/m beta-gamma</u>
1	Floor near tower (Foundry)	78	10,105
2	Inside side wall crucible hood (Foundry)	270	11,224
3	Step to tower (Foundry)	78	17,559 <sup>(1)</sup>
4	Floor of tower hood (Foundry)	189	5 mR/hr <sup>(1)</sup>
5	Inside paint hood, side wall (Foundry)	34	705
6	Floor near hack saw (Foundry)	25	4,256
7	Floor near exit to hall (Main shop area)	6	686
8	Tower counter top (Foundry)	40	5,331
9	Floor near entrance to shipping and receiving area(Main Shop Area)	6	335
10	Floor in hall at reception room	9	148
