March 19, 2008

Subject: Non Destructive Examination Summary of Pressurizer Safety Nozzles Removed from Service at Port St Lucie Unit 1

INITIAL EXAMINATION OF PORT ST LUCIE UNIT 1 PRESSURIZER SAFETY NOZZLES

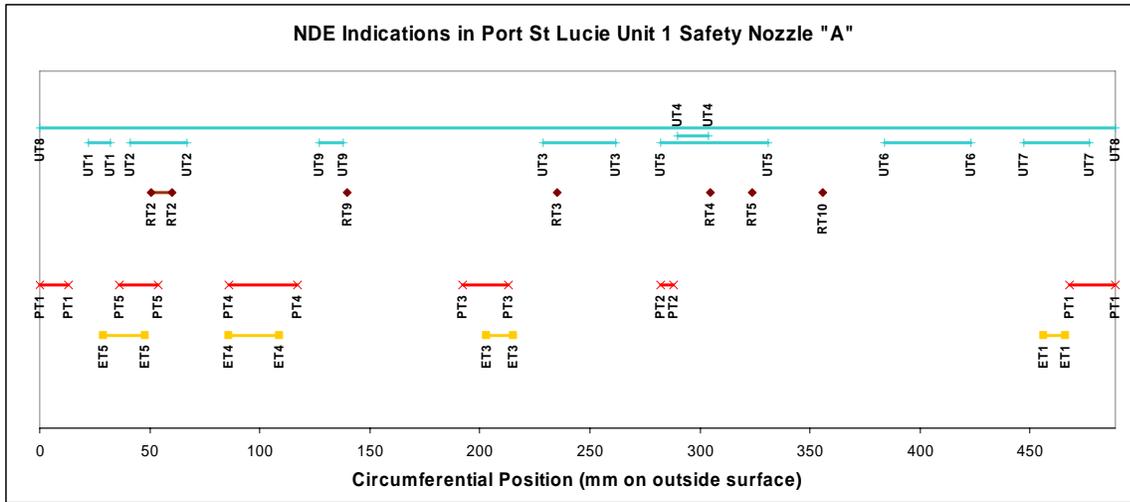
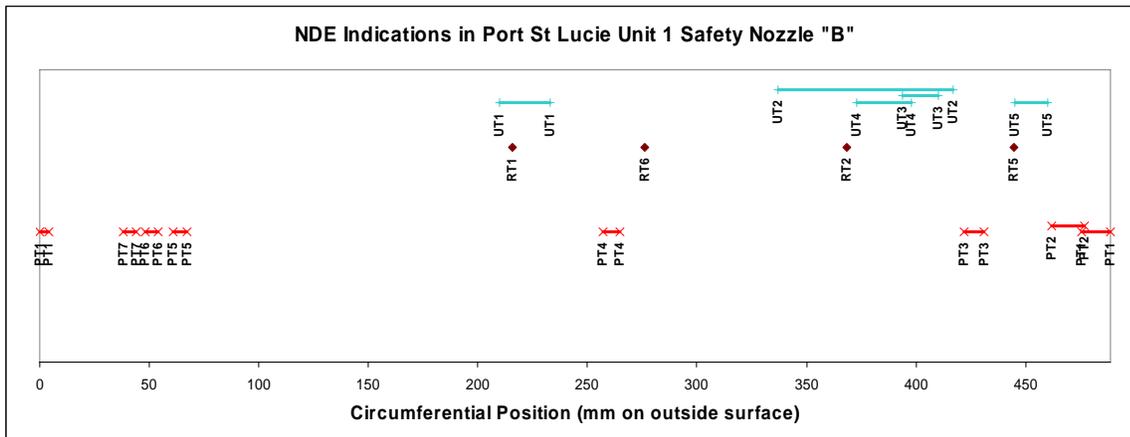
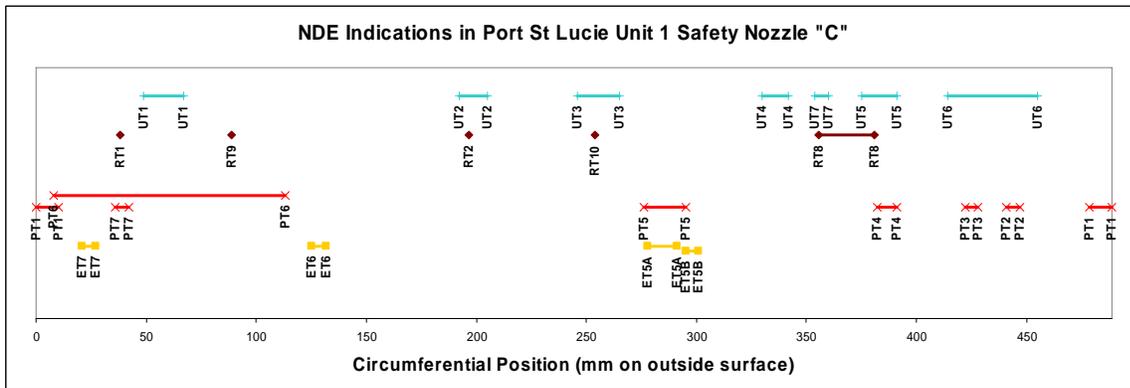
Figure 1. Comparison of all NDE results for PSL safety nozzles A, B, and C.

Nine indications were reported in nozzle A, five in nozzle B, and seven in nozzle C. All indications were attributed to subsurface flaws resulting from the fabrication process. All were characterized as embedded flaws that are adequately separated from both the inside and outside surfaces of the nozzle. Many additional responses from embedded reflectors were observed but were below the amplitude threshold for reporting indications, as defined in the examination procedure.

The vendor concluded that the double-wall examination of all three nozzles revealed no inside surface connected indications indicative of stress corrosion cracking. Embedded flaws indicative of fabrication defects were detected in all three welds.

The vendor concluded that the single-wall examination of nozzle A detected no cracking but also detected fabrication defects. Linear indications were detected and verified to be from an ID machining process performed during fabrication.

This examination was performed in February at the same time as the manual ultrasonic examination. Five linear indications were identified in nozzle A, seven indications were identified in nozzle B, and seven indications were identified in nozzle C. One of the indications in nozzle C was 50mm long. All the other 18 indications were less than or equal to 16mm long.

Four circumferential linear indications were identified in nozzle A. They range in length from 0.25 to 0.46 inch (6.3mm – 12mm). No indications were recorded in nozzle B. Four indications were identified in nozzle C; they lacked definitive characteristics of either circumferential or axial orientation, and were identified as surface blemishes.

A graphical summary of the comparison is presented in Figure 1. The results of the two volumetric methods, UT and RT, should be compared to each other for assessment of indications obtained throughout the material. The results of ET and PT should be compared to each other for assessment of inside surface conditions. The vertical positions of the indications in Figure 1 are not indicative of the axial position of the indications; a few of the overlapping indications have been staggered vertically for clarity.

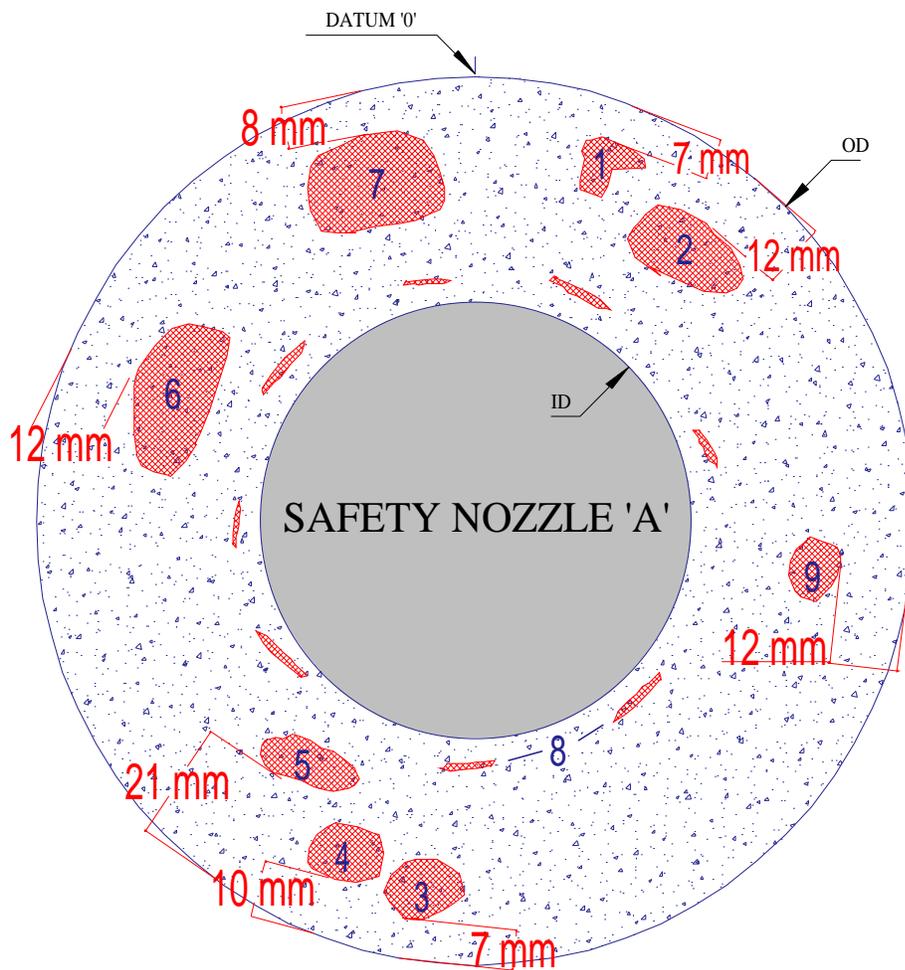
Figure 2. Profile of indications from encoded ultrasonic examination.

The profile of the indications reported from the manual data is shown in Figure 2 (the same profile that had been reported in Reference [4]). The indications that were reported by the encoded UT vendor were overlaid on the manual UT profile as shown in Figure 3. The two profiles are mutually consistent. Some discrepancies may be due to the difficulty of precisely maintaining a constant circumferential position while scanning manually. There are gaps in the encoded UT profile because the vendor reported only those reflectors whose amplitudes exceeded the procedure’s reporting threshold. Many additional reflectors are present in the encoded data and corresponded well with the manual UT measurements, as shown in the side-by-side comparisons in Attachment 8.

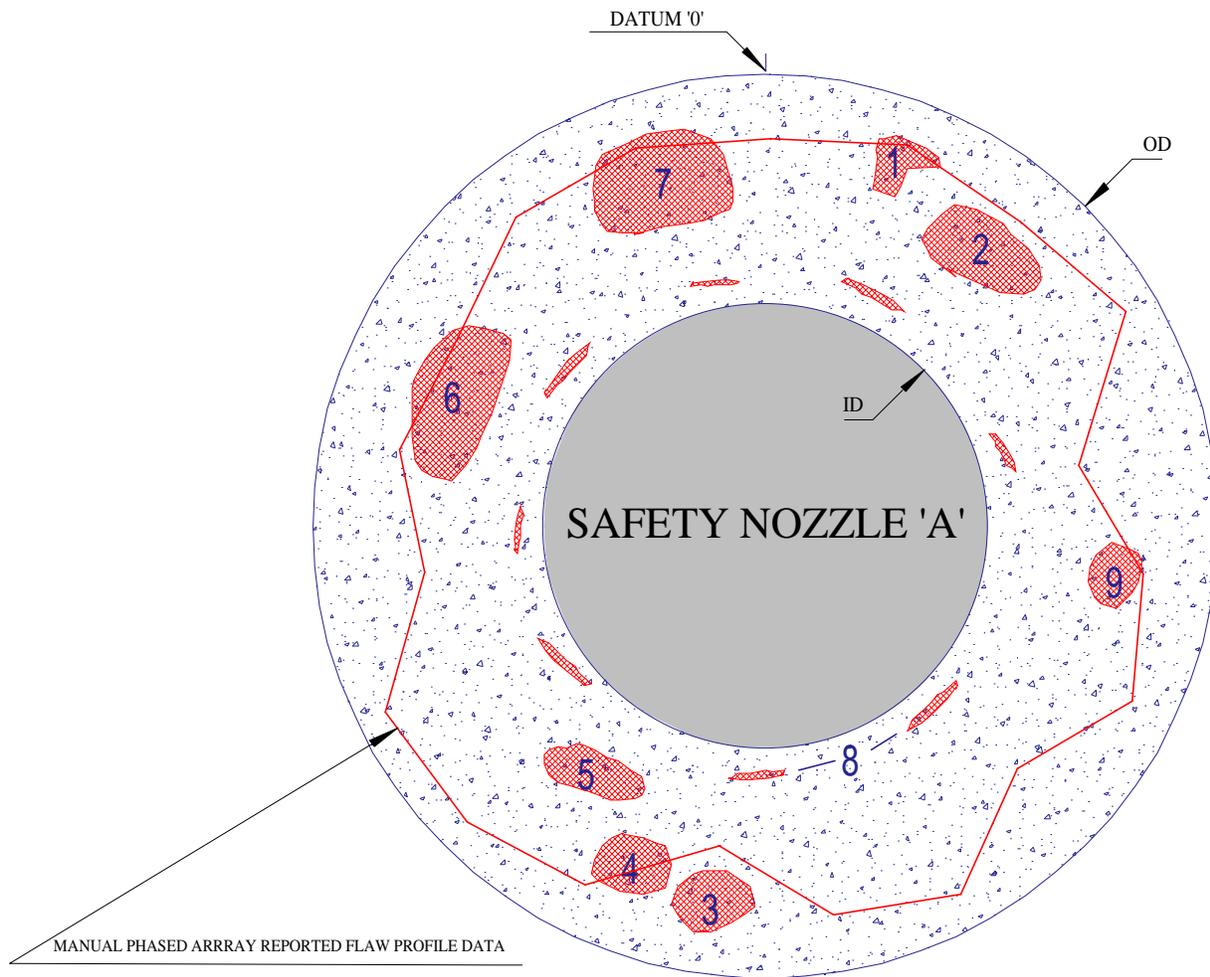
Figure 3. Encoded UT data profile, with manual UT data profile (from MRP 2008-014) overlaid.

The manual UT examiner was provided an opportunity to review the encoded UT data to help develop an understanding of the relative behavior of manual vs encoded examination. After reviewing the encoded data he concurred that the indications represent fabrication defects.
