Subject: Duke Power Company LLC d/b/a Duke Energy Carolinas LLC (Duke)  
Oconee Nuclear Station, Unit 1  
Docket No: 50-269  
Relief Request No. 08-ON-003  
Relief Request from Immediate ASME Code Flaw Repair of Low Pressure  
Service Water Piping

**Oconee Nuclear Station - Unit 1  
Relief Request Number 08-ON-003**

**1LPSW-21 weld neck flange pin hole  
leaks Operability Evaluation**

**1LPSW-21 weld neck flange pin hole  
leaks UT thickness data report**

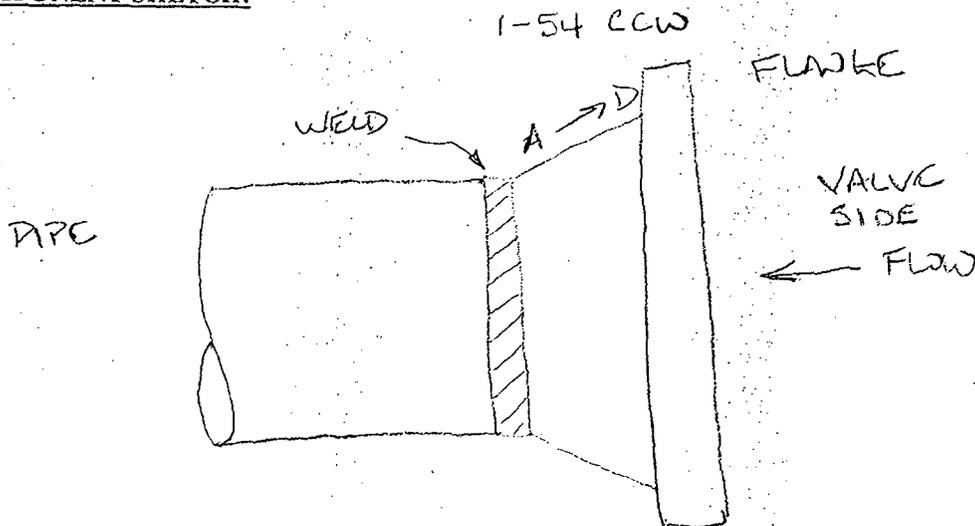
C1LPS-040 (Valve 1LPSW-21) Flange UT  
 1/2" Dual Transducer 02/06/08

UT data at the 2 adjacent pinhole leaks on the 1LPSW-21 flange hub measured a thickness of only 0.100 inch, but the weld-neck flange thickness adjacent to the pipe weld (axially downstream from the leak) was approx. 0.25 inch. Measured thickness at the other eight flanges (adjacent to pipe-to-flange weld) directly in front (axially downstream) of the obstructed areas were approximately 0.40 inch. Since the measured thickness at the pipe-to-flange weld for the eight flanges greatly exceeds that of 1LPSW-21, there is reasonable basis to conclude adequate thickness exists in the obstructed areas such that pinhole leakage is not imminent.

Single Leak adjacent to  
 weld at Row 19

Double Leak 1" from  
 weld at Rows 42/43

Circles identify  
 locations of proposed 1"  
 half-couplings for leak  
 repair

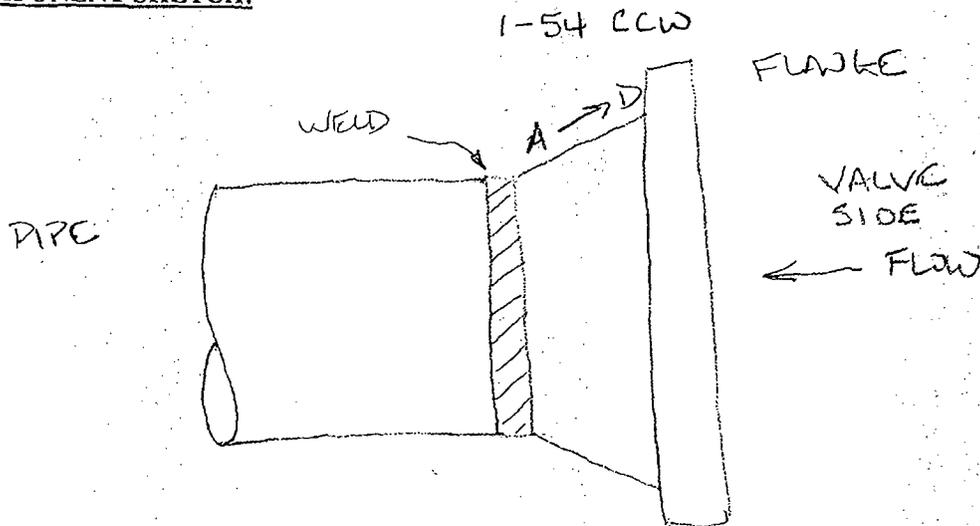
C1LPS-040 (Valve 1LPSW-21) Flange UT  
 1/4" Dual Transducer 03/04/08

Single Leak adjacent to  
 weld at Row 19

Double Leak 1" from  
 weld at Rows 42/43

Circles identify  
 locations of proposed  
 1" half-couplings for  
 leak repair
