Re: Turkey Point Unit 3
Docket No. 50-250
Reportable Event: 2007-002-01
Date of Event: June 6, 2007
LER 2007-002-01, Completion of Shutdown Required by Technical Specifications
due to Inoperable Rod Position Indication for Two Control Rods in the Same Control
Bank

LICENSEE EVENT REPORT (LER)

4. TITLE Completion of Shutdown Required by Technical Specifications due to Inoperable Rod Position Indication for Two Control Rods in the Same Control Bank

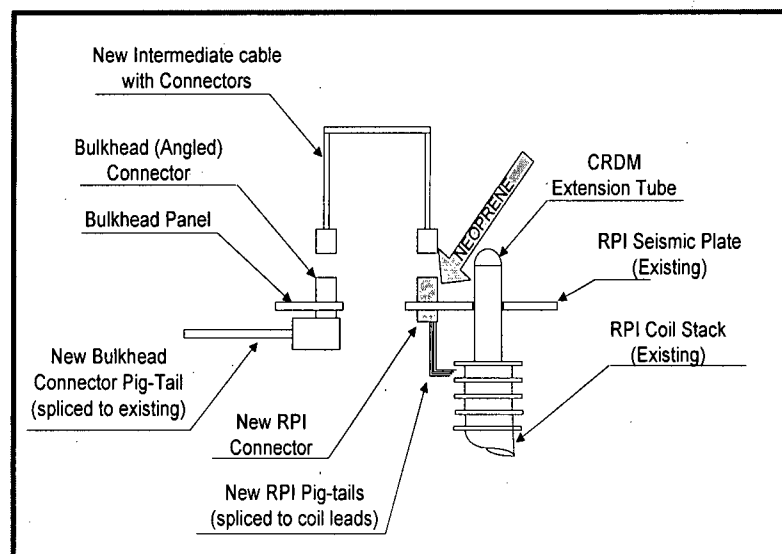
Figure 1: RPI Coil Stack Cable Connectors

The RPI cable replacement included the following (Refer to Figure 1): a) replacement of cables surrounding the reactor cavity with new cable spliced into the existing cable, b) new bulkhead connector and panel on the refueling floor on the west end of the reactor cavity, c) new intermediate cables with connectors from the bulkhead connector panel to the RPI Seismic Plate Coil stack connectors. The existing Rod Position Indicator (RPI) coils were reused. The RPI coil stack seismic plate connectors were also replaced.

After testing the RPI cables and connectors it was determined that the cause of the erratic RPI indication was the insulation breakdown of the connector insert on the reactor head. Based on part numbers, vendor documentation, insert material color, and laboratory testing of the failed dielectric from the M-6 RPI coil stack connector, it was determined that the RPI coil stack seismic plate connectors utilized neoprene rubber inserts, instead of silicone rubber. The connector insert, which should provide insulation between connector pins and connector body, was found to be conductive across its exposed face. All the failures identified were at the RPI coil stack seismic plate connection with the seismic plate-mounted male connectors being the failure initiator/propagator. For these failed connectors, all tests showed evidence of a migration of neoprene material to the mating cable connectors with silicone rubber inserts.

The RPI coil stack seismic plate connectors with neoprene inserts are a subcomponent of the RPI coil stack pigtail assembly. These assemblies were fabricated and installed during the Fall 2004 outage for the replacement of the reactor vessel head. The RPI cables and connectors installed in the vicinity of the reactor vessel must be able to maintain their physical and electrical insulation properties over many years under high temperature environmental conditions. The degradation of the neoprene rubber insert from the pigtail assembly connector contaminated and permeated the silicon rubber insert of the intermediate cable mating connector. The contamination of the intermediate cable connector resulted in a breakdown of its silicon rubber insert and caused it to become conductive. This conductivity resulted in shorting of conductor dielectric thus causing the erratic RPI detector oscillations.

Turkey Point Unit 3 was shutdown and the RPI seismic plate coil stack connectors were removed. Because of parts unavailability and the long lead time to procure new connectors, the RPI coil stack pigtail assembly wires have been spliced to the RPI intermediate head cables as a corrective action which eliminates the failure mode by eliminating the unqualified portion of the RPI system.
