Re: Turkey Point Unit 3
Docket No. 50-250
Steam Generator Tube Inspection Report

Turkey Point Unit 3

EOC 22

Steam Generator Tube Inspection Report

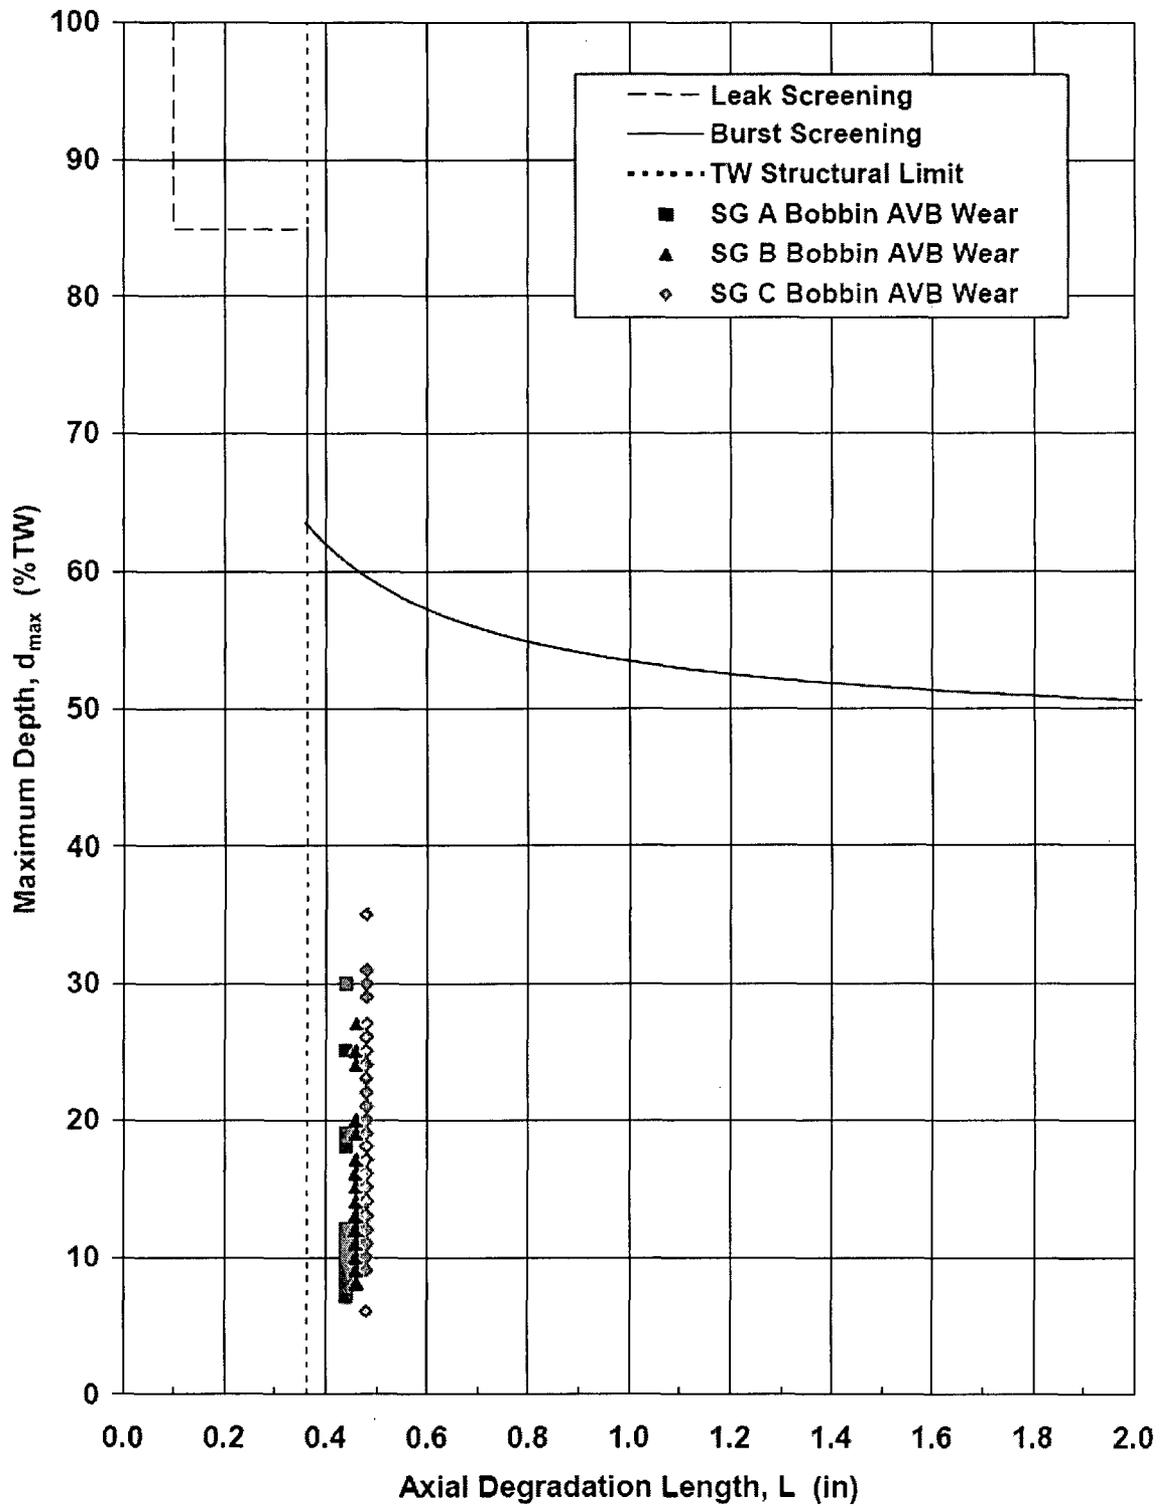
FIGURE 1

The size of each of the wear indications at AVB, Top of Tube Sheet (TTS), broached Tube Support (TSP) and flow baffle (BAH) locations was evaluated and compared to structural limits. As shown in Figures 1 through 4, the wear indications were shallow in depth and within the calculated structural limits. Therefore, all indications met industry requirements for structural integrity. Leakage potential for the tubes was zero. Therefore, these mechanisms remain within the tube integrity performance criteria. Profile analysis of three baffle plate locations was completed for tubes R31 C77, R39 C64, and R43 C45 in SG 3B. The lowest calculated lower 95% burst pressure, taking into account material strength, sizing, and relational uncertainties, is 7760 psi for R39 C64. This value is significantly greater than three times normal operating pressure differential (4552 psi). Therefore, these indications met the structural and leakage integrity performance criteria and in situ pressure testing was not required

AVB Wear (Bobbin) vs. Structural Limit (All S/G's)

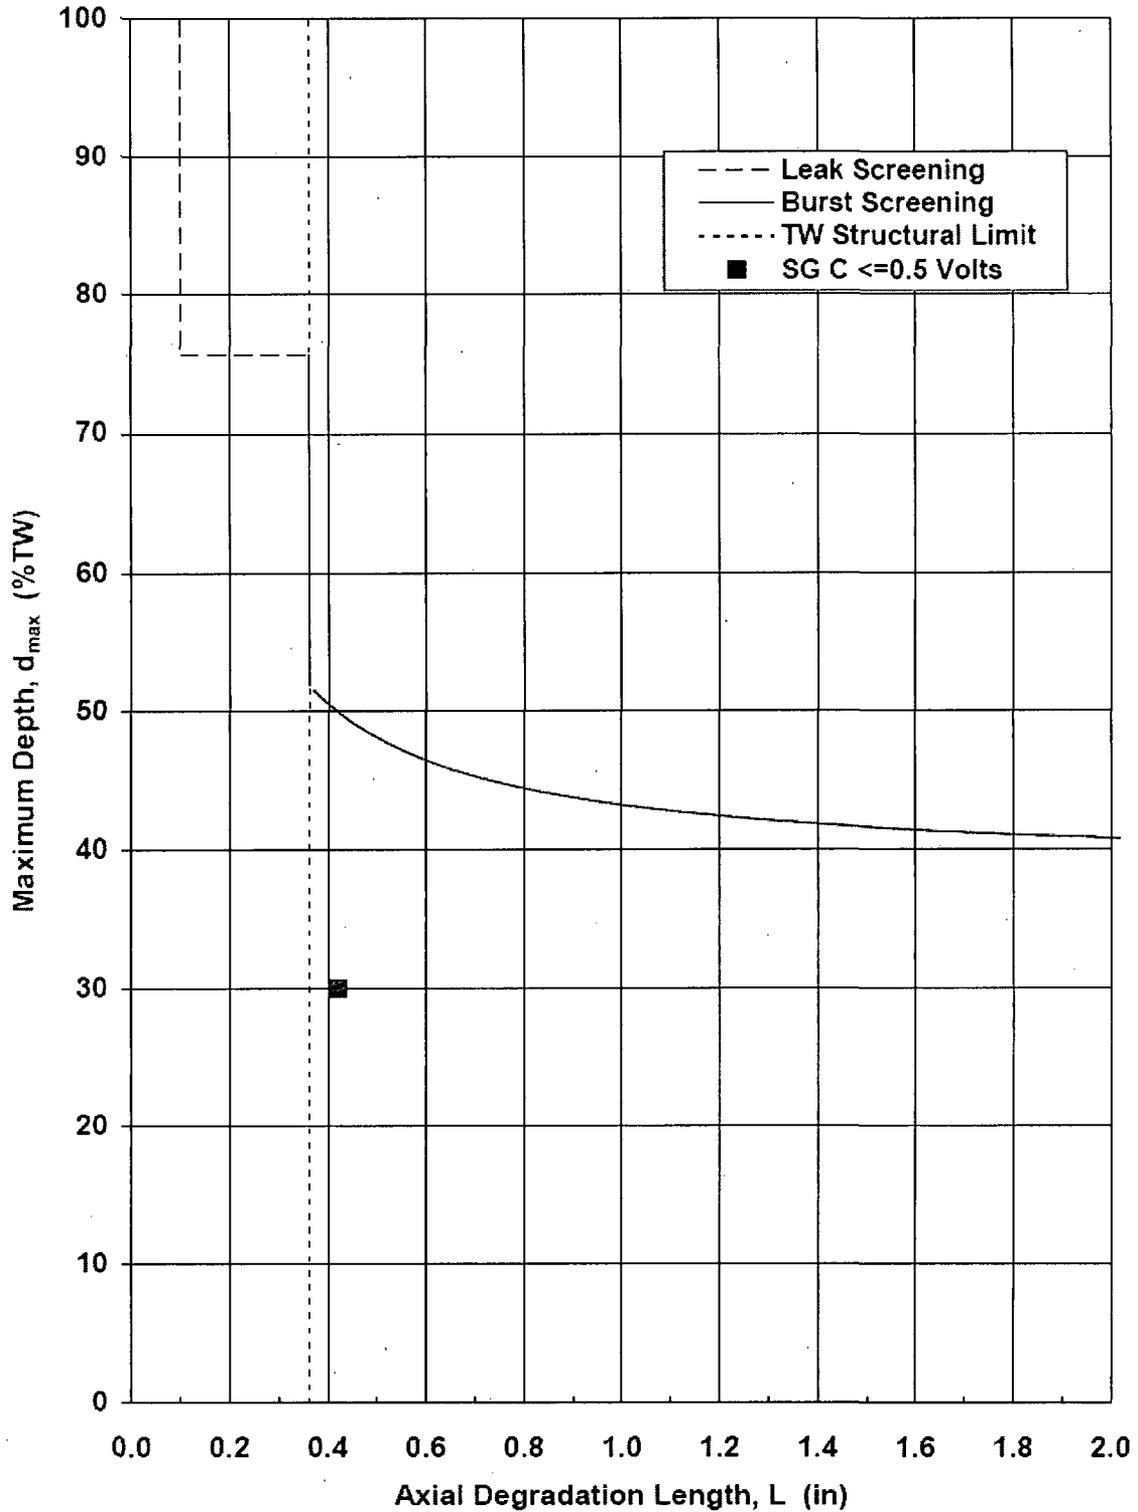
FIGURE 5

The size of the single volumetric indication within the hot leg tubesheet was also compared to the structural limits. This indication (S/G 3C R20 C67) met the initial screening as shown in Figure 5. Subsequent profile analysis and structural evaluations were completed to determine if in situ pressure testing was required. The calculated lower 95% burst pressure, taking into account material strength, sizing, and relational uncertainties, is 6980 psi. This value is significantly greater than three times normal operating pressure differential (4552 psi). Therefore, this indication met the structural and leakage integrity performance criteria and in situ pressure testing was not required

Tube R20 C67 in S/G 3C, Condition Report 2007-28662, was plugged for the outside diameter (OD) volumetric indication detected approximately 6 inches below the hot-leg TTS. This indication is within the tubesheet and the tube-to-tubesheet crevice is closed. Therefore, there is no adverse service environment and this indication is considered to most likely be a result of manufacturing or installation and not service induced.

Tubesheet Volumetric (+Point™) vs. Structural Limit (All S/G's)
