# **Fabrication Flaw Density and Distribution In Repairs to Reactor Pressure Vessel and Piping Welds**

The Pacific Northwest National Laboratory is developing a generalized fabrication flaw distribution for the population of nuclear reactor pressure vessels and for piping welds in U.S. operating reactors. The purpose of the generalized flaw distribution is to predict component-specific flaw densities. The estimates of fabrication flaws are intended for use in fracture mechanics structural integrity assessments. Structural integrity assessments, such as estimating the frequency of loss-of-coolant accidents, are performed by computer codes that require, as input, accurate estimates of flaw densities. Welds from four different reactor pressure vessels and a collection of archived pipes have been studied to develop empirical estimates of fabrication flaw densities.

This report describes the fabrication flaw distribution and characterization in the repair weld metal of vessels and piping. This work indicates that large flaws occur in these repairs. These results show that repair flaws are complex in composition and sometimes include cracks on the ends of the repair cavities. Parametri

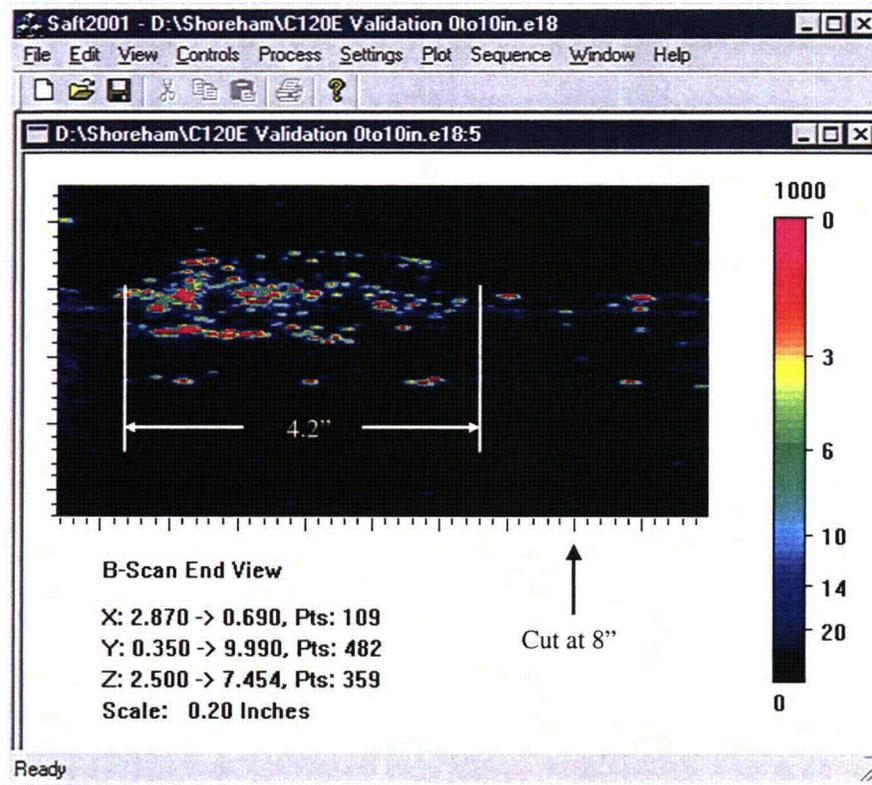
**Figure 3.2** Location of an Undocumented Repair in Shoreham Specimen C120E. The units in this figure are shown in inches because the SAFT-UT system is programmed to do so. To convert to centimeters, multiply by 2.54.

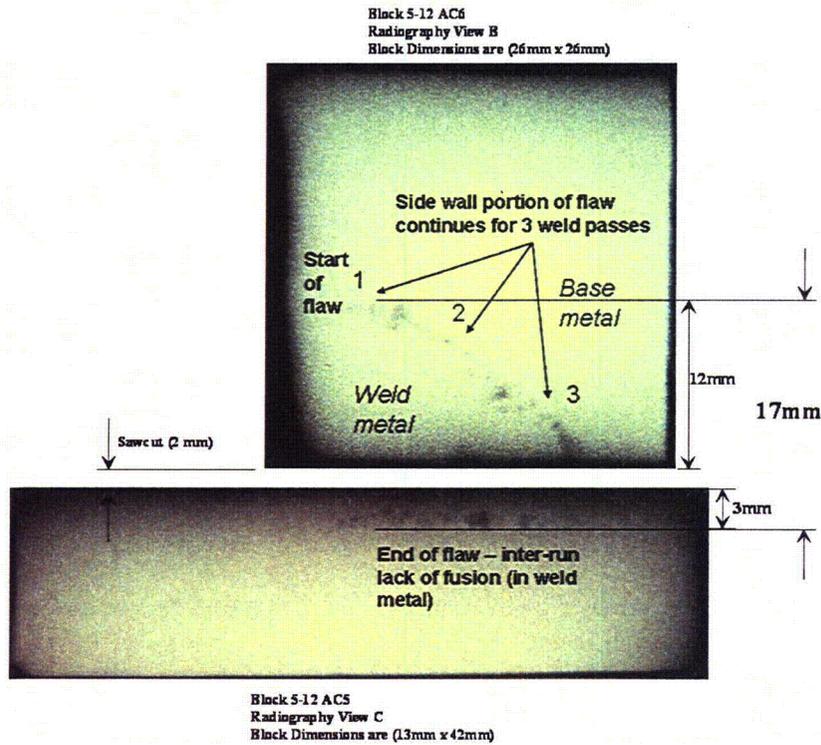
**Figure 4.1 Radiographic Images of PVRUF 17-mm Flaw in OD Seam Weld Repair. The location of this repair flaw and the repair cavity surrounded by the original weld can be seen in Figure 4.5.**

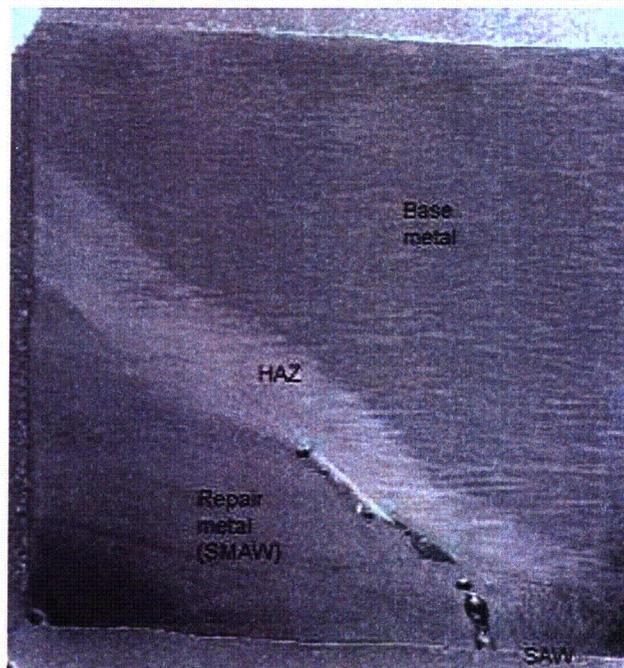
**Figure 4.2 Micrograph of Portion of PVRUF 17-mm Flaw Showing Location and Composition**

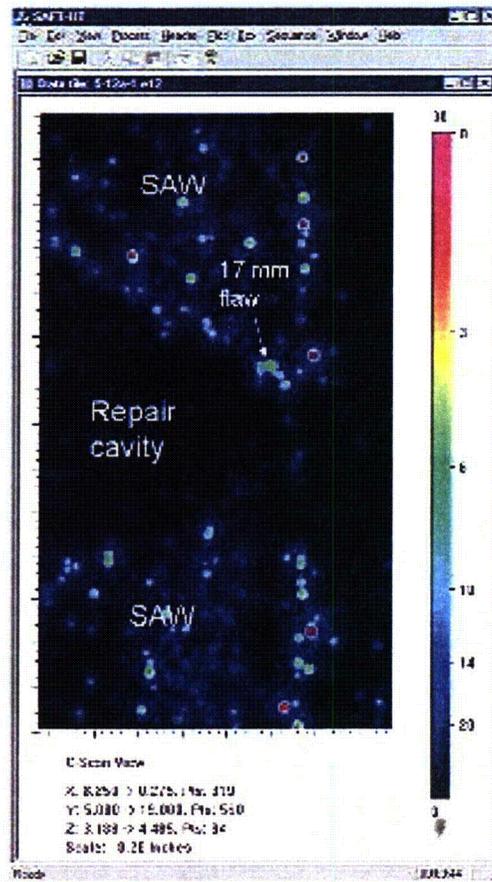
**Figure 4.5 Weld-Normal UT C-Scan Image of Weld Fusion Zone Showing Profile of Weld Repair Cavity and Location of PVRUF 17-mm Flaw. To convert to centimeters, multiply by 2.54.**

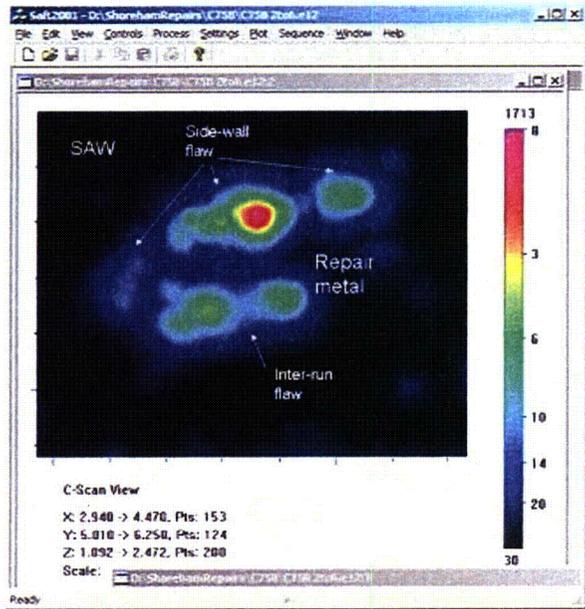
**Figure 4.9 High-Resolution Image of Shoreham 14-mm Repair Flaw. To convert to centimeters, multiply by 2.54.**

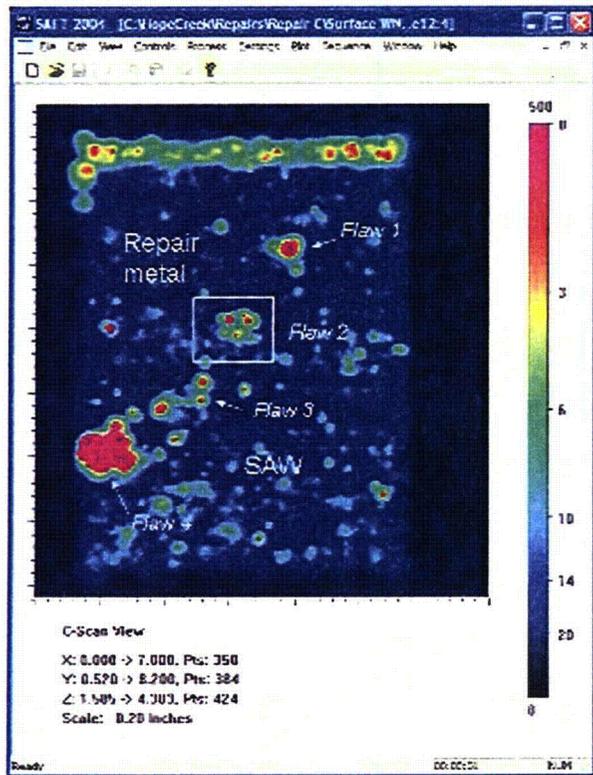
**Figure 4.10 Weld-Normal UT C-Scan Image of Flaw in Fusion Zone and on End of Repair Cavity C in Hope Creek Unit 2 Reactor Pressure Vessel. To convert to centimeters, multiply by 2.54.**

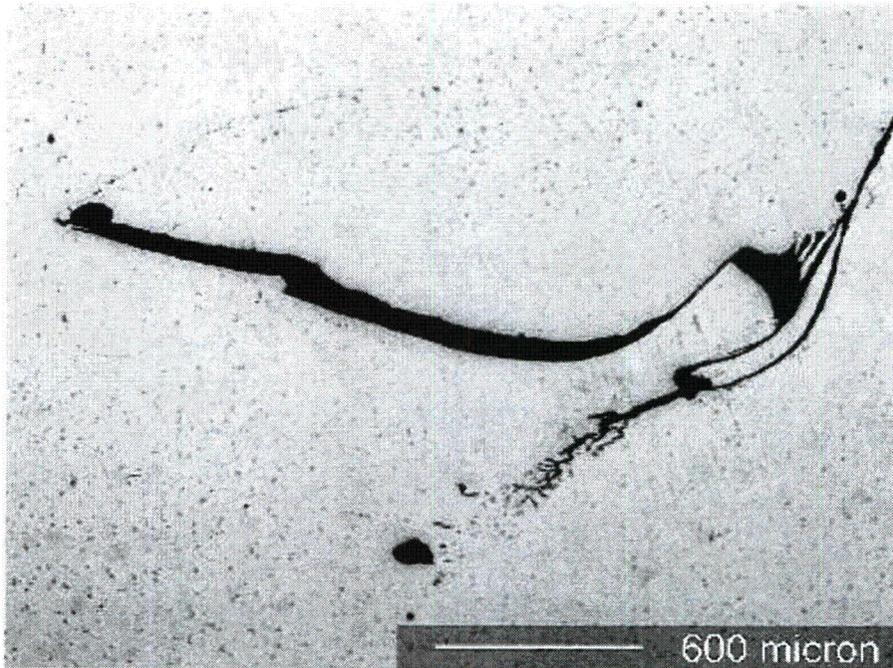
**Figure 4.11** Micrograph, as Machined, of Portion of Crack in Hope Creek Unit 2 RPV Specimen C2CC

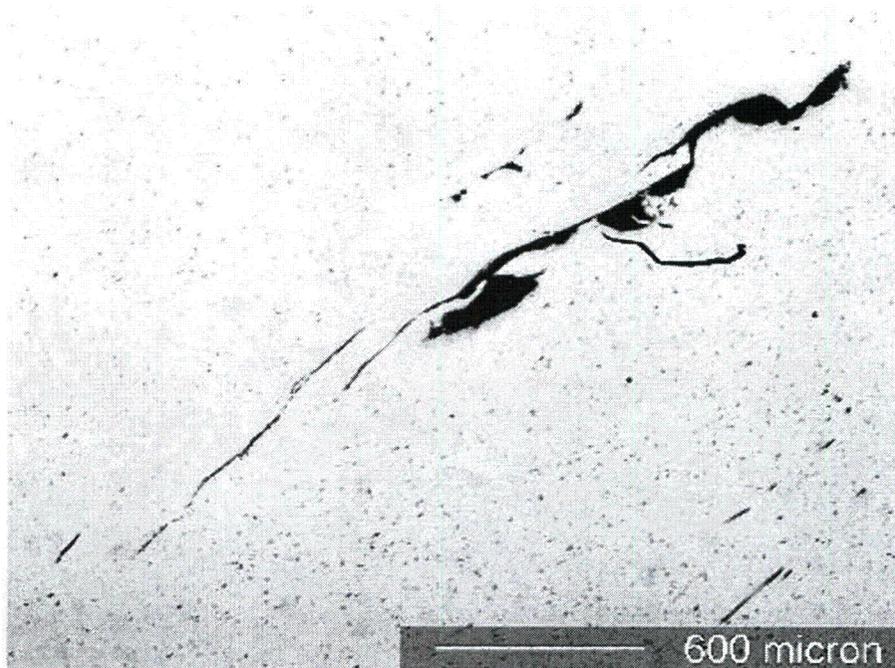
**Figure 4.12** Micrograph, as Machined, of Portion of Crack in Hope Creek Unit 2 RPV Specimen C2CC

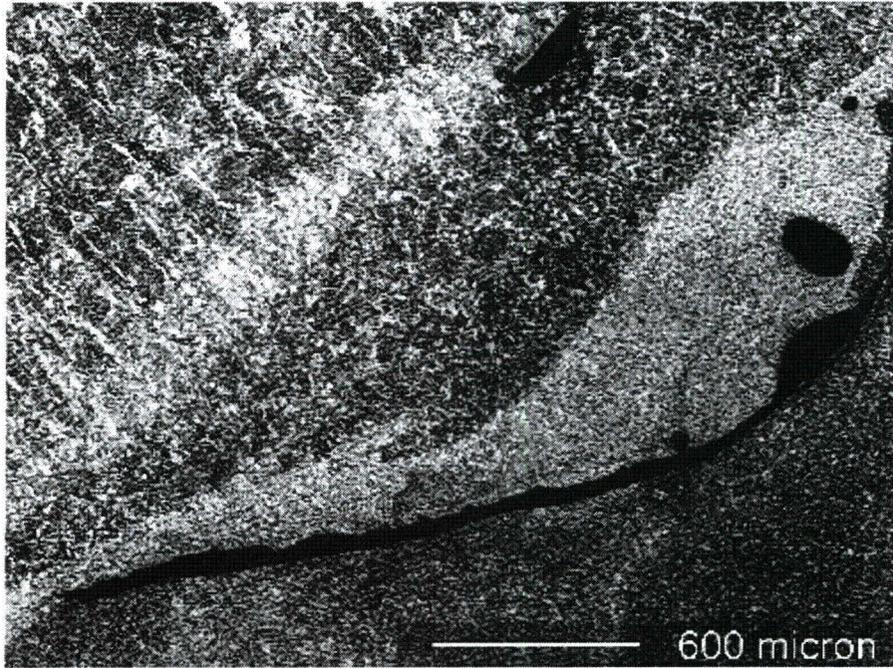
**Figure 4.13** Micrograph, as Polished and Etched, of Portion of Crack in Hope Creek Unit 2 RPV Specimen C2CC

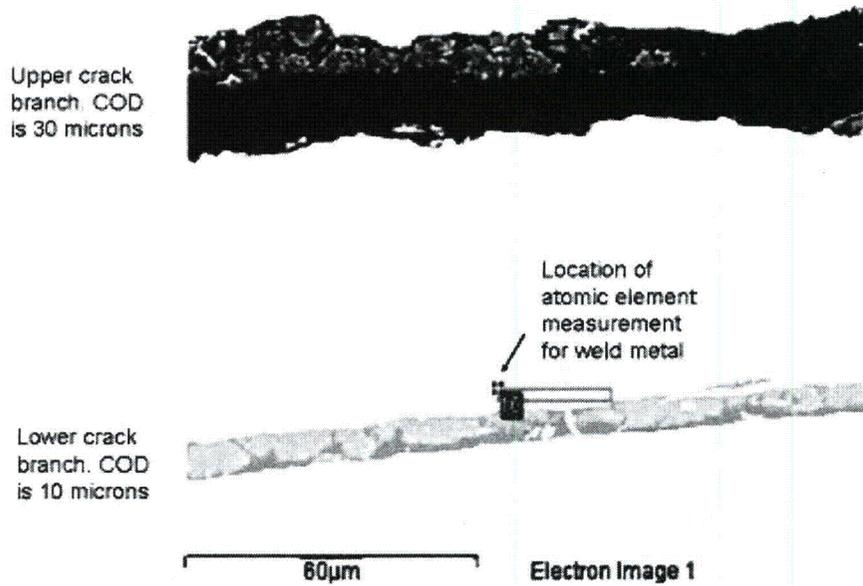
**Figure 4.14** Electron Image of Portion of Two Cracks in Hope Creek Unit 2 RPV Specimen C2CC

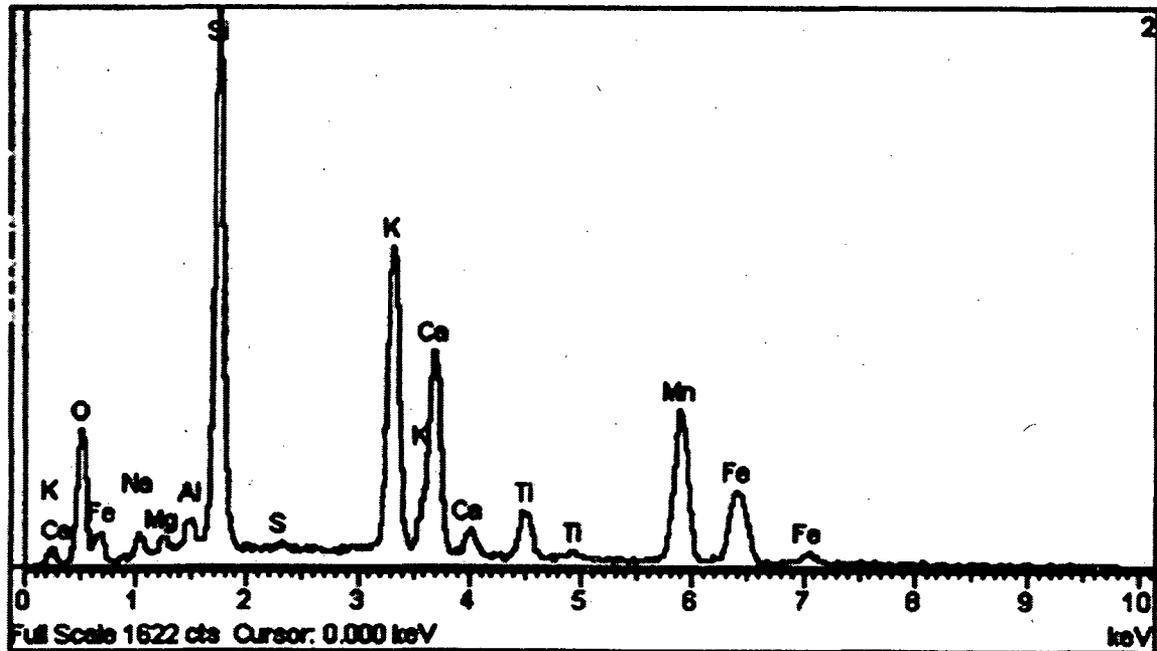
Figure 4.17, an electron image of a portion of a crack in Hope Creek 2 RPV specimen C2CC, shows the location, inside the upper crack, of the measurement of the elemental composition of the contamination in the crack. Figure 4.18 gives the elemental composition of contamination in the crack in Hope Creek 2 RPV Specimen C2CC; Figure 4.19 provides the x-ray spectrum from that elemental analysis.

Figure 4.19 X-Ray Spectrum from Elemental Analysis of Contamination in Crack in Hope Creek Unit 2 RPV Specimen C2CC

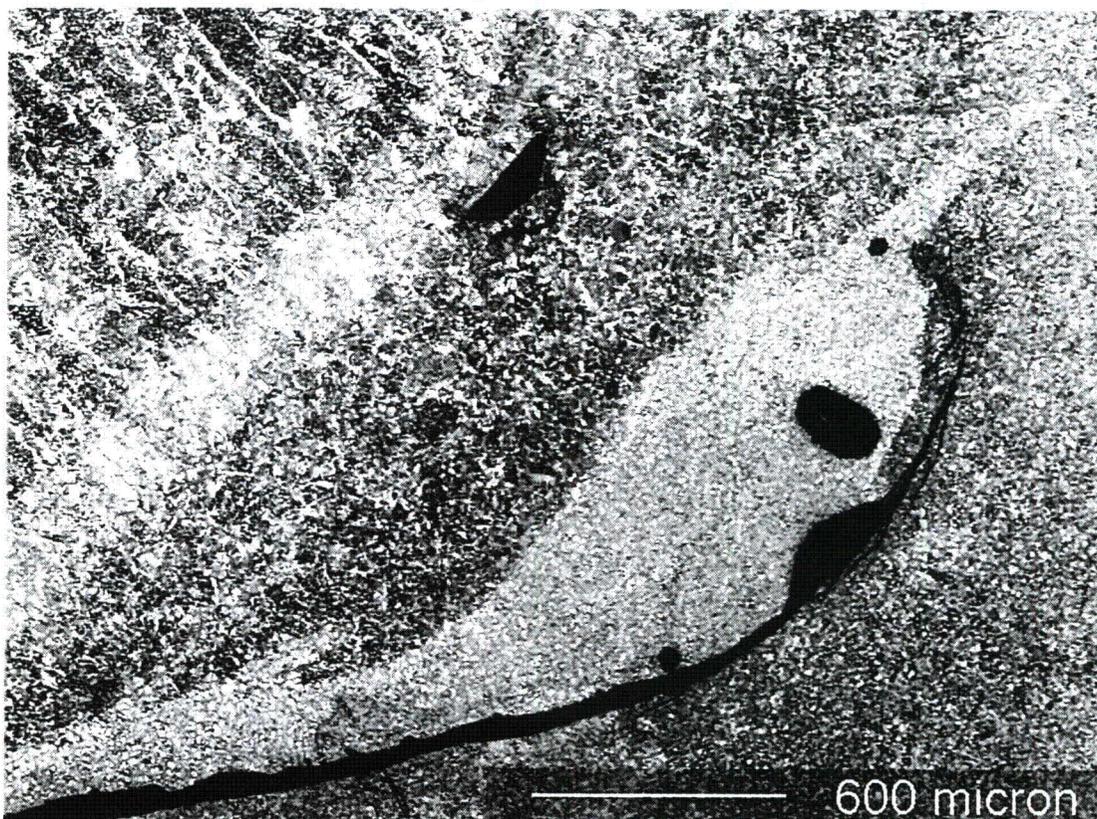
**Figure A.1** Flaw C2CC on the End of Seam Repair C, as Polished and Etched. Flaw has properties of lack of fusion with weld solidification cracks.

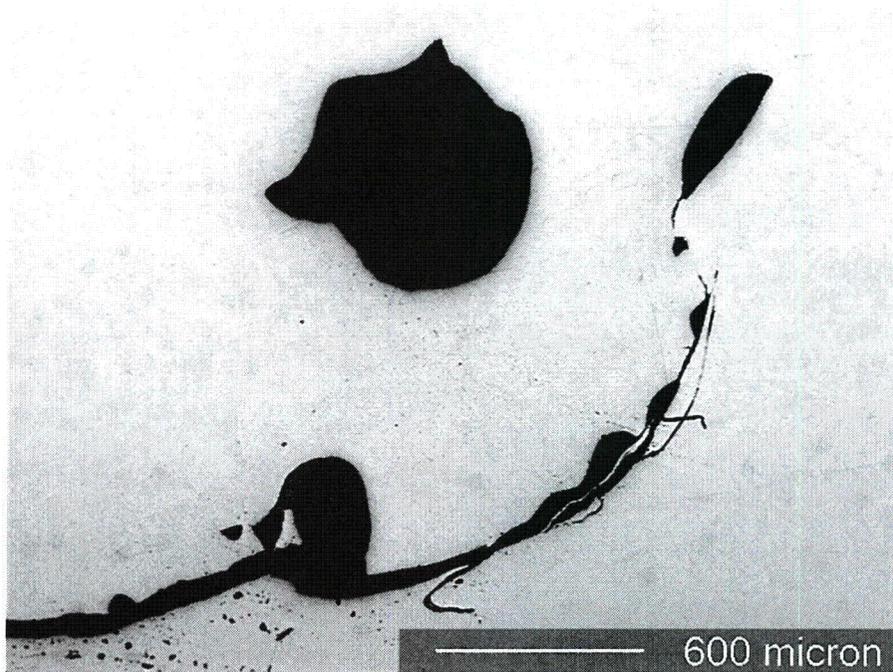
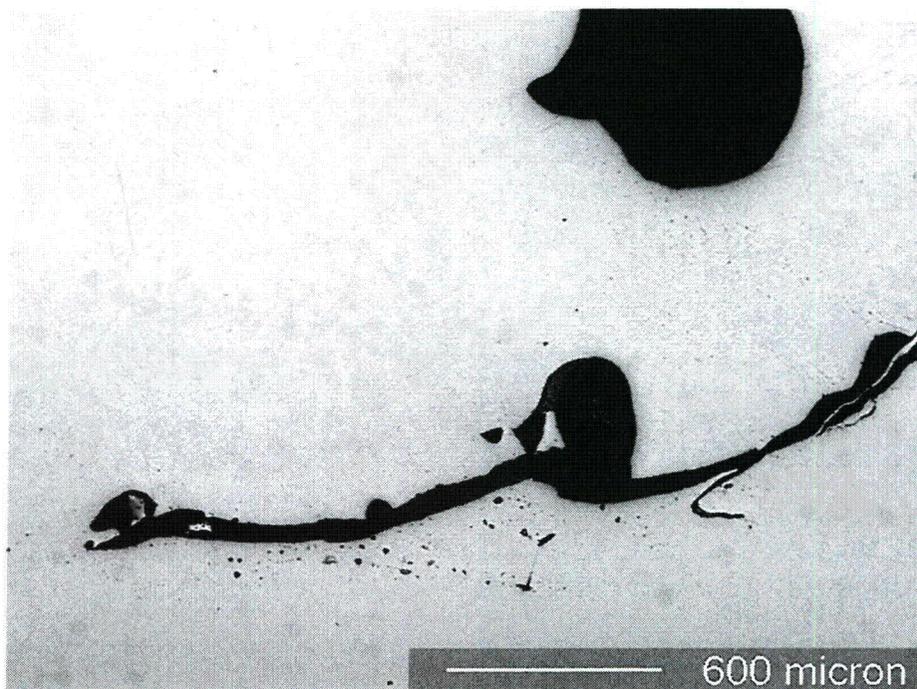
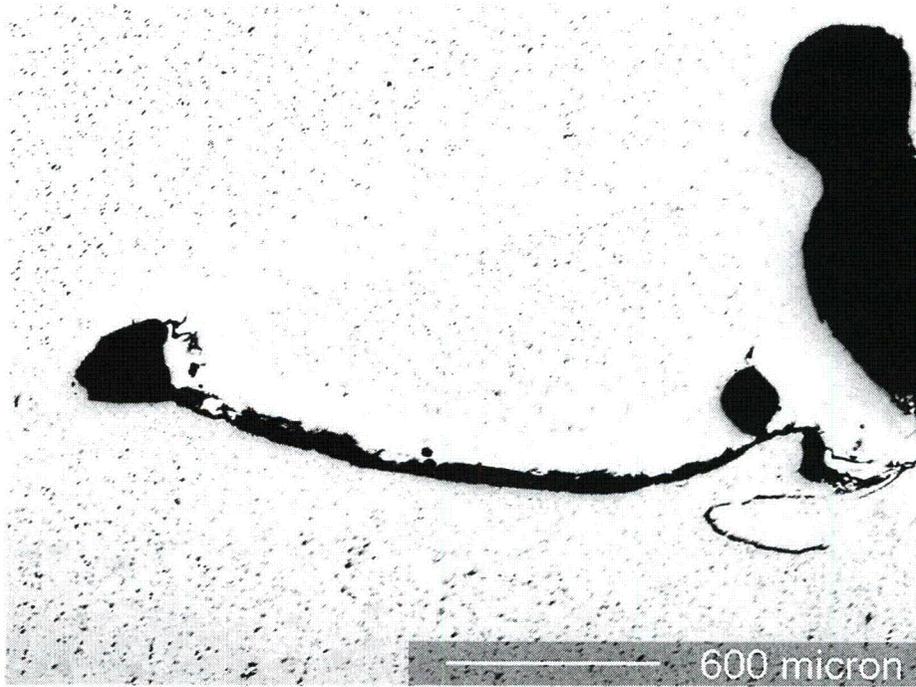
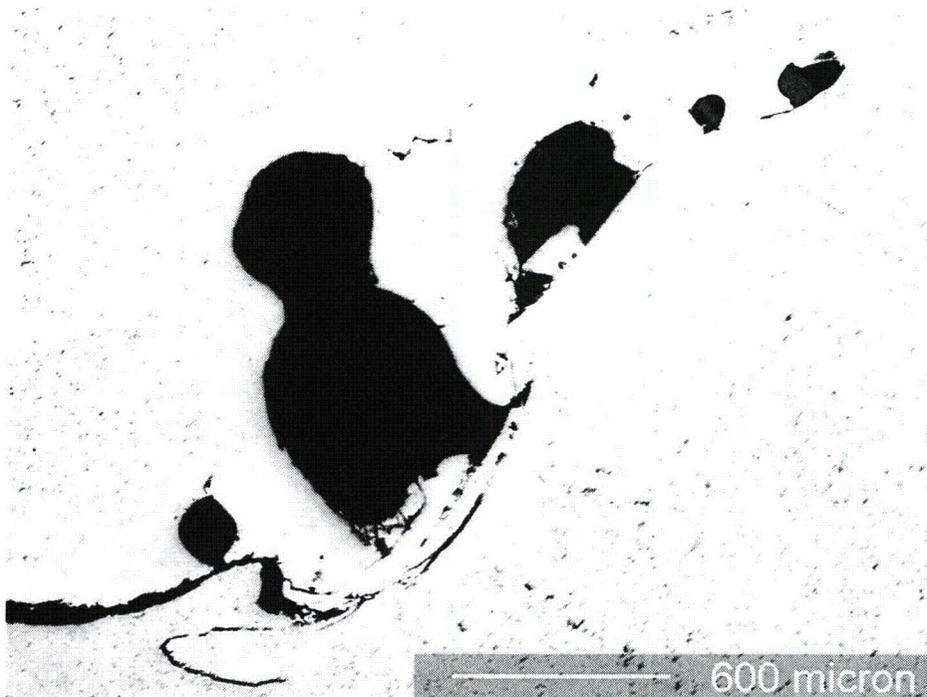
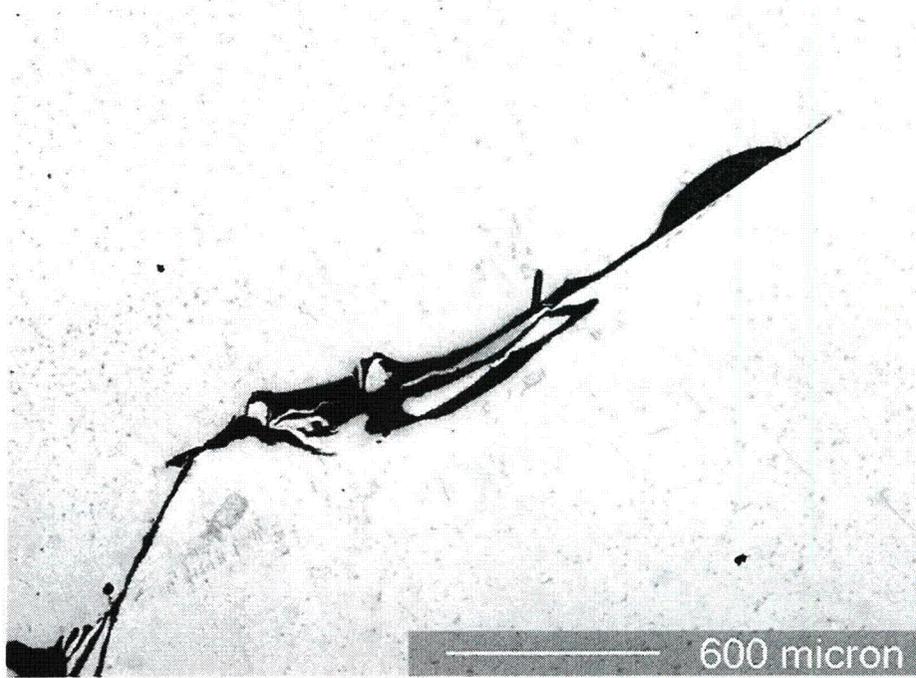
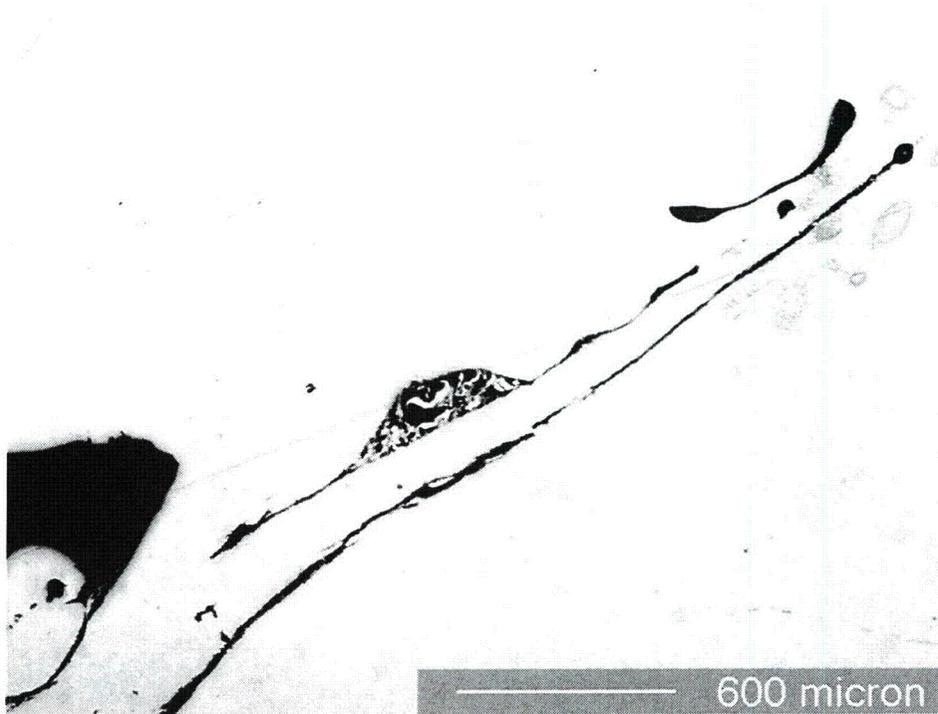
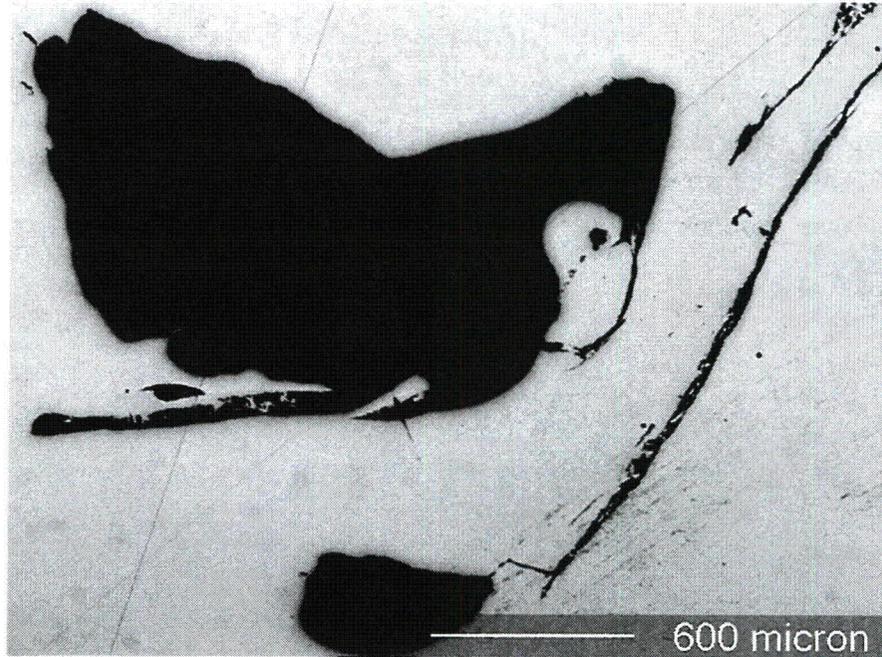
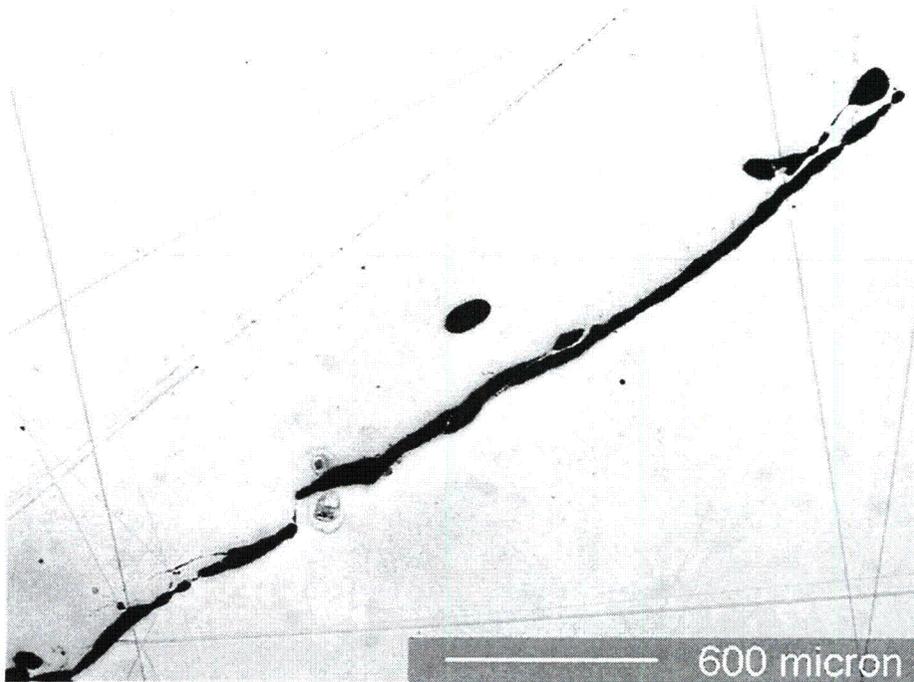
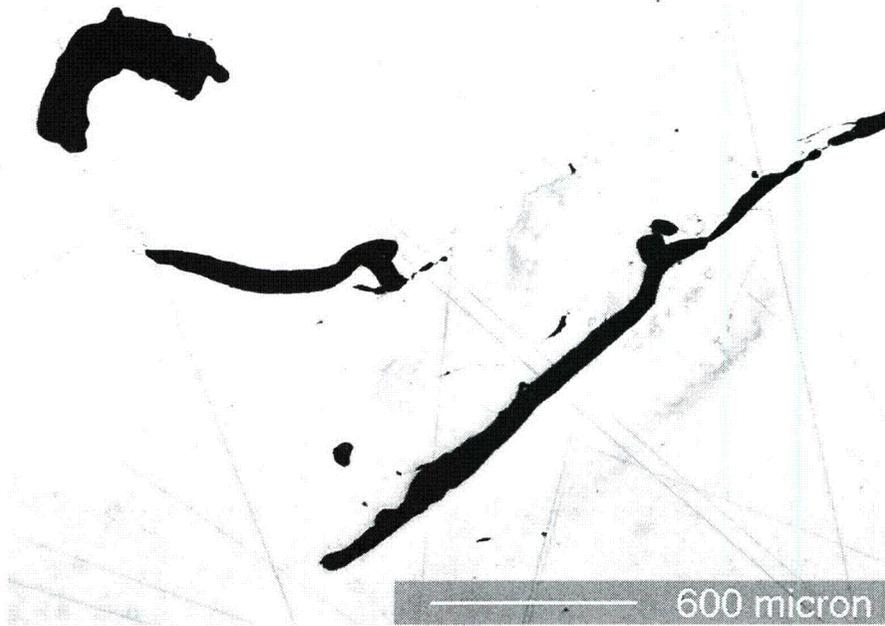
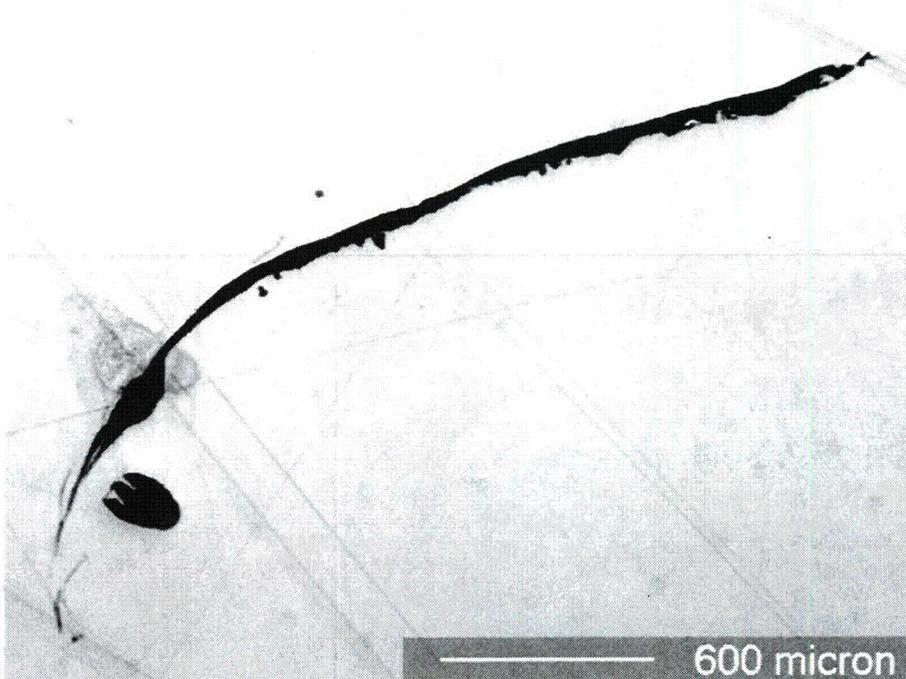
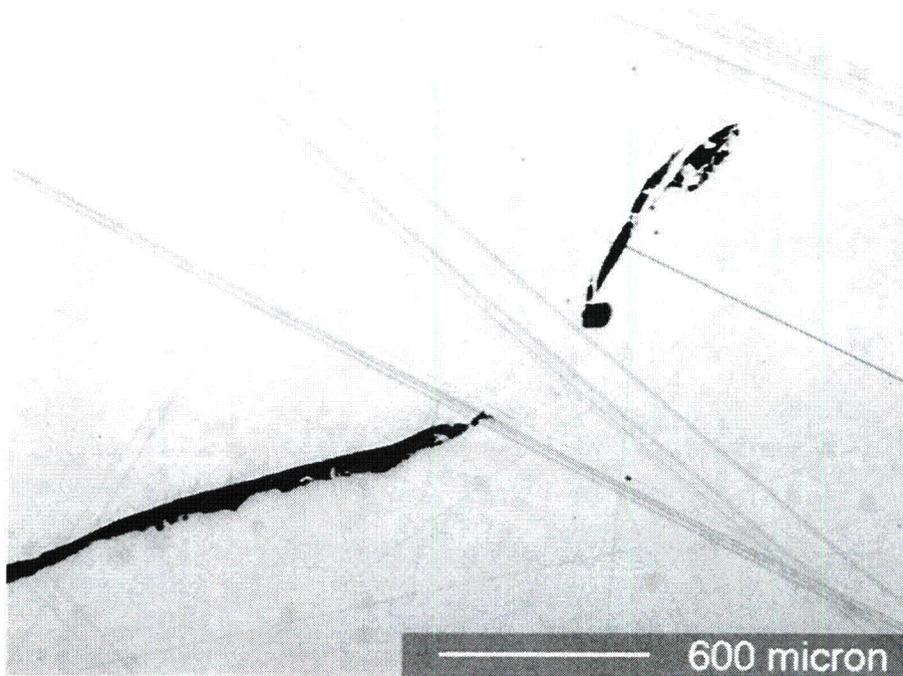
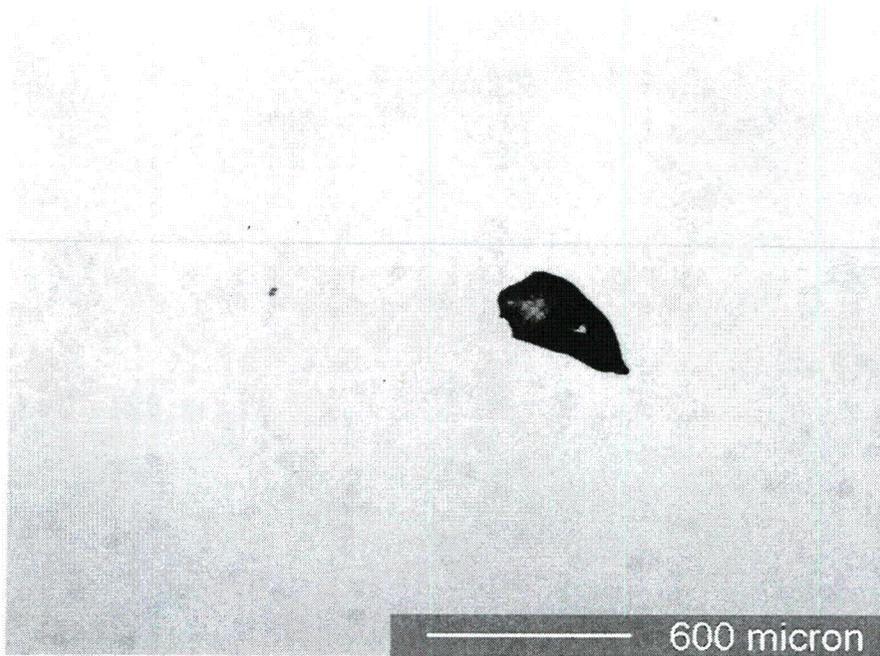
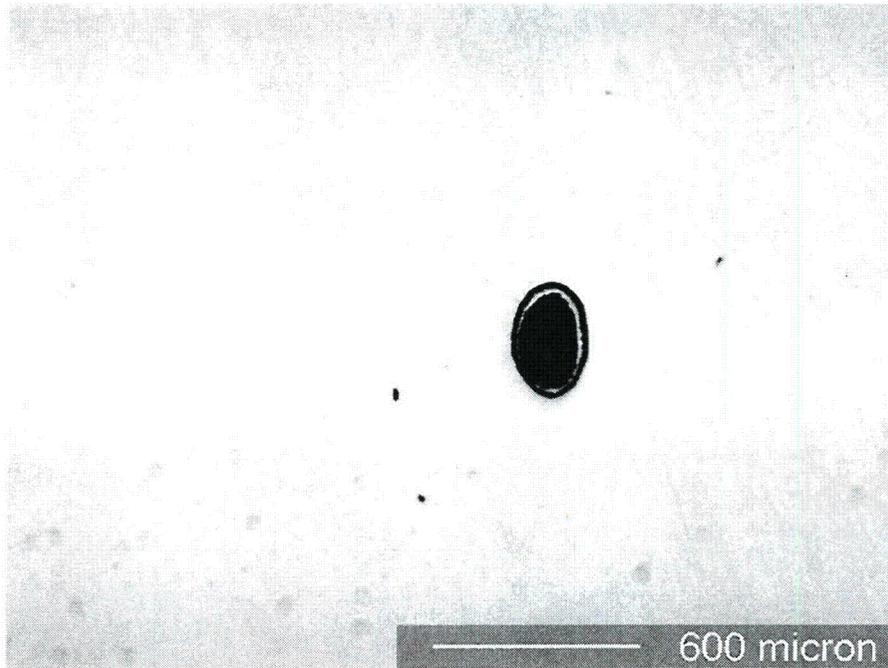
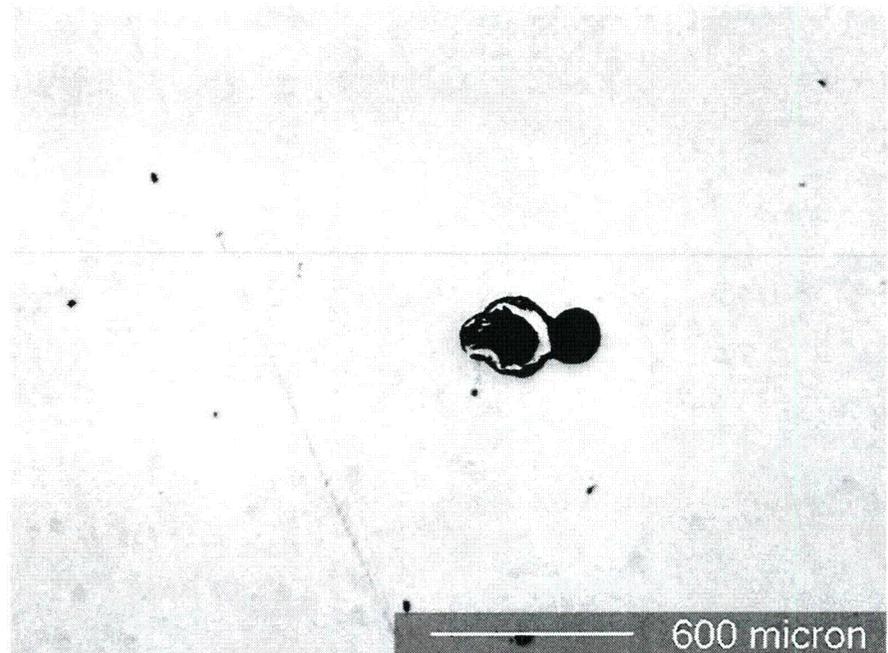
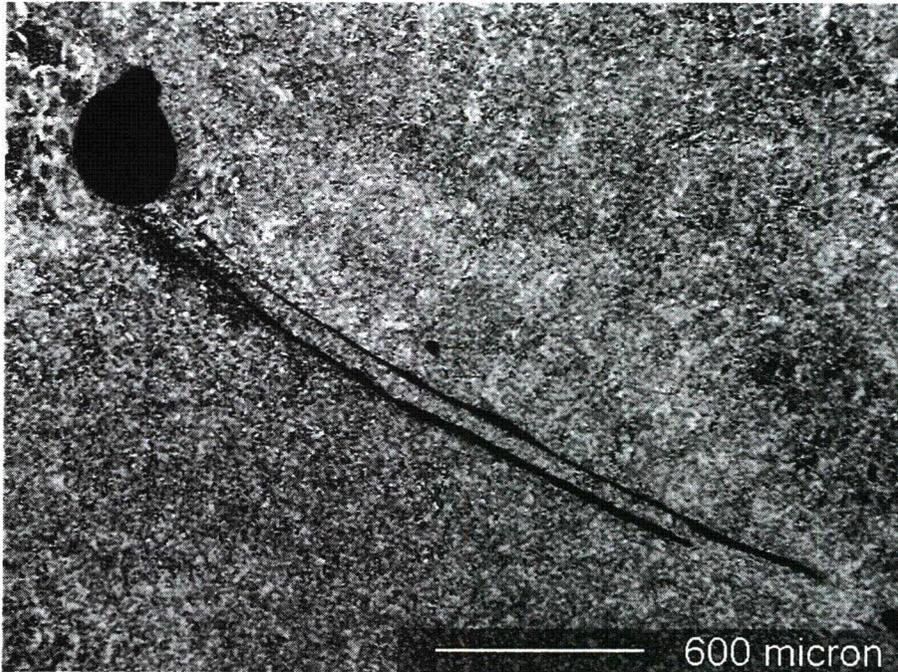
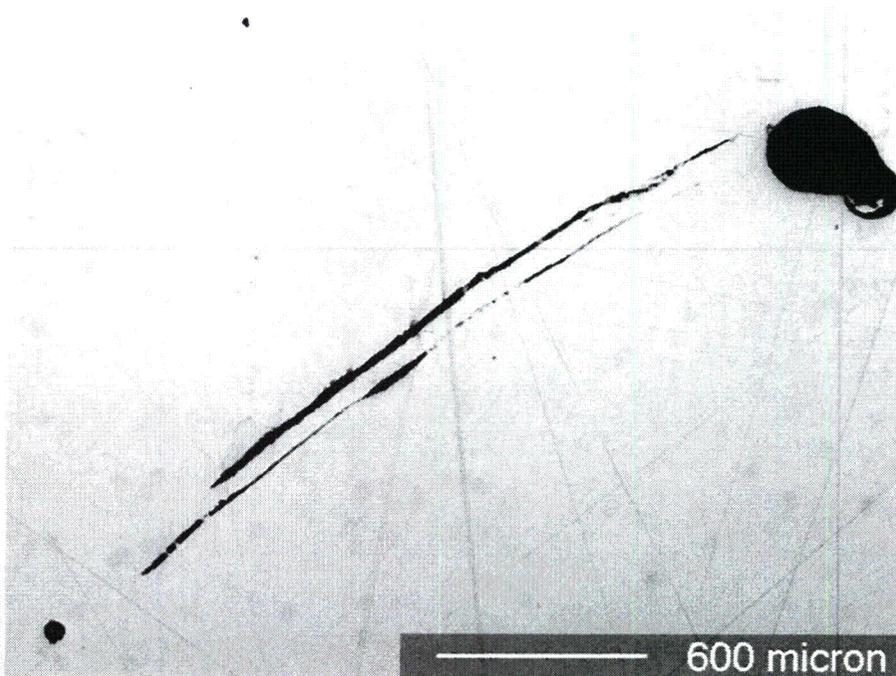
**Figure A.2 Flaw C2CC on the End of Seam Repair C, as Machined**

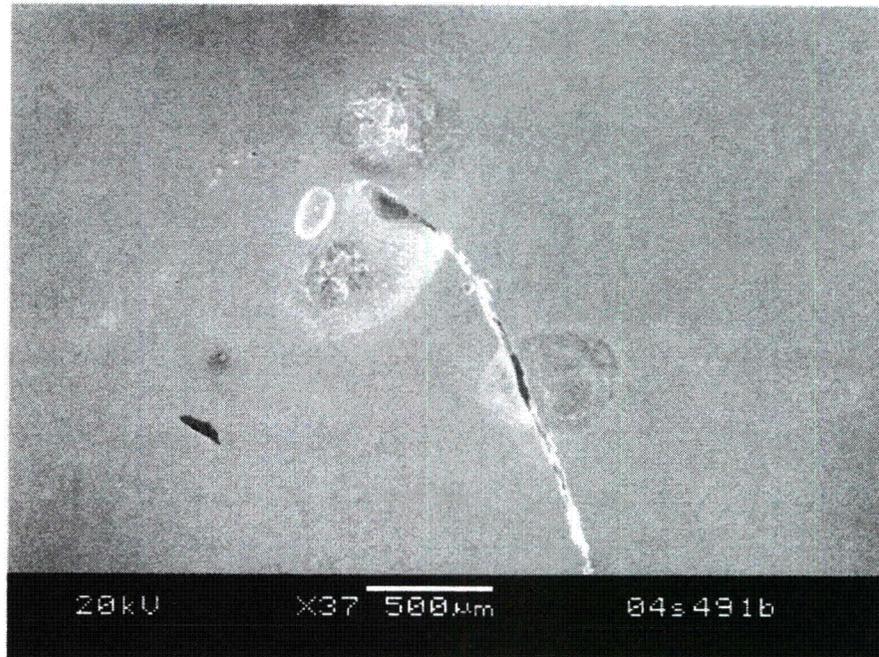
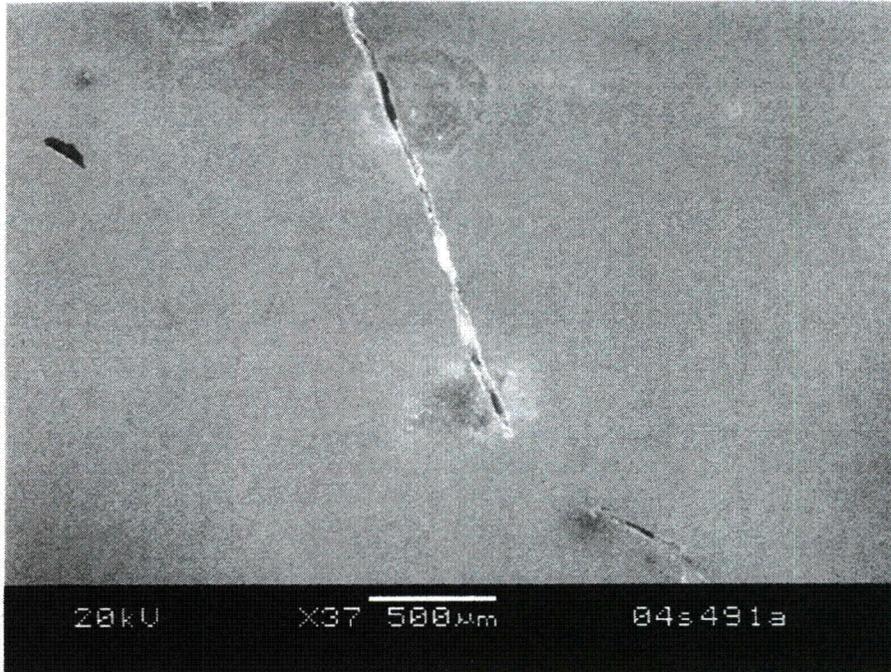
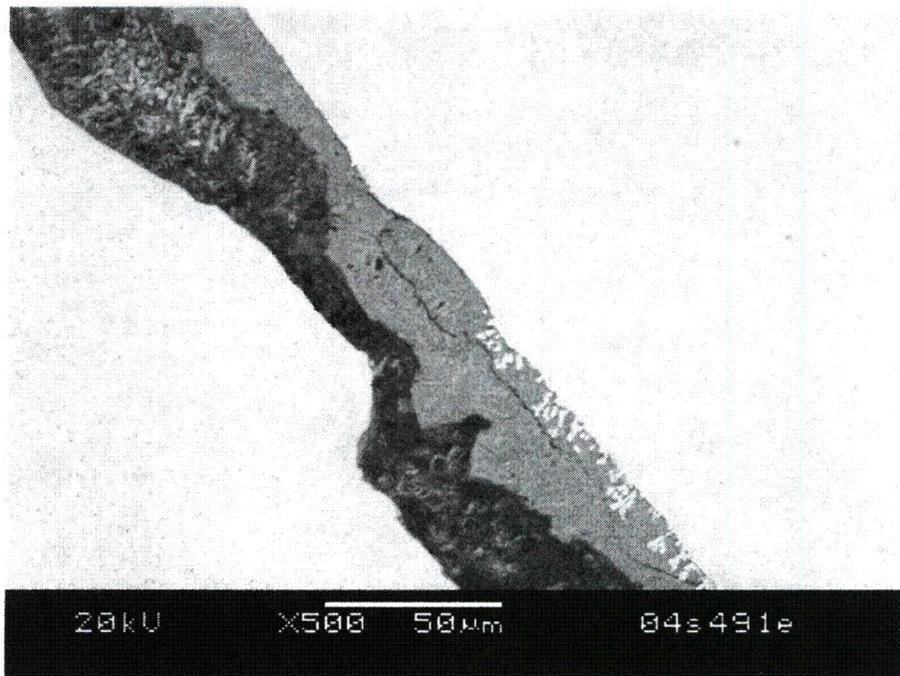
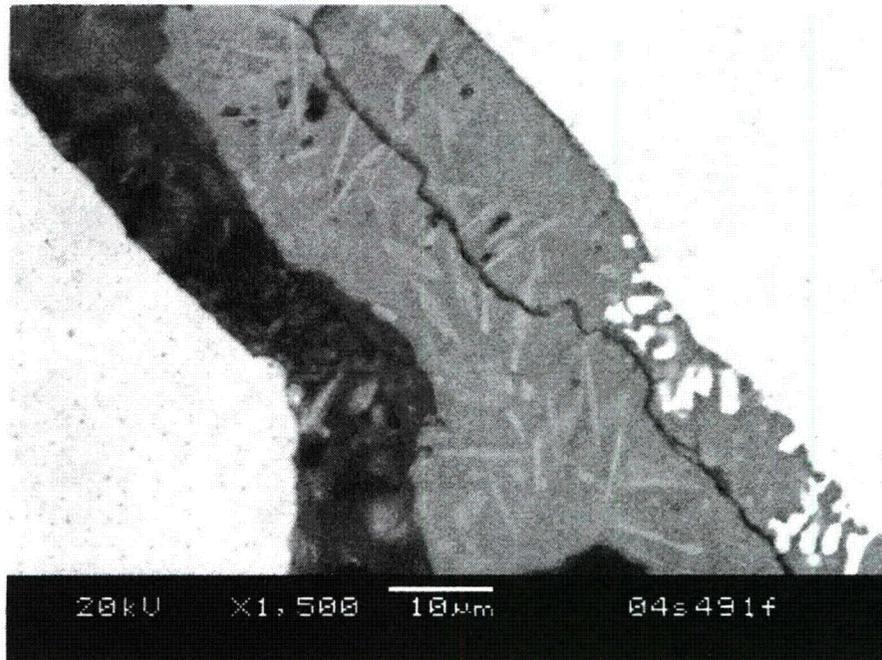
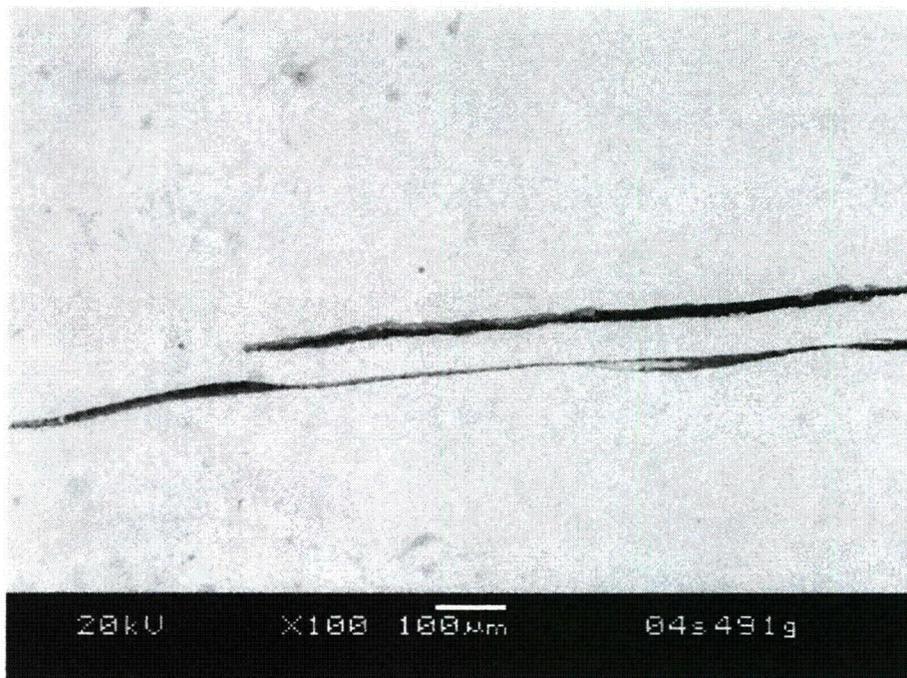
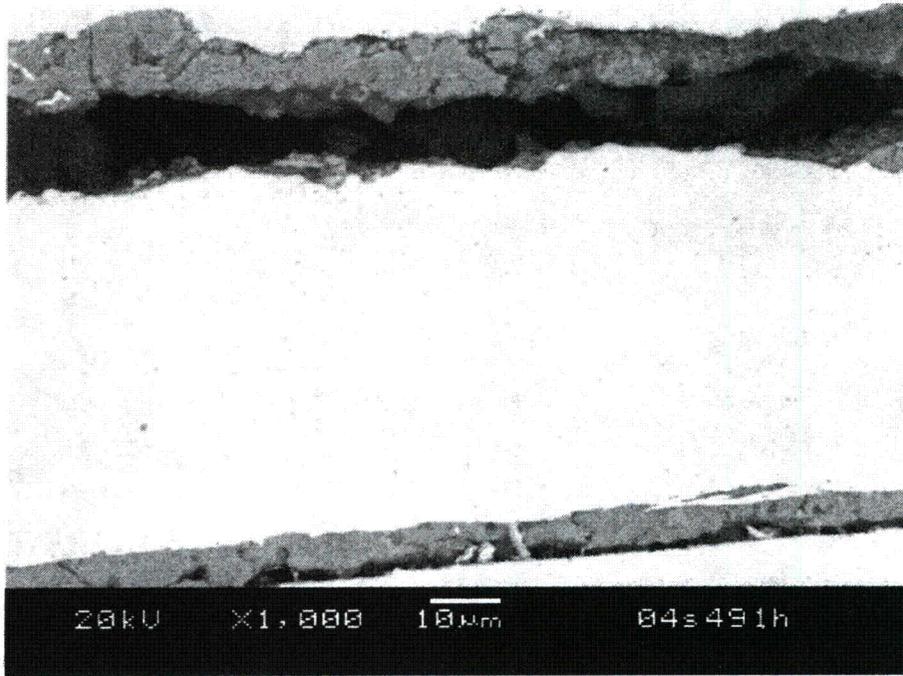
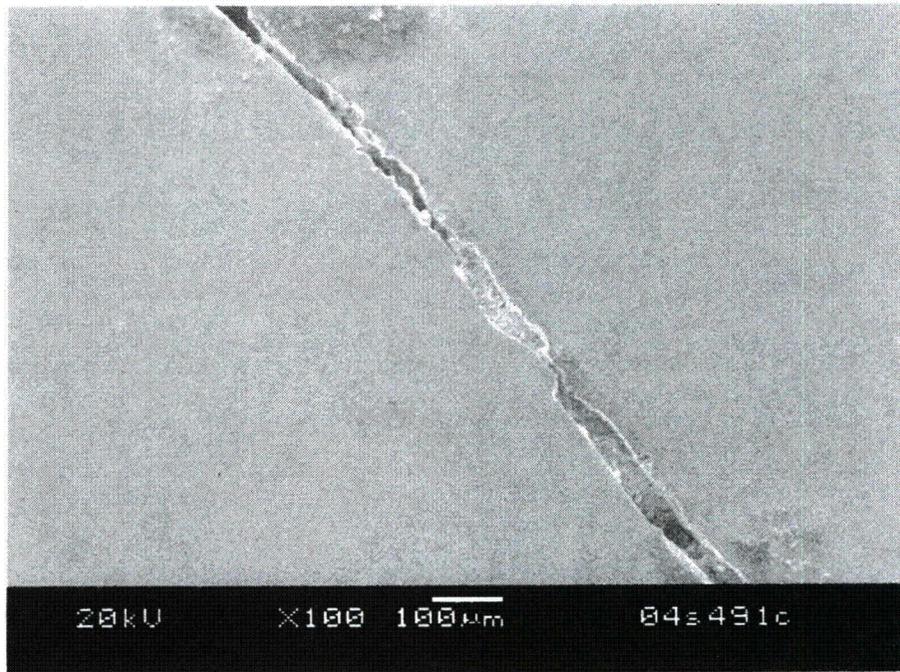
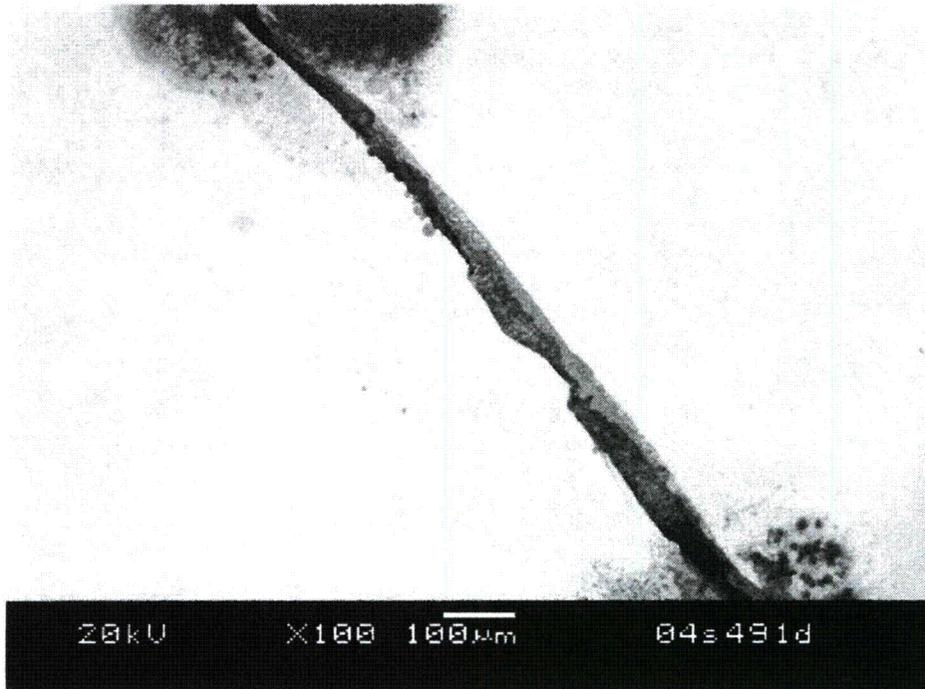
**Figure B.1 Flaw C2CC on the End of Seam Repair C**

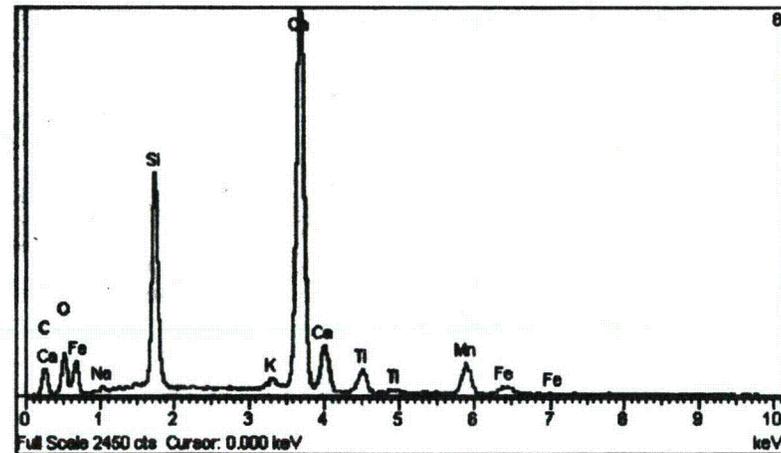
Figure B.14 Elemental Analysis of Flaw in C2CC on the End of Seam Repair C
