Subject: 10CFR21 Reporting of Defects and Non-Compliance -
Engine Systems, Inc. Report No. 10CFR21-0094, Rev. 0

Plunger and Barrel Assembly, Fuel Injection Pump
Haynes P/N 9041367

Report No. 10CFR21-0094

COMPONENT: Plunger and barrel assembly, fuel injector pump
Haynes P/N 9041367

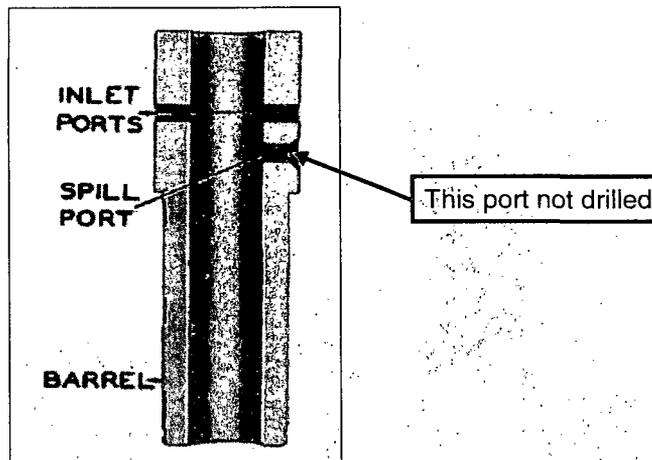
The pump barrels (Haynes P/N 9041375) were manufactured with only 2 drilled ports instead of 3 drilled ports as required by the final configuration print for this part number barrel. The notification also states that use of the supplied barrels in a fuel injector pump would result in the pump not passing functional calibration requirements.

Figure 1: Typical pump barrel
(see references on page 3)

The customer has returned all 36 assemblies from order 3003324 to ESI. 23 assemblies have also been returned to ESI from order 3002554 (the remaining assembly was utilized by the customer for material testing).
