Subject: 10CFR21 Reporting of Defects and Non-Compliance -
Engine Systems, Inc. Report No. 10CFR21-0094, Rev. 0

Plunger and Barrel Assembly, Fuel Injection Pump
Haynes P/N 9041367

Report No. 10CFR21-0094

COMPONENT: Plunger and barrel assembly, fuel injector pump
Haynes P/N 9041367

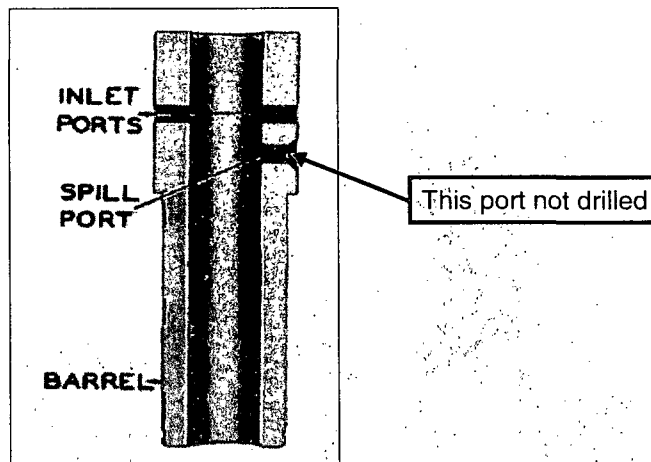
The pump barrels (Haynes P/N 9041375) were manufactured with only 2 drilled ports instead of 3 drilled ports as required by the final configuration print for this part number barrel. The notification also states that use of the supplied barrels in a fuel injector pump would result in the pump not passing functional calibration requirements.

Figure 1: Typical pump barrel
(see references on page 3)

The customer has returned all 36 assemblies from order 3003324 to ESI. 23 assemblies have also been returned to ESI from order 3002554 (the remaining assembly was utilized by the customer for material testing).

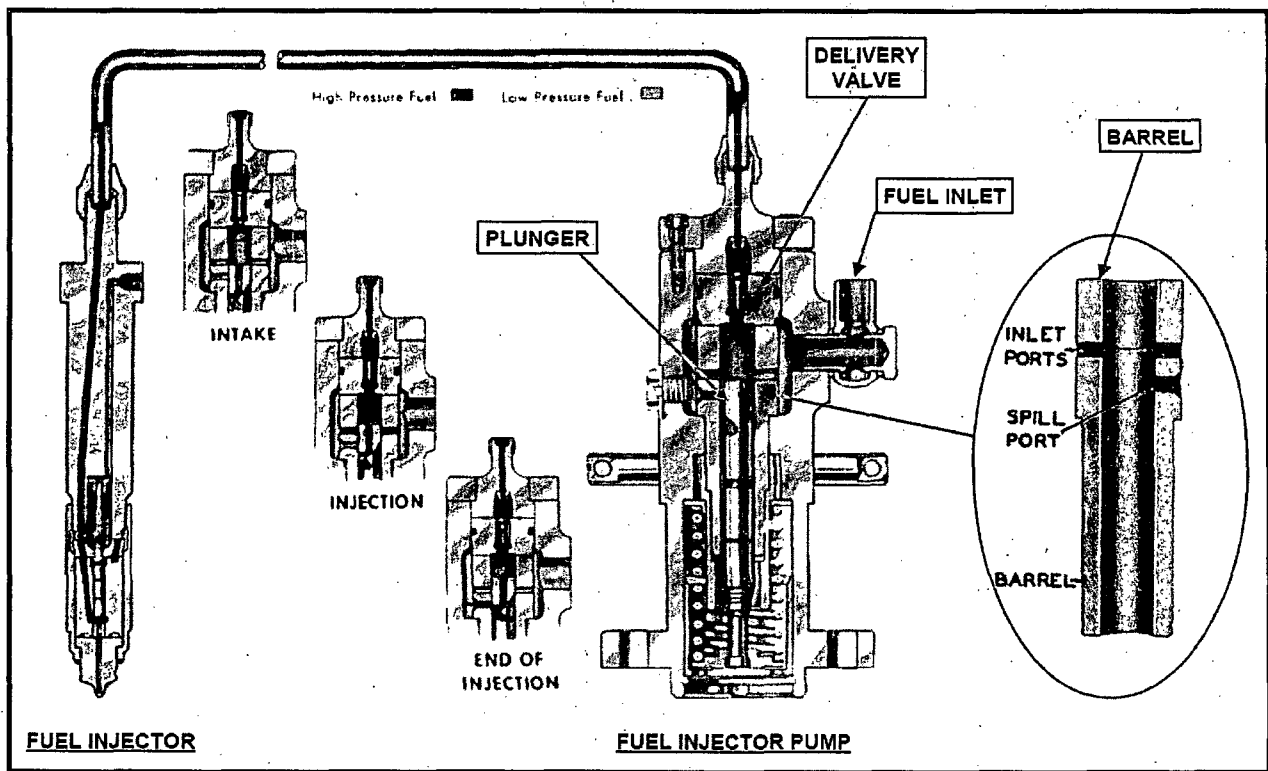
The plunger and barrel assembly is a sub-component of the Haynes (Bendix) type FDX fuel injector pump utilized on diesel engines by various manufacturers (Enterprise, CES, Worthington, Nordberg). Fuel injection is accomplished by the barrel's inlet and spill ports working in conjunction with a helix (passage) in the plunger. Basic theory of operation is as follows: With the plunger at its lowest position, fuel enters the barrel from the pump inlet chamber through the inlet ports (INTAKE). The fuel in the chamber also enters the plunger helix which extends to the top of the plunger. As the plunger rises, it eventually covers the barrel inlet ports and the area within the barrel bore above the plunger becomes a pressure chamber. Pressure continues to rise as the plunger continues upward. High pressure fuel is forced through the pump delivery valve to the fuel injector (INJECTION). Fuel injection continues until the plunger rises high enough for the helix to reach the spill port. When this occurs, the high pressure fuel in the barrel chamber is released (spills) into the inlet chamber via the plunger helix; fuel pressure drops and injection stops (END OF INJECTION).

Figure 2: Typical plunger & barrel application
