**UNITED STATES
NUCLEAR REGULATORY COMMISSION**
REGION II
SAM NUNN ATLANTA FEDERAL CENTER
61 FORSYTH STREET, SW, SUITE 23T85
ATLANTA, GEORGIA 30303-8931

Mr. J. D. Fuller
Chief Executive Officer and Facility Manager
Global Nuclear Fuels - Americas, L.L.C.
P.O. Box 780
Wilmington, NC 28402

SUBJECT: NRC SPECIAL INSPECTION TEAM REPORT NO. 70-1113/2008-002

The purpose of the Special Inspection Team (SIT) was to inspect and assess the facts and circumstances surrounding the potential introduction of moisture into Dry Conversion Process (DCP) Line 2A (L-2A) cooling hopper which contained uranium dioxide powder. The SIT objectives were to: (1) develop a complete sequence of events related to the declared Alert; (2) identify and evaluate effectiveness of licensee corrective actions; (3) evaluate the actual and/or reasonable potential criticality safety significance; (4) evaluate the risk significance to workers, public, and environment; (5) evaluate the licensee's root cause analysis; (6) evaluate the licensee's emergency response organization activities; (7) determine the contributing events and root causes; and (8) determine planned actions to prevent recurrence. The inspection results

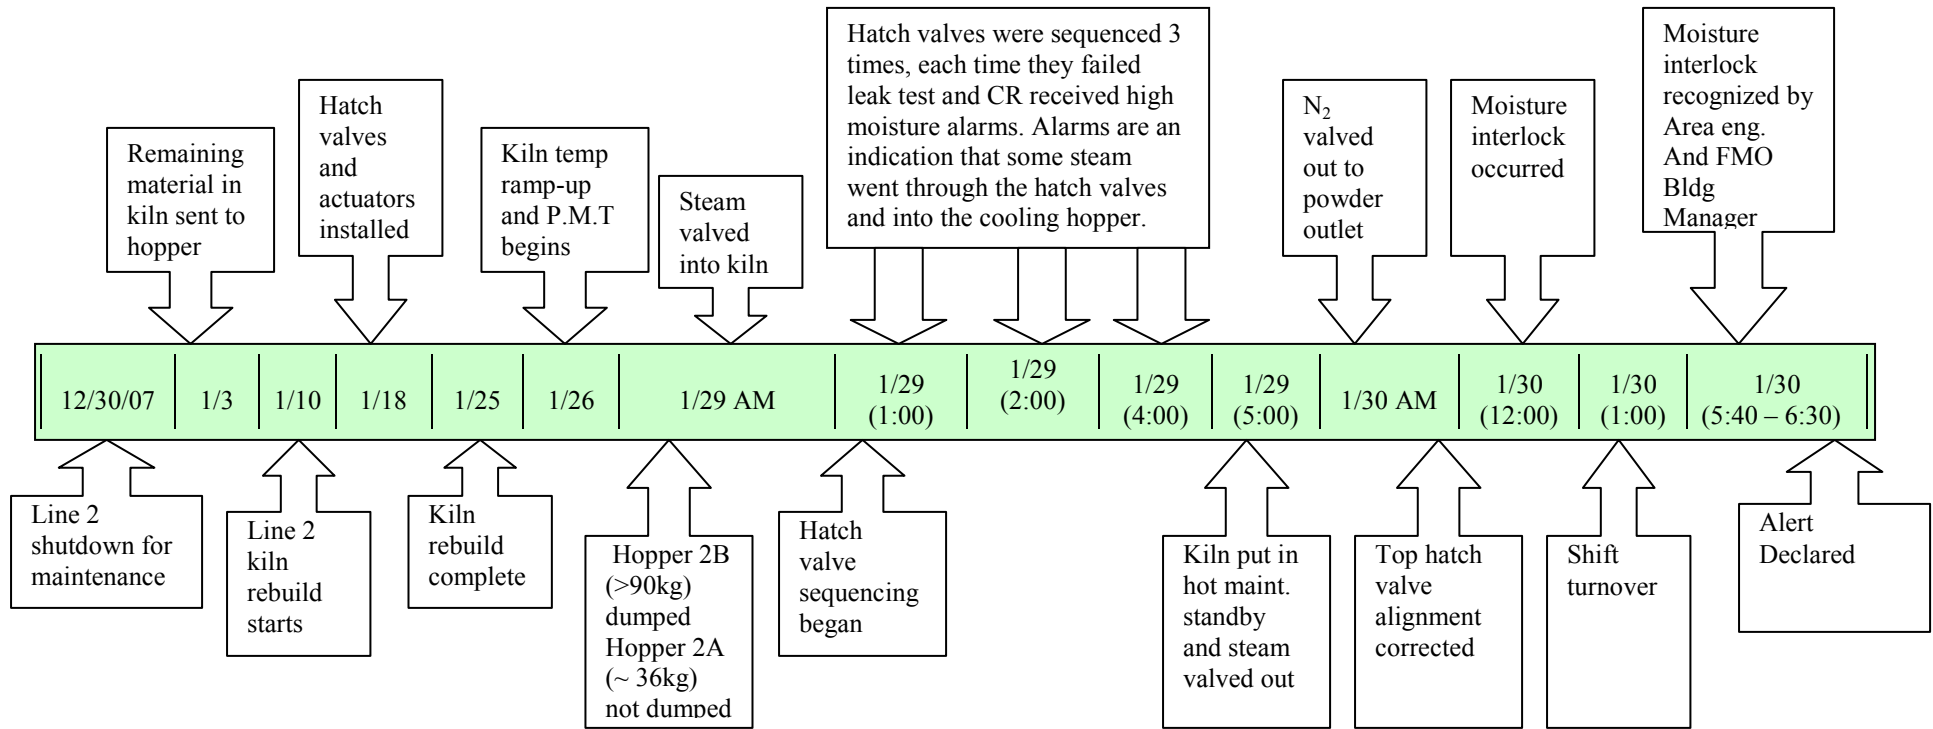
Figure 1
Sequence of Events that Led to the Alert Declaration

At approximately 5:40 p.m. on January 30, 2008, the Acting Manager for the Fuel Manufacturing Operation (FMO) Building recognized the moisture interlock in the control room and also recognized that fissile material, UO₂ powder, was present in the DCP L-2A cooling hopper indicating the potential for moderated unsafe mass conditions in the nonfavorable geometry vessel. In response to the FMO manager's observations, the licensee staffed their Emergency Control Center (ECC) at 6:19 p.m.. Based on the

mass of material estimated to be in excess of the licensee's established 31 kg safe mass limit for uncontrolled powder and suspected ingress of moisture into the cooling hopper, the licensee declared an Alert at 6:30 p.m.

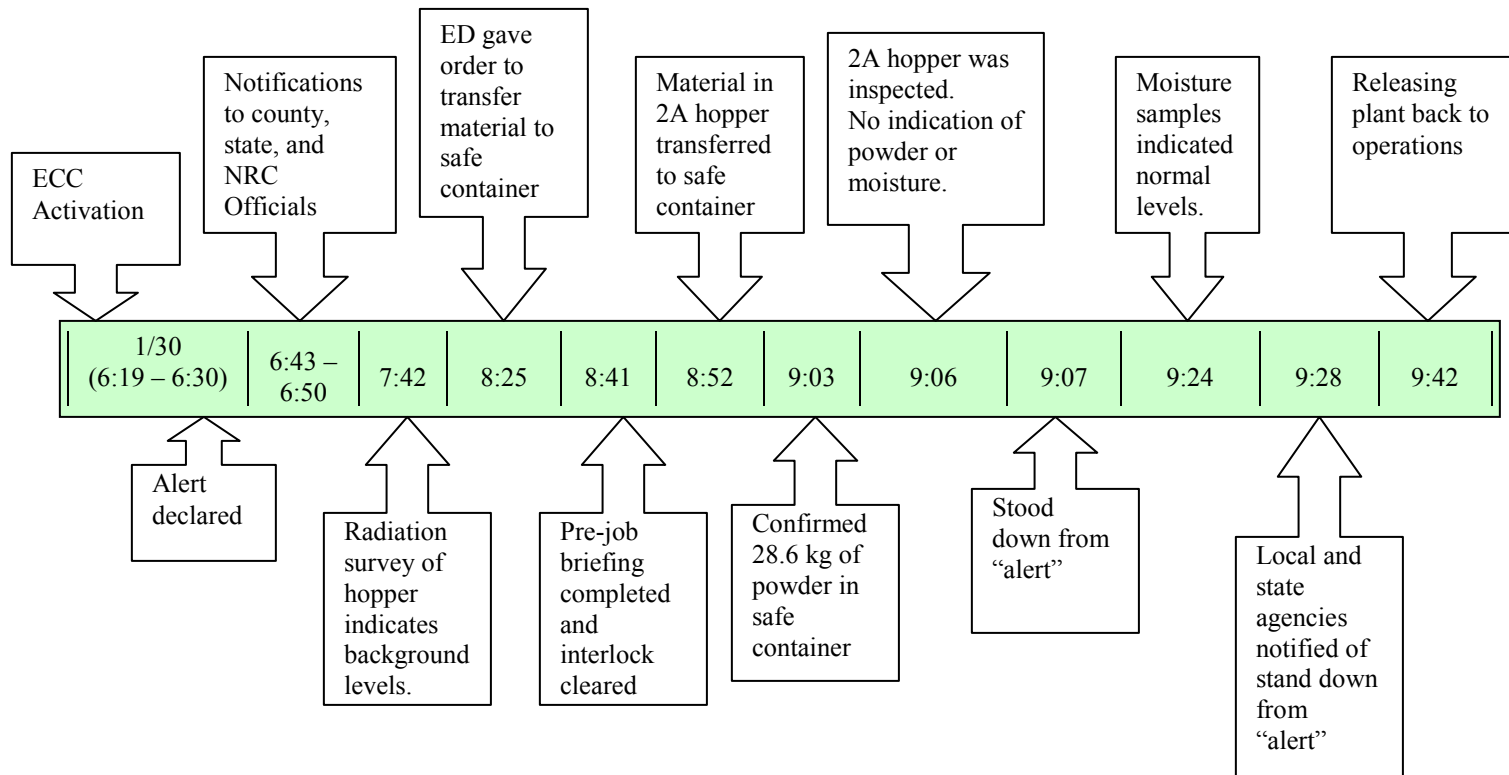
Figure 2
Licensee's Response to the Event

Subsequent to the actual Alert declaration, licensee representatives made the appropriate notifications regarding the Alert condition to local government and State of North Carolina officials, and to the NRC Headquarter Operations Office (HOO) as required. NRC staff from the Region II (RII) Division Fuel Facility Inspections and Headquarters Office of Nuclear Material Safety and Safeguards (NMSS) staff conducting routine inspection activities at GNF-A during the week of January 28, 2008, were notified and returned to the site's ECC at approximately 7:00 p.m.. At 7:22 p.m., the NRC entered the monitoring mode with communications between the onsite NRC inspectors and the NRC Region II Incident Response Center established to monitor and report ongoing licensee actions.

At approximately 8:52 p.m., the UO₂ powder was transferred safely from the L-2A cooling hopper into a safe geometry container. Subsequently the licensee quantitatively determined the mass of the subject powder transferred from the L-2A cooling hopper, and collected and analyzed three samples of the UO₂ material for moisture content. Based on the quantitative measurements, normal moisture content and less than the established safe mass, the licensee exited the Alert at approximately 9:21 p.m.. At approximately 9:42 p.m., licensee representatives notified local, State, and NRC officials of their stand-down from the Alert status. At that time all DCP operations were suspended pending completion of a root-cause analysis and development of corrective actions to prevent recurrence. In addition, production activities outside of the DCP also were suspended pending licensee management review regarding potential extent of similar conditions within those areas. Figure 2 presents a timeline of the licensee's response to the event.

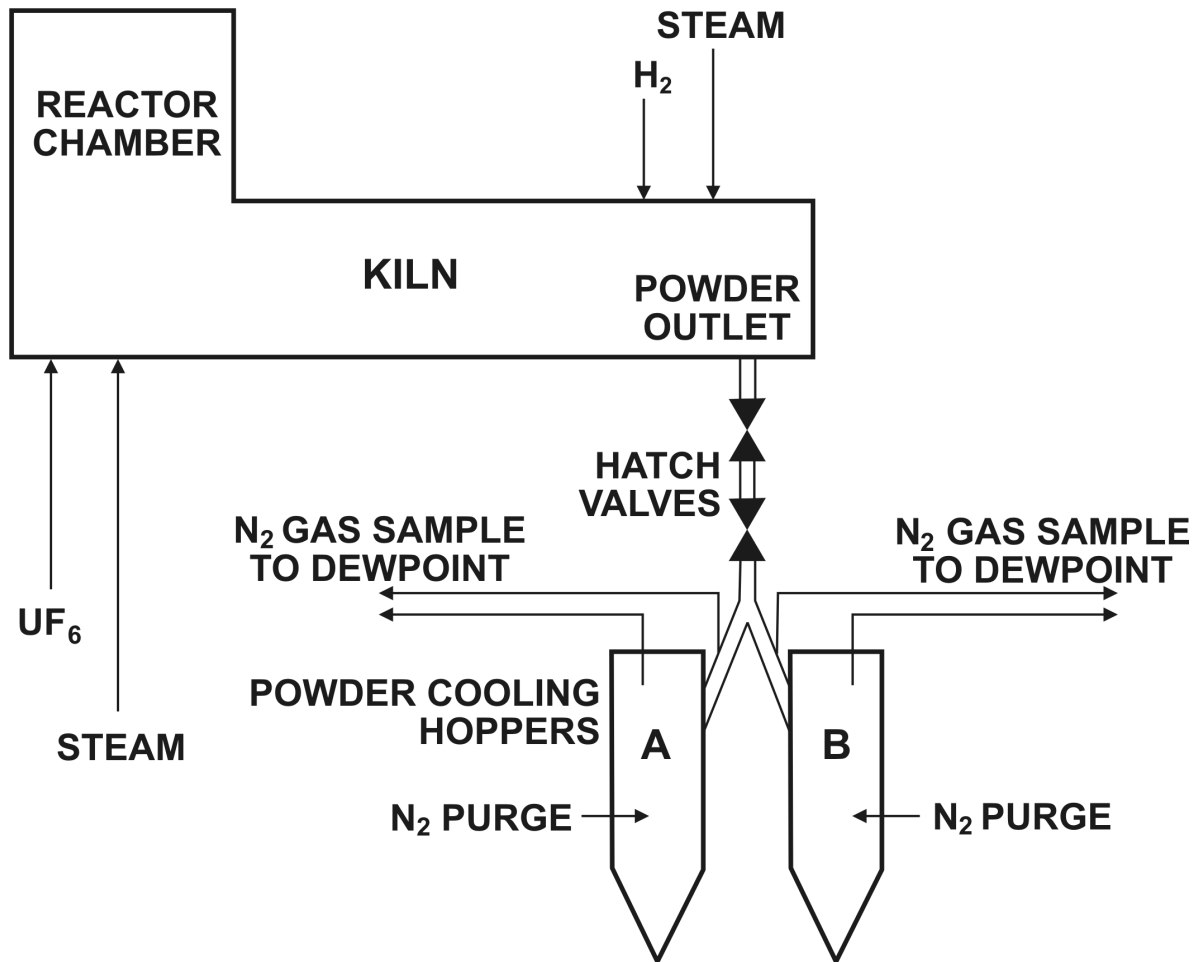
Figure 3
Conversion Reactor/Kiln and Cooling Hopper Equipment Arrangement

The licensee's CSA for the cooling hopper equipment identifies two engineered NCS controls for the hoppers consisting of outlet-hatch valve operation and redundant dewpoint (moisture) probe interlocks in each cooling hopper. Moderation is limited by controls in the conversion reactor-kiln which interface directly to the cooling hoppers. During normal DCP operations the hatch valves operate in a sequence that prevents the ingress of conversion process gases into the hoppers during the gravity transfer of UO_2 powder from the kiln to the cooling hoppers. One of the two, in-line hatch valves is expected to be closed at all times during normal operations.

Prior to the alert declaration, the licensee was performing maintenance consisting of rebuilding the conversion reactor-kiln on L-2 of the DCP area. The maintenance included replacing the two in-line hatch valves leading to the cooling hoppers. During this maintenance, one of the two hatch valves was connected incorrectly to its actuator which resulted in misalignment thereby preventing the subject valve from closing completely. After completion of the maintenance, the licensee performed startup testing of the rebuilt equipment which included sending steam to the reactor-kiln and cycling the

hatch valves to ensure that both hatch valves were seating properly. Hatch valve cycling consists of opening one valve at a time and pressure checking between the valves while both are closed to assure that there is no direct path for steam to enter the hoppers. Because the hatch valves were cycled while the top hatch valve was unable to fully close, a direct path for steam to enter the hoppers was present. Thus, the hatch valves were not preventing the ingress of conversion process gases as stated in the CSA. The hatch valve operational sequence is an engineered NCS control, one of two double contingency controls assuring exclusion of moderation from the hoppers.

The inspectors determined that the hatch valve control was lost while fissile material remained in the L-2A cooling hopper. Section 5.1.1 of the license application (Application) requires that process designs shall incorporate sufficient margins of safety to require at least two unlikely, independent, and concurrent changes in process conditions before a criticality accident is possible. For each significant portion of the process, a defense of one or more system parameters is documented in the CSA, which is reviewed and enforced. The failure to maintain double contingency control for the DCP L-2 powder cooling hoppers was considered an **Apparent Violation (AV 70-1113/2008-002-01)**.
