**UNITED STATES
NUCLEAR REGULATORY COMMISSION**
REGION II
SAM NUNN ATLANTA FEDERAL CENTER
61 FORSYTH STREET, SW, SUITE 23T85
ATLANTA, GEORGIA 30303-8931

SUBJECT: NRC SPECIAL INSPECTION TEAM REPORT NO. 70-1113/2008-002

The purpose of the Special Inspection Team (SIT) was to inspect and assess the facts and circumstances surrounding the potential introduction of moisture into Dry Conversion Process (DCP) Line 2A (L-2A) cooling hopper which contained uranium dioxide powder. The SIT objectives were to: (1) develop a complete sequence of events related to the declared Alert; (2) identify and evaluate effectiveness of licensee corrective actions; (3) evaluate the actual and/or reasonable potential criticality safety significance; (4) evaluate the risk significance to workers, public, and environment; (5) evaluate the licensee's root cause analysis; (6) evaluate the licensee's emergency response organization activities; (7) determine the contributing events and root causes; and (8) determine planned actions to prevent recurrence. The inspection results were as follows:

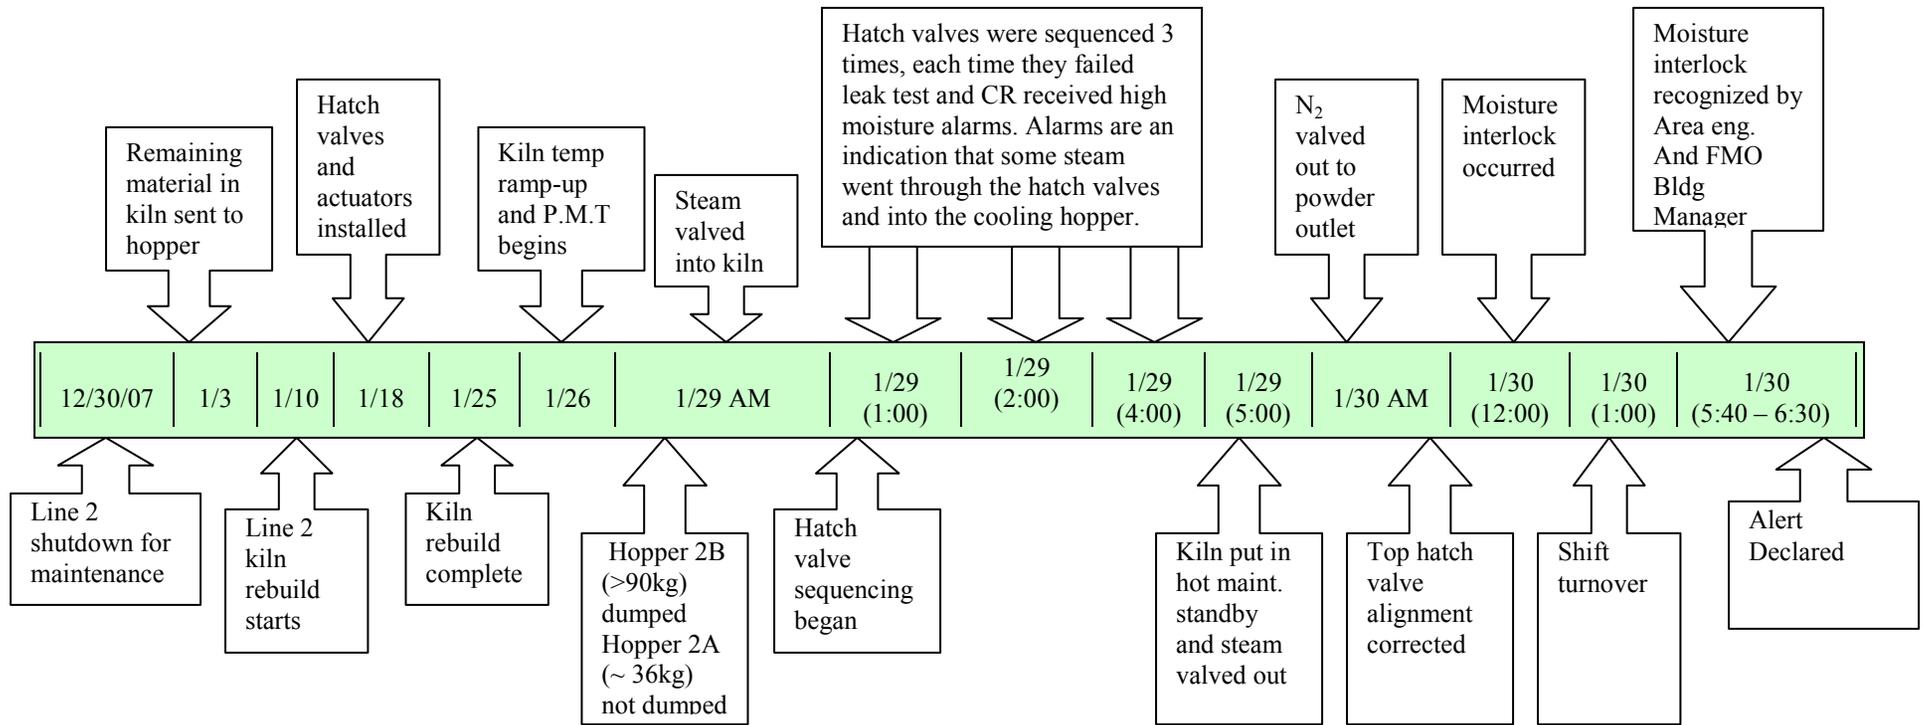
Figure 1
Sequence of Events that Led to the Alert Declaration

At approximately 5:40 p.m. on January 30, 2008, the Acting Manager for the Fuel Manufacturing Operation (FMO) Building recognized the moisture interlock in the control room and also recognized that fissile material, UO₂ powder, was present in the DCP L-2A cooling hopper indicating the potential for moderated unsafe mass conditions in the nonfavorable geometry vessel. In response to the FMO manager's observations, the licensee staffed their Emergency Control Center (ECC) at 6:19 p.m.. Based on the

mass of material estimated to be in excess of the licensee's established 31 kg safe mass limit for uncontrolled powder and suspected ingress of moisture into the cooling hopper, the licensee declared an Alert at 6:30 p.m.

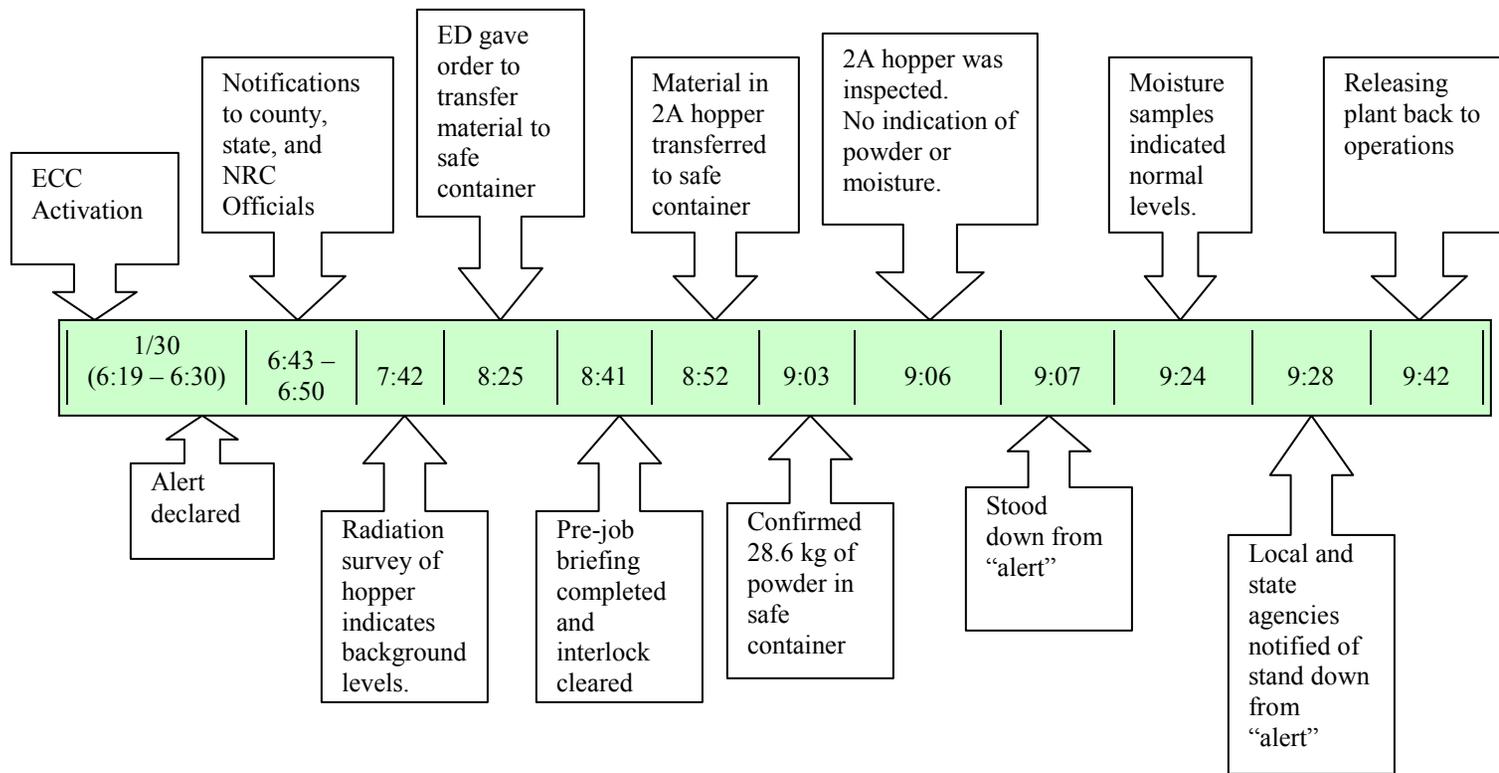
Figure 2
Licensee's Response to the Event

At approximately 8:52 p.m., the UO₂ powder was transferred safely from the L-2A cooling hopper into a safe geometry container. Subsequently the licensee quantitatively determined the mass of the subject powder transferred from the L-2A cooling hopper, and collected and analyzed three samples of the UO₂ material for moisture content. Based on the quantitative measurements, normal moisture content and less than the established safe mass, the licensee exited the Alert at approximately 9:21 p.m.. At approximately 9:42 p.m., licensee representatives notified local, State, and NRC officials of their stand-down from the Alert status. At that time all DCP operations were suspended pending completion of a root-cause analysis and development of corrective actions to prevent recurrence. In addition, production activities outside of the DCP also were suspended pending licensee management review regarding potential extent of similar conditions within those areas. Figure 2 presents a timeline of the licensee's response to the event.

The inspectors noted that the declared activation to the Alert status was based on the information available at the time of the event and included approximate estimates of the UO_2 mass in the L-2A cooling hopper, general knowledge of on-going L-2 maintenance activities, and the moisture sensor equipment interlock observed in the control room. Immediate licensee actions included cessation of work in the plant and evacuation of personnel from the DCP area. Prior to sending a team to assess actual conditions in the area, the licensee assessed radiological conditions using the plant's remote radiological monitoring system. After actual radiological conditions within the affected process line equipment were understood, licensee staff including Safety, Licensing, and Operations personnel developed a planned course of action to remove and place the fissile material from the L-2A cooling hopper into a safe geometry configuration prior to additional quantitative analyses. Subsequently, the fissile material was removed successfully from the L-2A cooling hopper. The licensee conducted detailed measurements of the powder mass and moisture content for the UO_2 removed from the L-2A cooling hopper.

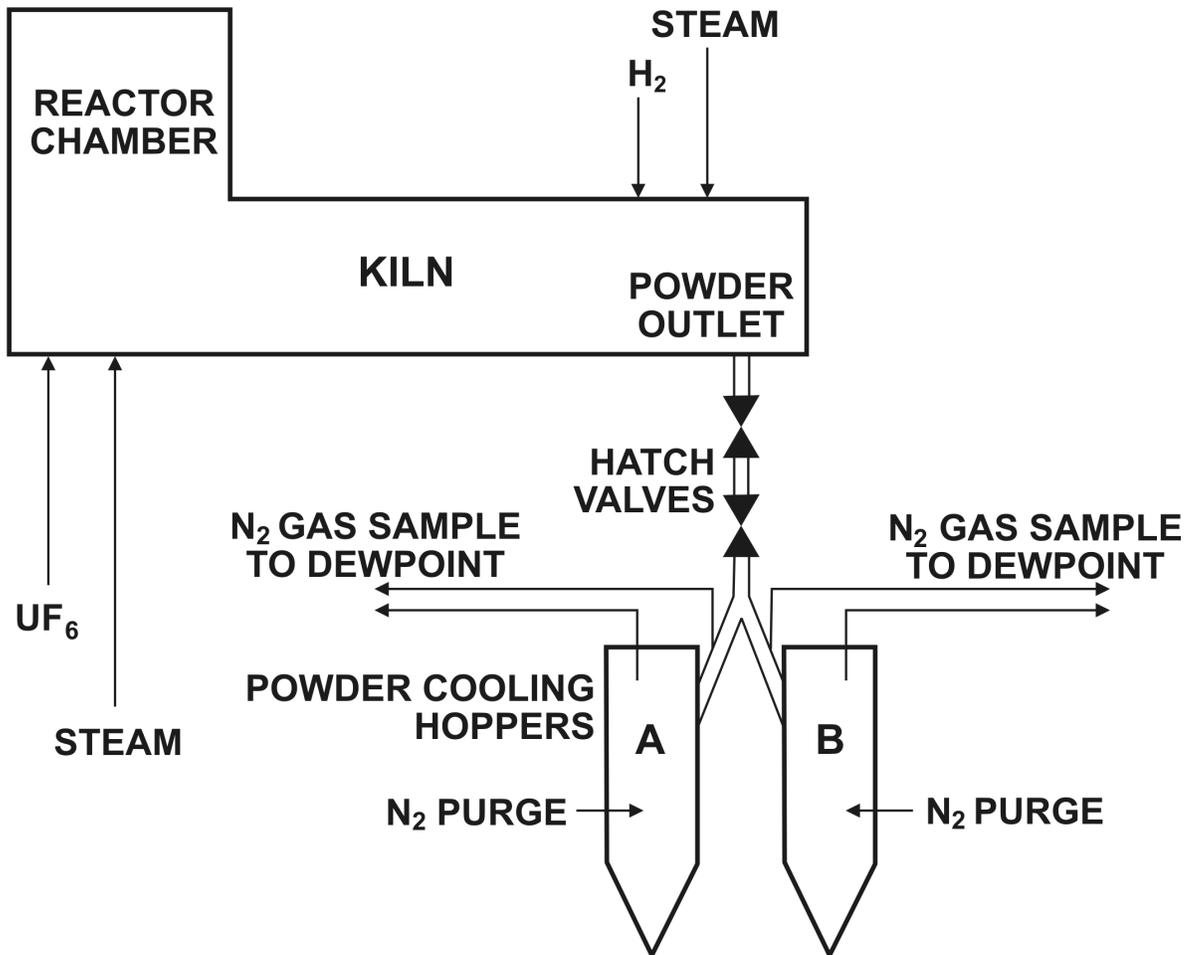
Figure 3
Conversion Reactor/Kiln and Cooling Hopper Equipment Arrangement

Prior to the alert declaration, the licensee was performing maintenance consisting of rebuilding the conversion reactor-kiln on L-2 of the DCP area. The maintenance included replacing the two in-line hatch valves leading to the cooling hoppers. During this maintenance, one of the two hatch valves was connected incorrectly to its actuator which resulted in misalignment thereby preventing the subject valve from closing completely. After completion of the maintenance, the licensee performed startup testing of the rebuilt equipment which included sending steam to the reactor-kiln and cycling the

hatch valves to ensure that both hatch valves were seating properly. Hatch valve cycling consists of opening one valve at a time and pressure checking between the valves while both are closed to assure that there is no direct path for steam to enter the hoppers. Because the hatch valves were cycled while the top hatch valve was unable to fully close, a direct path for steam to enter the hoppers was present. Thus, the hatch valves were not preventing the ingress of conversion process gases as stated in the CSA. The hatch valve operational sequence is an engineered NCS control, one of two double contingency controls assuring exclusion of moderation from the hoppers.

The inspectors determined that the hatch valve control was lost while fissile material remained in the L-2A cooling hopper. Section 5.1.1 of the license application (Application) requires that process designs shall incorporate sufficient margins of safety to require at least two unlikely, independent, and concurrent changes in process conditions before a criticality accident is possible. For each significant portion of the process, a defense of one or more system parameters is documented in the CSA, which is reviewed and enforced. The failure to maintain double contingency control for the DCP L-2 powder cooling hoppers was considered an **Apparent Violation (AV 70-1113/2008-002-01)**.
