2008-128 _____ BWR Vessel & Internals Project (BWRVIP)

Subject: Additional BWRVIP commitments to revise BWRVIP-139

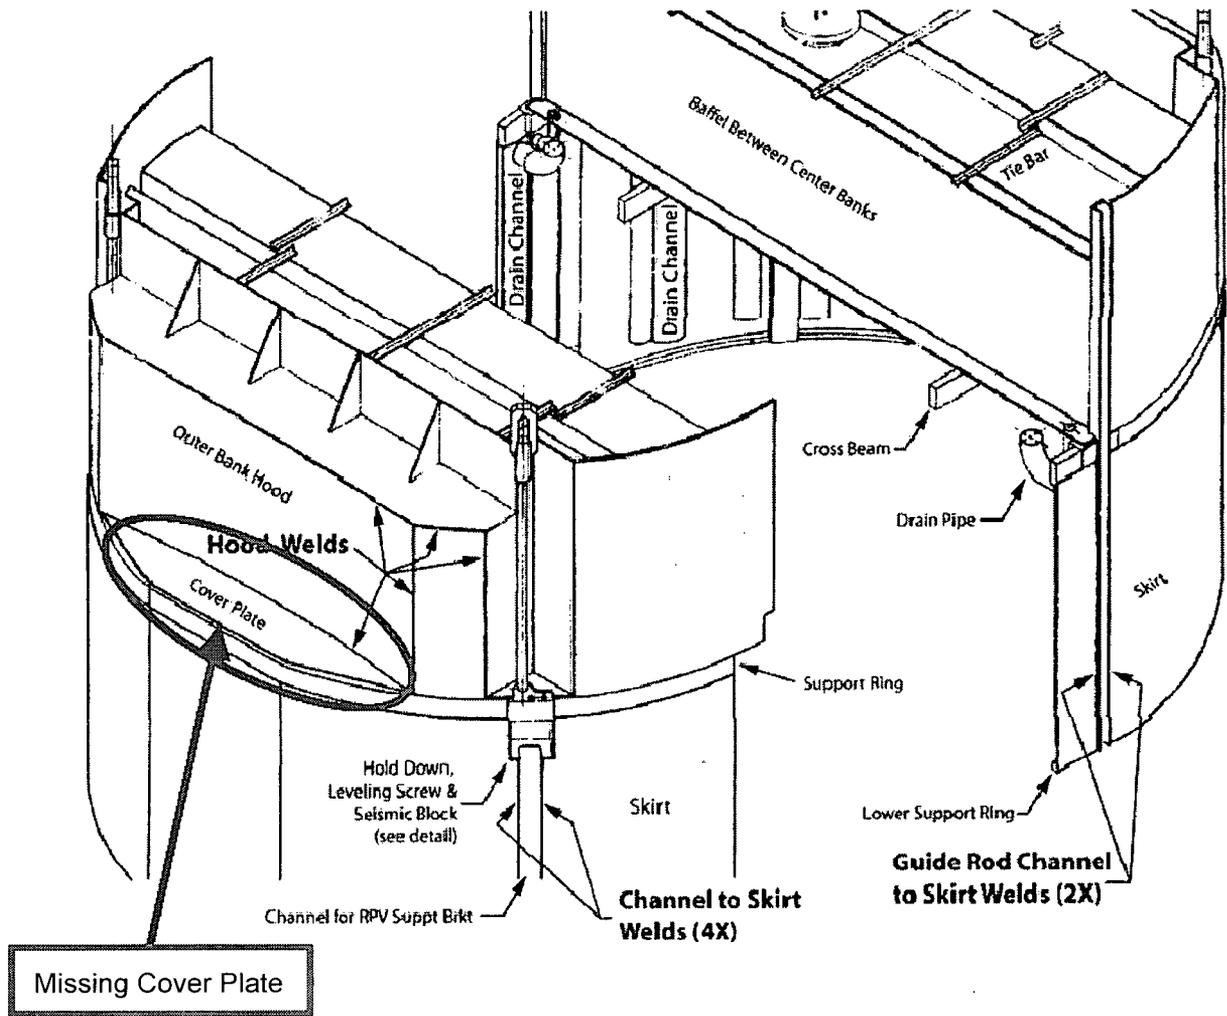
Figure A-1: Location of the 2002 Lower Cover Plate Failure

Inspection of the steam dryer revealed that a ¼-inch stainless steel cover plate measuring approximately 120" x 15" had failed near the MSL "A" and "B" nozzles (Figure A-1). The failure of this cover plate allowed steam to bypass the dryer banks and exit through the reactor MSL nozzles, causing the observed increase in moisture content. The majority of the cover plate was found as a single piece on top of steam separators. However, a piece of the cover plate (approximately 16"x 6") had failed and was found lodged in and partially blocking the MSL "A" flow venturi contributing to the MSL flow imbalance and water level perturbations. Several smaller loose pieces (believed to have come from a startup pressure sensor bracket which may have been knocked off by the cover plate) were located at the turbine stop valve strainer basket. Minor gouges and scratches from the transport of foreign material were noted in the "A" steam nozzle cladding, the main steam piping and the MSL "A" flow venturi. All loose pieces were recovered. No collateral damage to other reactor vessel components was observed.

Preliminary laboratory analysis has been completed. The main crack originated from the bottom side of the cover plate and propagated upward through both the plate base metal and weld metal. The *transgranular*, as opposed to *intergranular*, nature of the fracture surface and the relative lack of crack branching indicated that the failure was not caused by stress-corrosion cracking. The lack of macro and micro ductility features in and near the fracture indicated the cracking occurred over a period of time and not due to a mechanical overload. Additionally, there was no evidence that the failure was a result of an original manufacturing defect. Based on the available evidence, the most probable cause of the cover plate cracking was mechanical, high cycle fatigue.

The results of the metallurgical analysis confirmed that the failure mechanism is high cycle fatigue. The cause of this high cycle fatigue is believed to be flow induced vibration. At this time there are two probable root causes of the cover plate failure:

The cover plates on both sides of the dryer have been replaced with ½-inch continuous plates (this eliminates two intermediate welds on the original plates). The fillet weld connecting the plate to the support ring was increased to ¾-inch and the weld to the vertical face of the dryer hood was increased to ½-inch. The plant has been returned to service with interim, enhanced monitoring of moisture content, reactor steam dome pressure, MSL flow rates and reactor water level. As an additional measure, the plant has implemented dynamic response monitoring of the MSLs to determine if higher flow induced vibration occurs as the steam flow is increased.

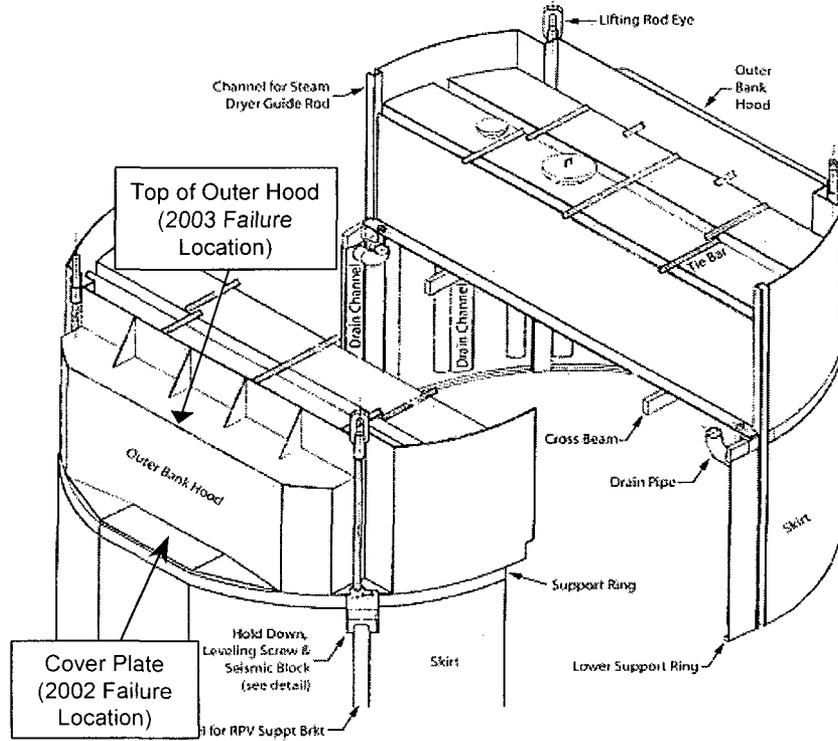
Figure B-1: Location of the 2003 Outer Hood Failure

The same BWR/3 experienced extensive through-wall cracking in the outer bank hood on the 90° side in May 2003. On the opposite side of the steam dryer (270° side), incipient cracking was observed on the inside of the outer hood cover plate. Several internal braces were detached and found on top of the steam separators. No damage was found on the inner banks of the dryer. Again, the failure was accompanied by a significant increase in moisture content. Of the other monitored reactor parameters, only the flow distribution between the individual steamlines was affected. The cause of this failure was attributed to high cycle fatigue resulting from low frequency oscillating pressure loads (<50 Hz) of higher amplitude at EPU operation and the local stress concentration introduced by the internal brackets that anchor the diagonal internal braces to the dryer hoods. Appendix B provides a more detailed description of this event.

The combined effect of these modifications was to increase the natural frequency of the outer hood, reduce the maximum stress by at least a factor of two, and reduce the pressure loading by reducing the magnitude of vortices in the steam flow near the MSLs.
