Engineering Report No. IP3-RPT-SG-03842 Rev. 1  
Page 1 of 17

Operational Assessment of Indian Point 3 Steam Generator Tubing for Cycle 13 and 14

# Operational Assessment of Indian Point 3 Steam Generator Tubing for Cycles 13 and 14

March, 2005

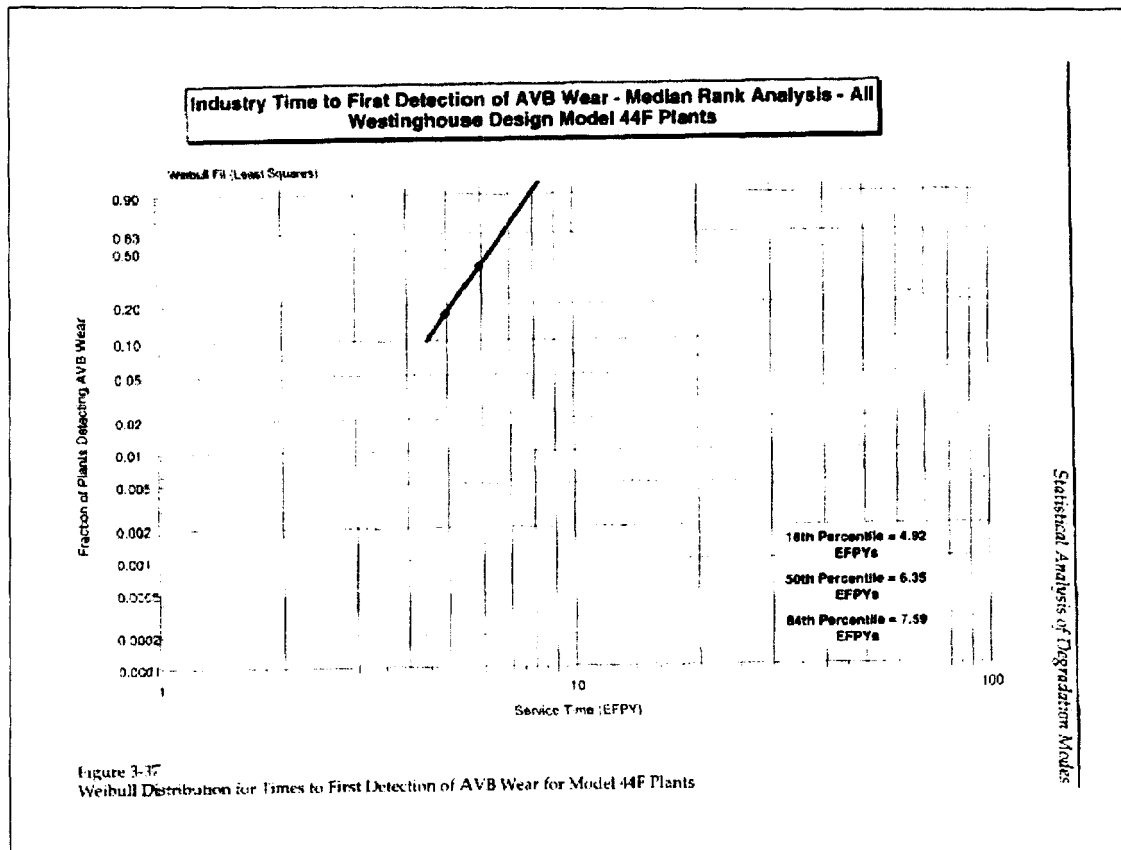
**Figure 4-3 Initiation of AVB Wear in Westinghouse Model 44F Steam Generators**

Figure 4-3 below was taken from reference 7. This depicts the estimated time to the first wear indication being identified in model 44F Westinghouse generators. Based on the Weibull estimate, Indian Point 3 should find the first indication at ~ 6.35 EFPY. This places it in RF11 outage timeframe in May 2001. This was the outage that an inspection was not performed. In the following outage (RF12), 25 % of all in-service tubes in all four generators were inspected with no wear identified. This is approximately 8.8 EFPY. It is clear that large scale wear is not developing in the Indian Point 3 steam generators.

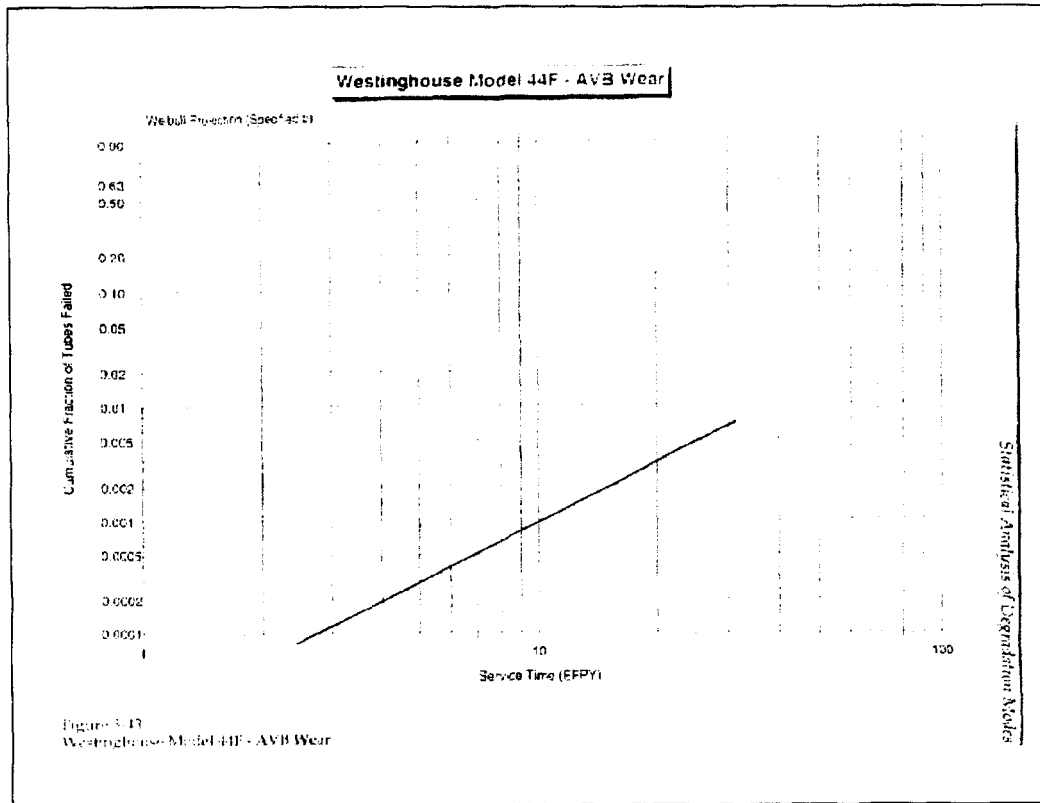
**Figure 4-4 AVB Wear for Westinghouse Model 44F SG**

Figure 4-4 was developed by EPRI<sup>7</sup> to determine the initiation of wear in model 44F generators. Based on the next inspection frequency (RF14 or 12.5 EPY), the anticipated cumulative number of indications should be approximately 0.0015% of the total tubes or:

$$(0.0015 * 3200) = \sim 5 \text{ tubes per generator}$$
