Fort Calhoun Station  
P.O. Box 550  
Fort Calhoun, NE 68023

April 30, 2008  
LIC-08-0057

**Subject: Licensee Event Report 2006-002 Revision 1 for the Fort Calhoun Station**

**4. TITLE**  
Inadequate Design Control Results in Potentially Insufficient Auxiliary Feedwater Flow

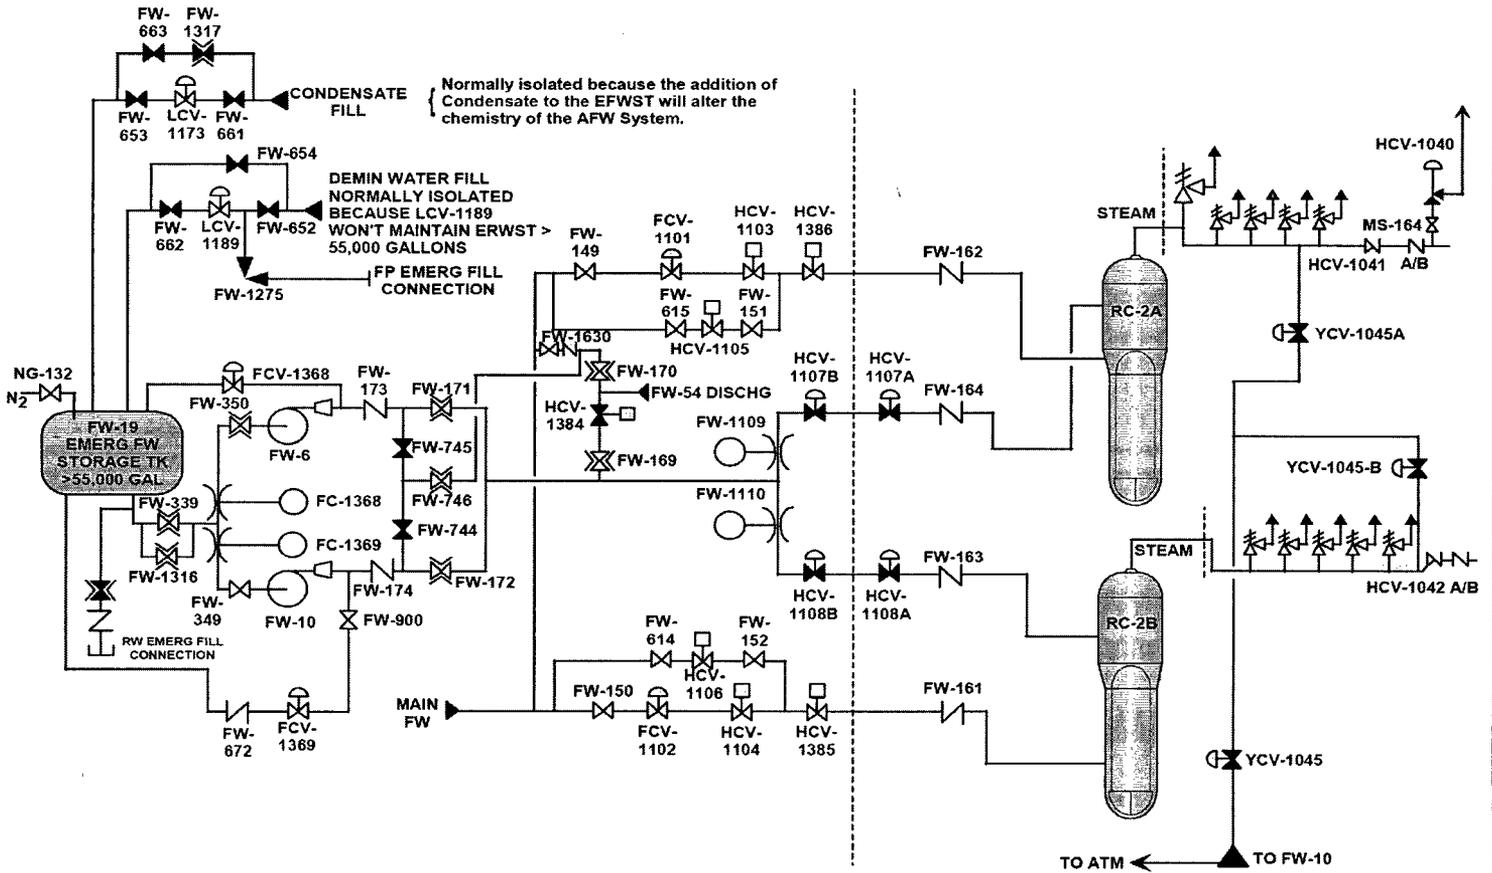
Figure 1

The system is designed to add feedwater to either or both steam generators under any condition, including the loss of all electrical power along with the loss of the MFW system and the loss of the main steam piping downstream of the main steam isolation valves. The AFW system fulfills both safety-related and non-safety-related functions. See Figure 1.
