# **Grain Boundary Damage in Alloy 690 after One Dimensional Cold Rolling *Preliminary Observations***

*Matt Olszta, Dan Edwards and Steve Bruemmer  
Pacific Northwest National Laboratory*

**2008 ICG-EAC**

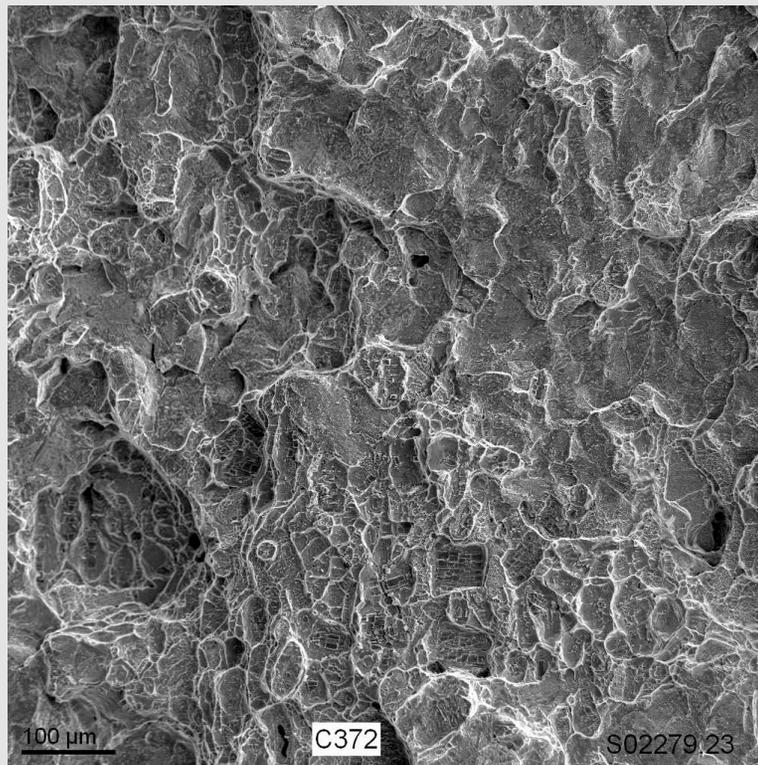
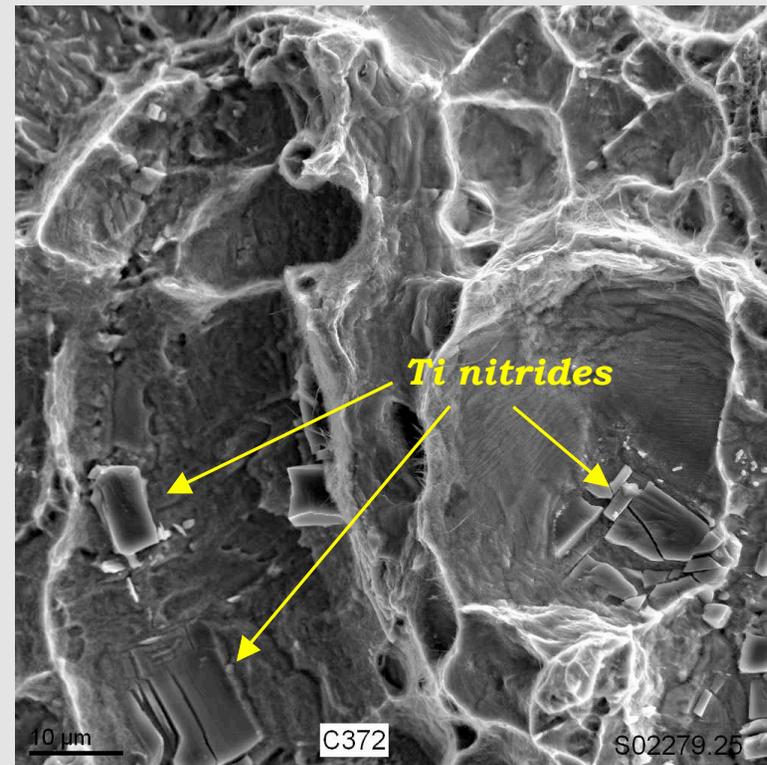
*Mixed-mode fracture surface with IG (described as granulated) and TG regions, tearing regions often contain cracked Ti nitrides.*

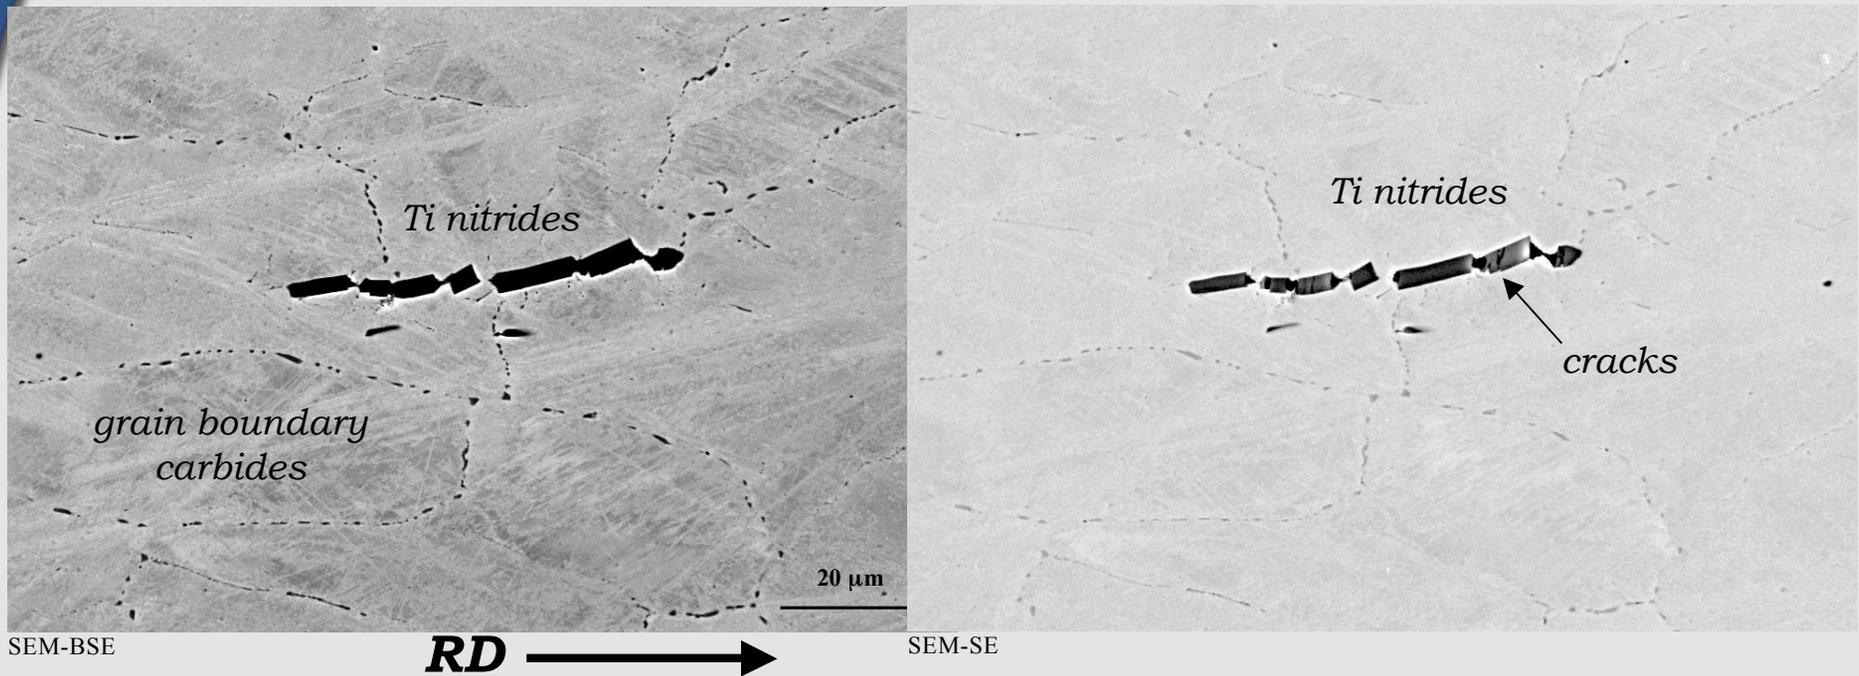
GEG Test Sample C372

*Metallographic examination of area far from fracture surface. Evidence for grain elongation along the rolling direction. High density of fine grain boundary  $Cr_{23}C_6$  carbides with moderate density of large, cracked Ti nitrides.*

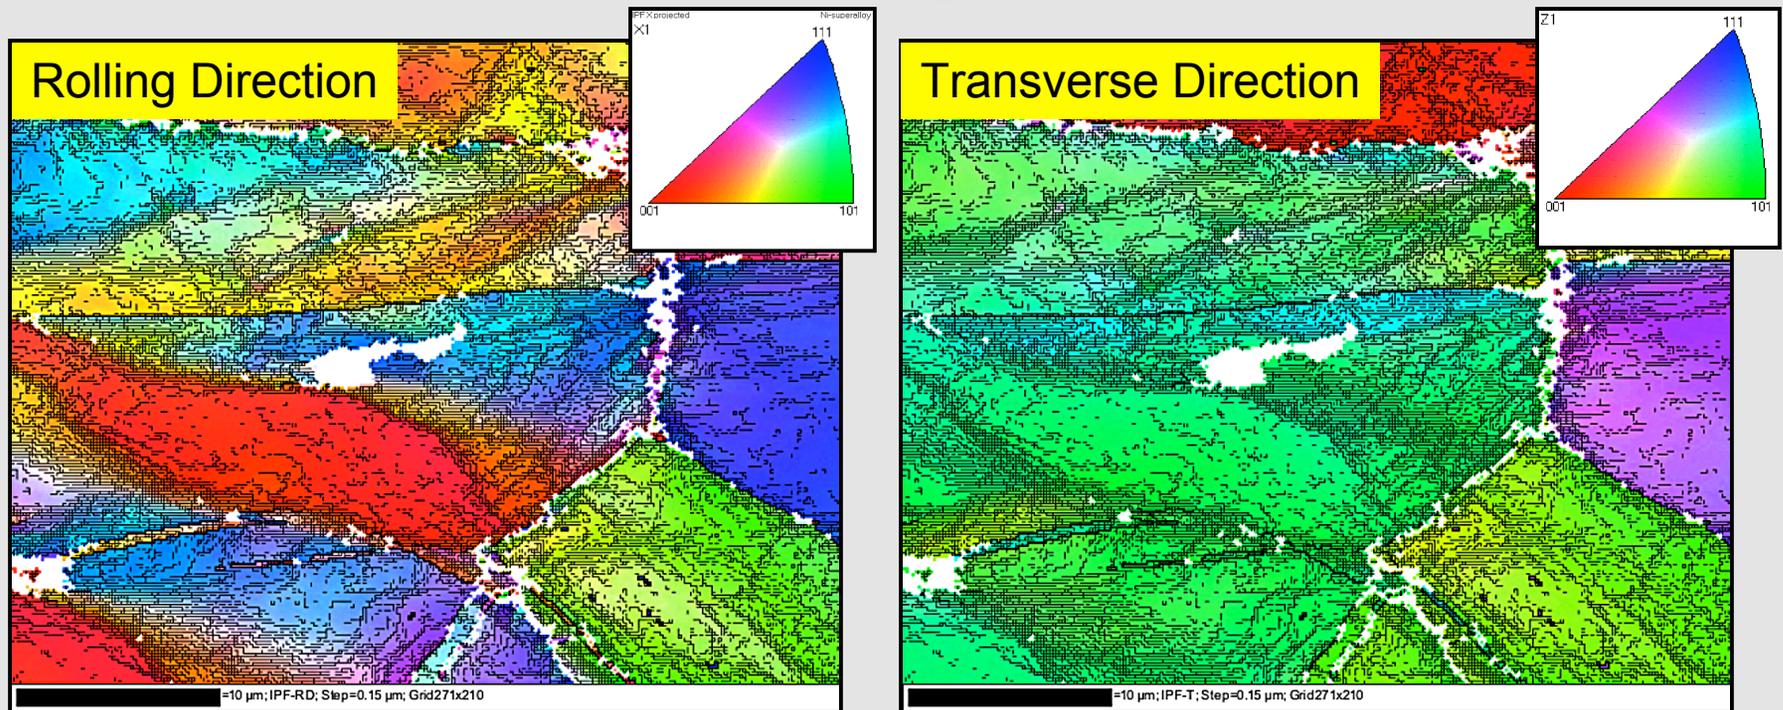
*GEG Test Sample C372*

*Comparison of inverse pole figure maps (RD versus TD): RD orientation map shows a greater degree of lattice misorientation than in the TD map. Boundaries are shown with regions of  $>0.75^\circ$  misorientation. Difficulty indexing near matrix TiN or grain boundary  $M_{23}C_6$  particles.*

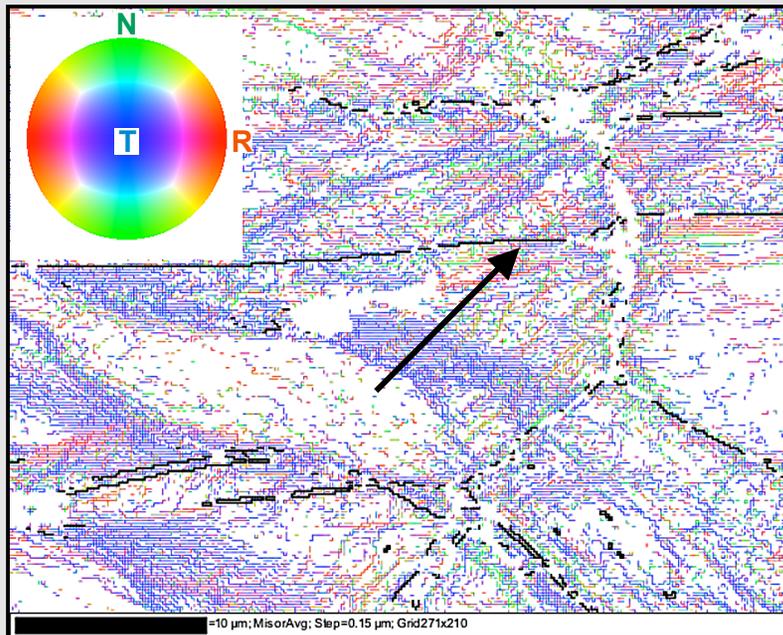
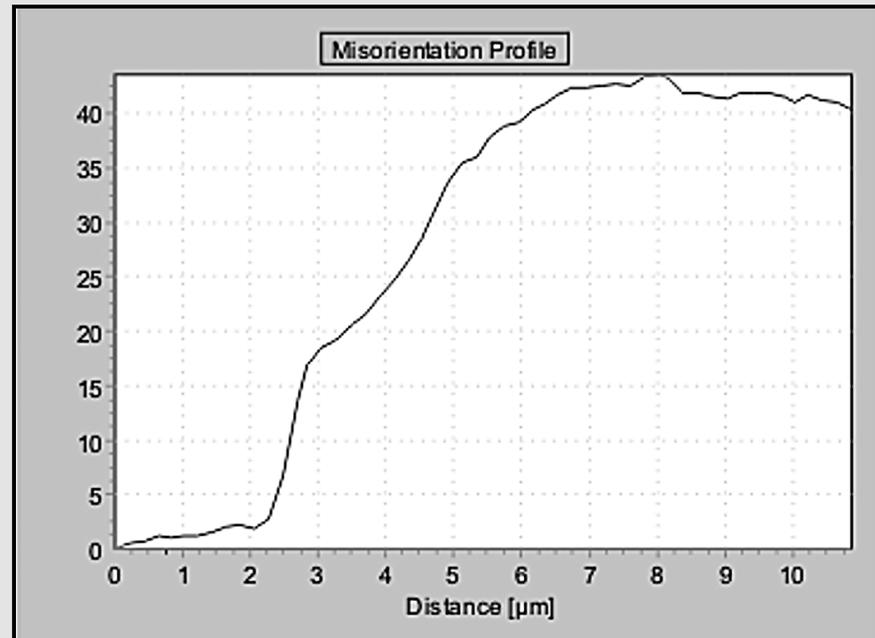
*GEG Test Sample C372*

*Misorientation axis map: Blue boundaries indicate the axis of rotation is the transverse (T) direction, red boundaries are rotated about the rolling (R) direction. Misorientation profile near TiN particle in the middle region (black arrow) shows the degree of misorientation across the grain to the boundary.*

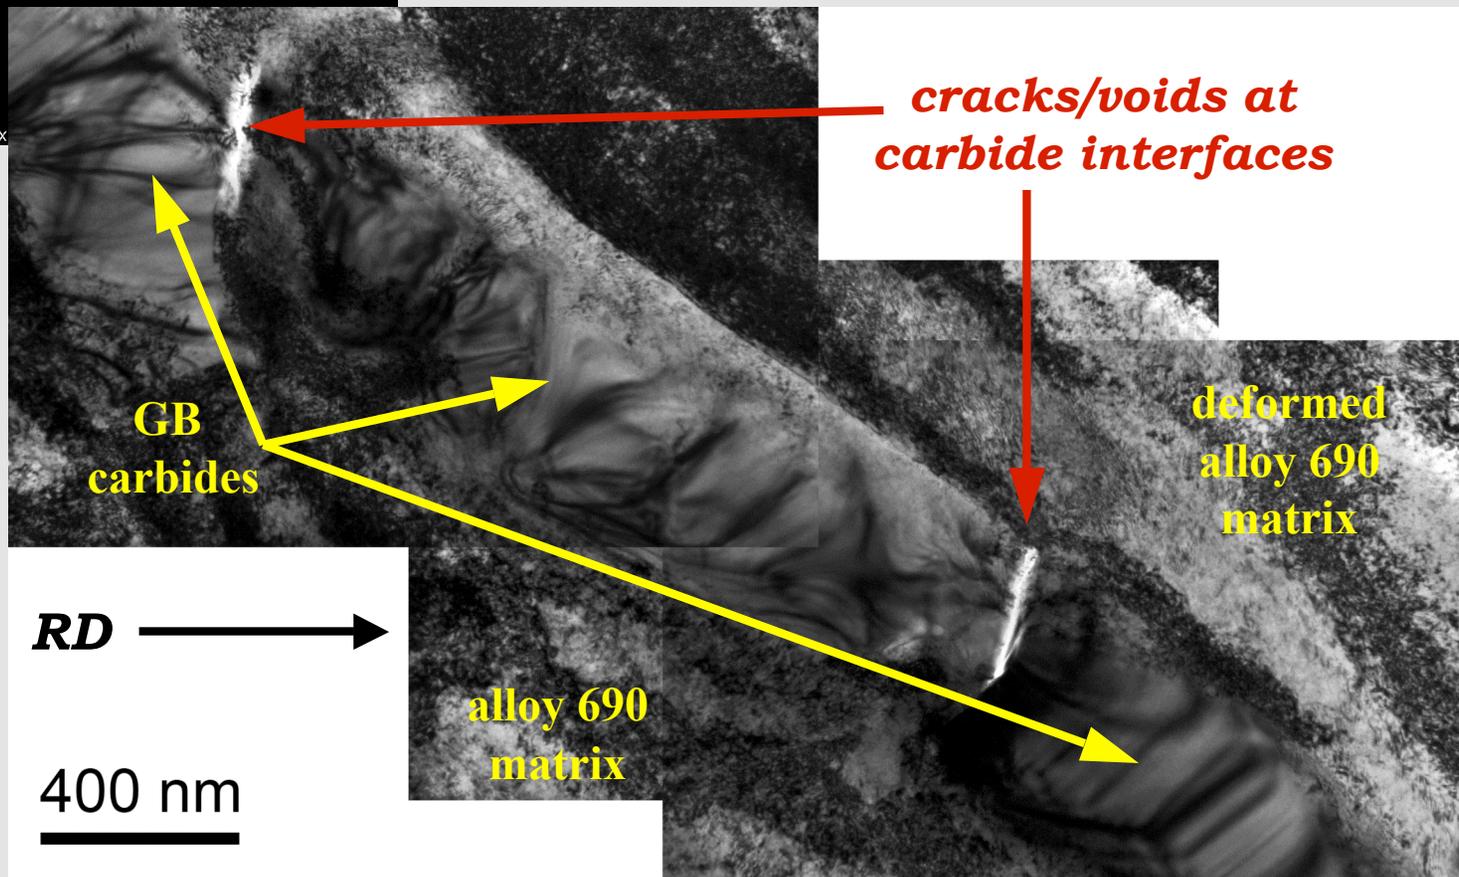
FIB is being used to evaluate nm-scale damage along grain boundaries in 1D-rolled alloy 690 that show high IGSCC crack-growth rates during tests in PWR primary water. **Nanoscale cracks and/or voids** found by TEM at grain boundary carbide interfaces.

FIB has removed samples from regions far from the CT fracture surface. Samples cut from several different section orientations in an attempt to assess the 3D grain boundary characteristics.

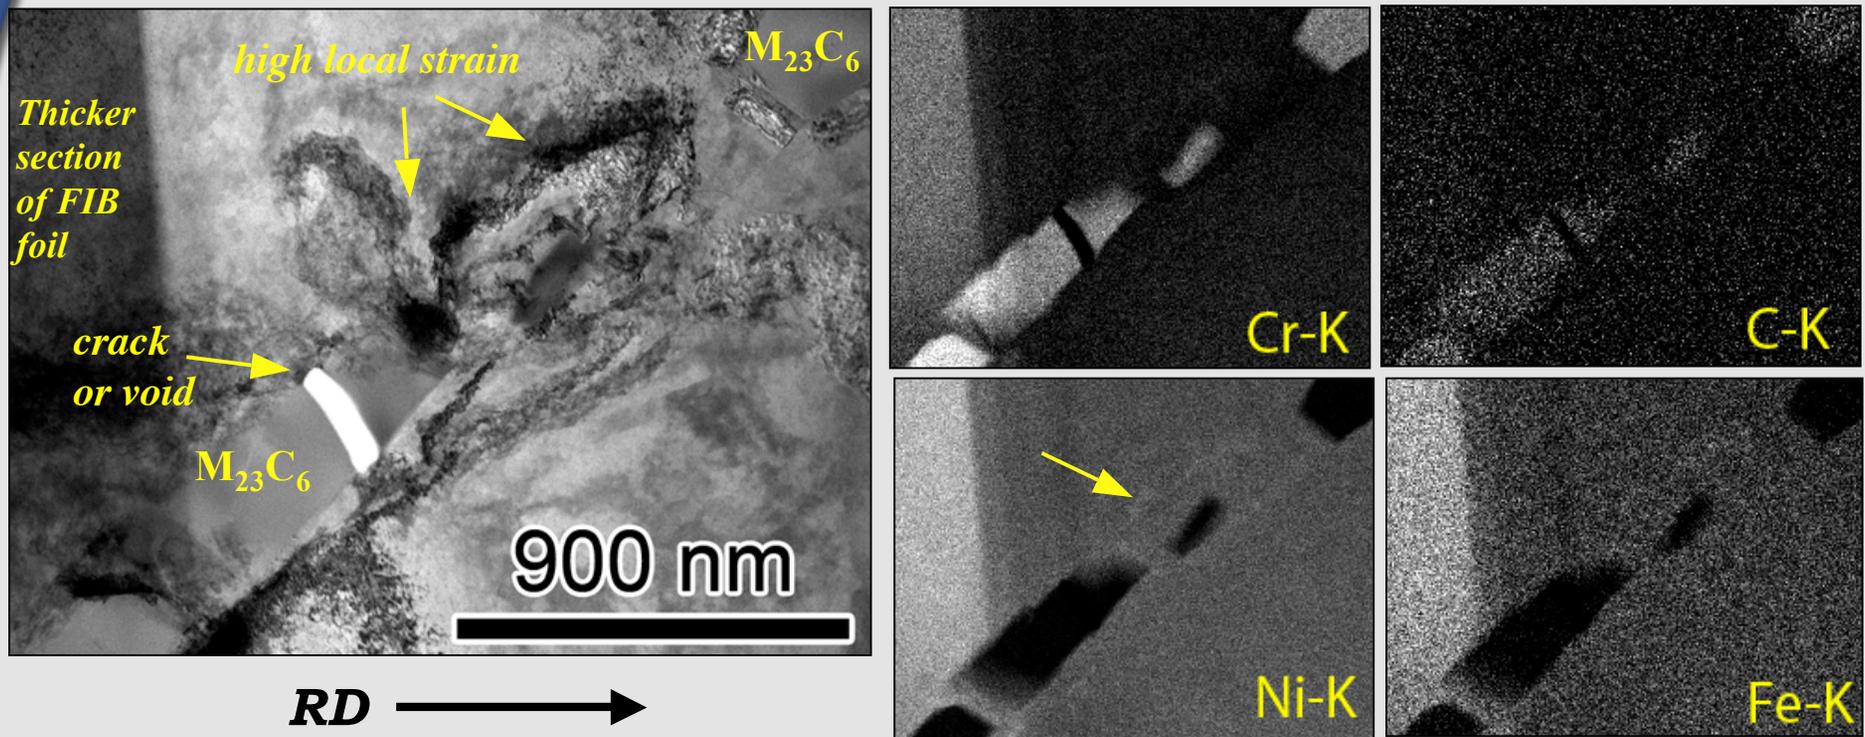
GEG Test Sample C372

TEM image from third series of FIB samples; crack separating carbides, high local strain at all carbide interfaces. EDS maps illustrating GB Cr carbides and Cr depletion.

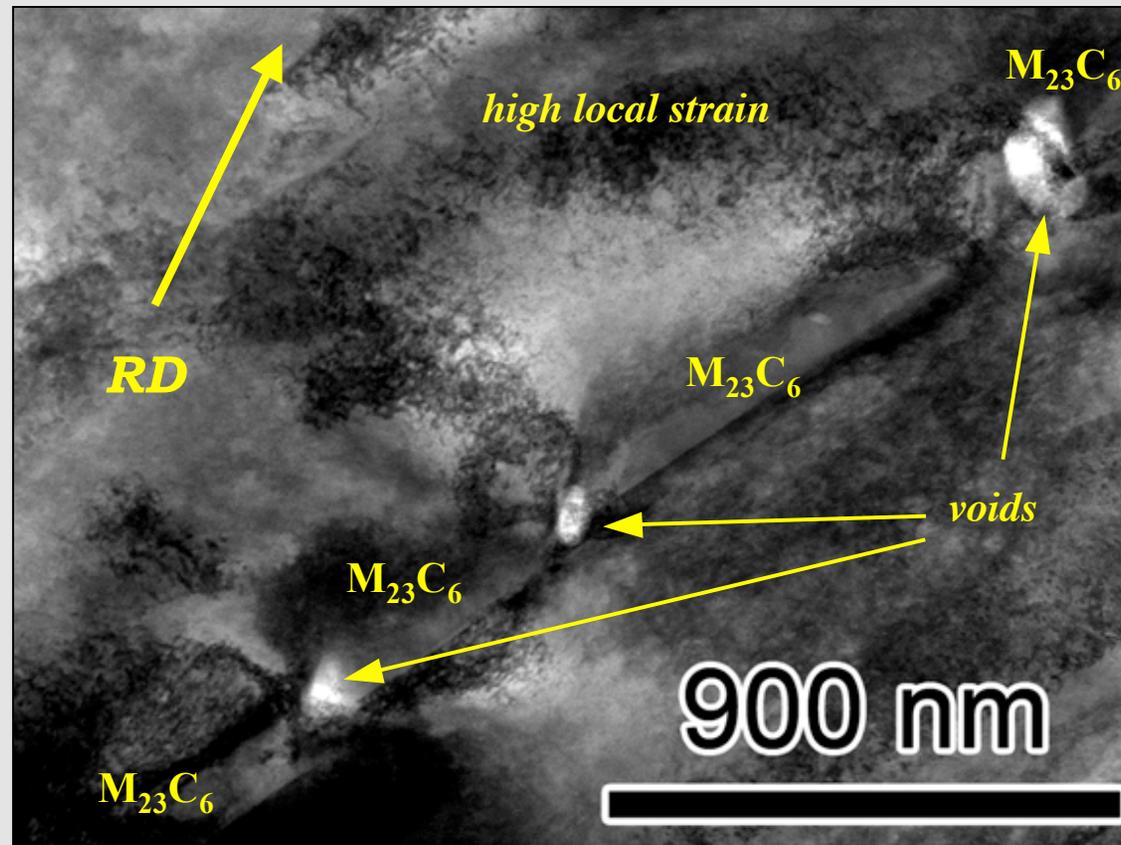
*GEG Test Sample C372*

*TEM image from third series of FIB samples (two orientations); voids separating carbides, high local strain at voids and at carbide interfaces.*

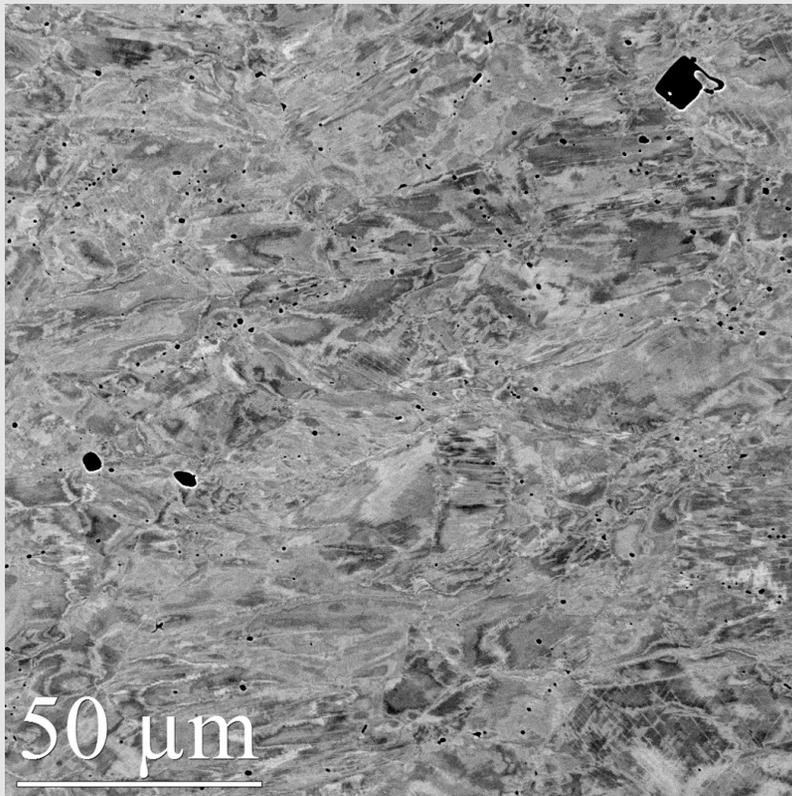
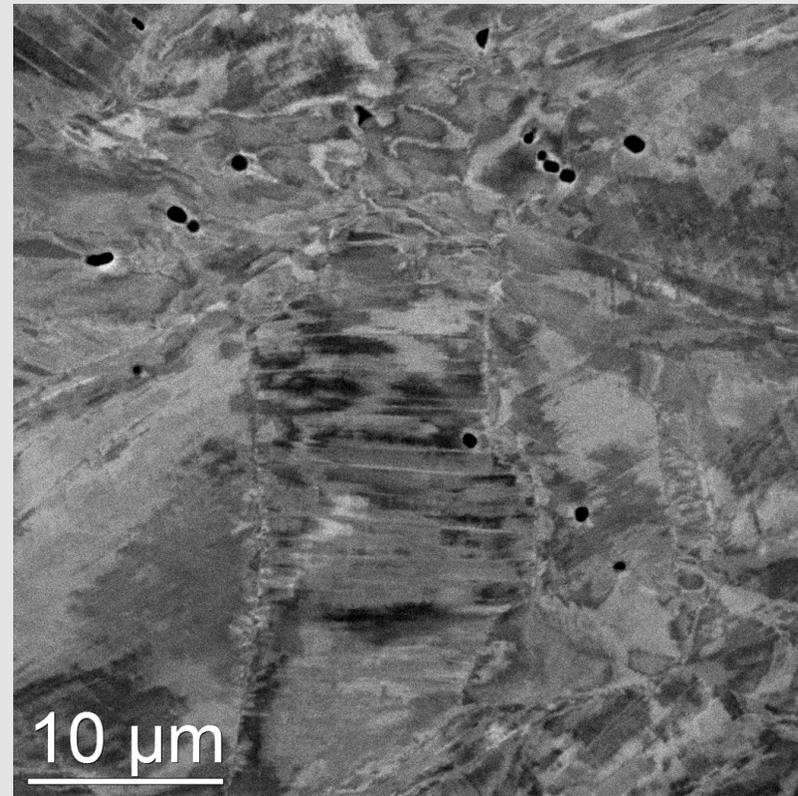
*BSE-SEM images show a highly deformed grain structure with few visible carbides on the grain boundaries, but moderate density of large TiNi particles.*

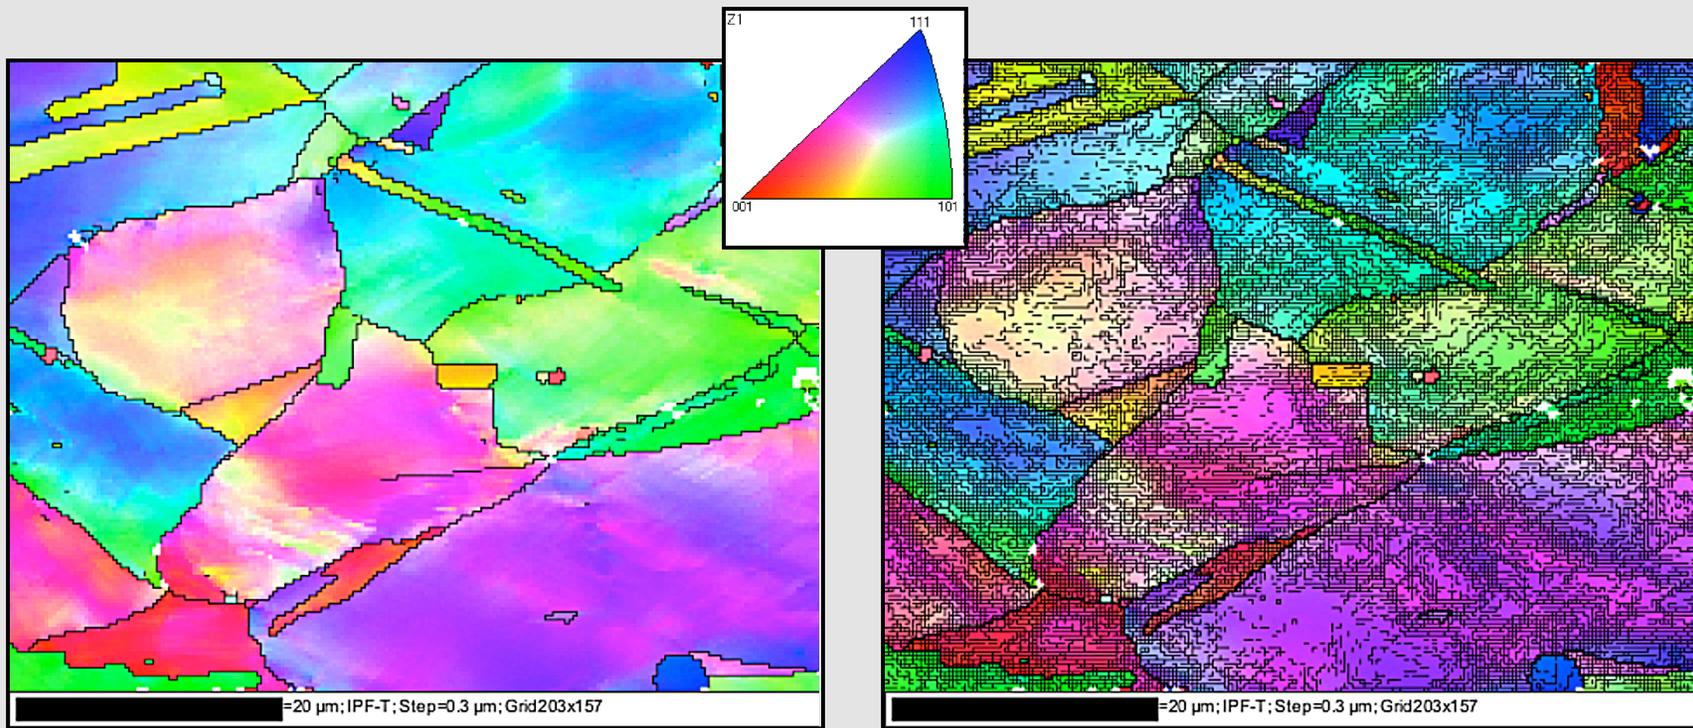
*GEG Test Sample C373*

*Inverse pole figure map (transverse direction): Non-uniform colors indicate lattice rotation across highly strained grains. Map shows boundaries with regions of greater than  $>0.75^\circ$  misorientation.*

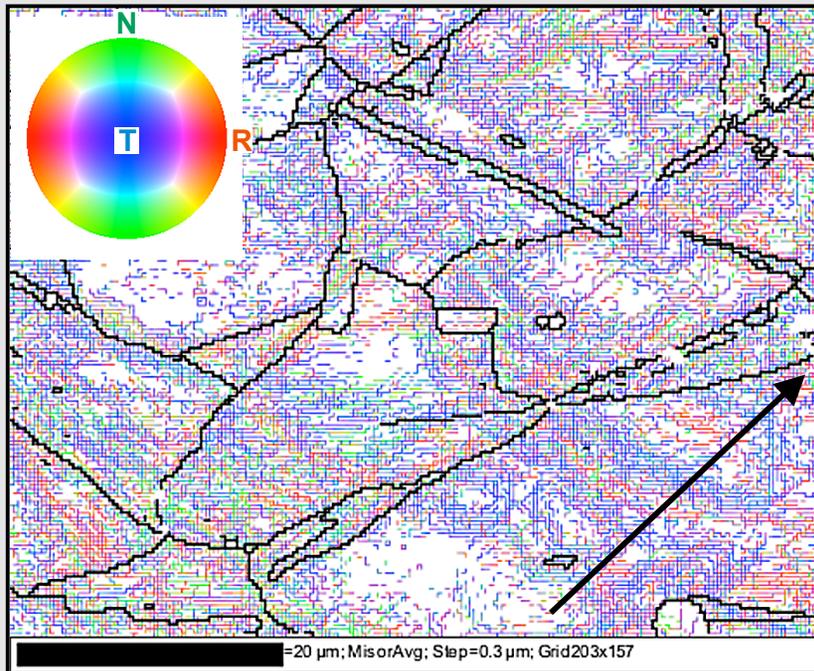
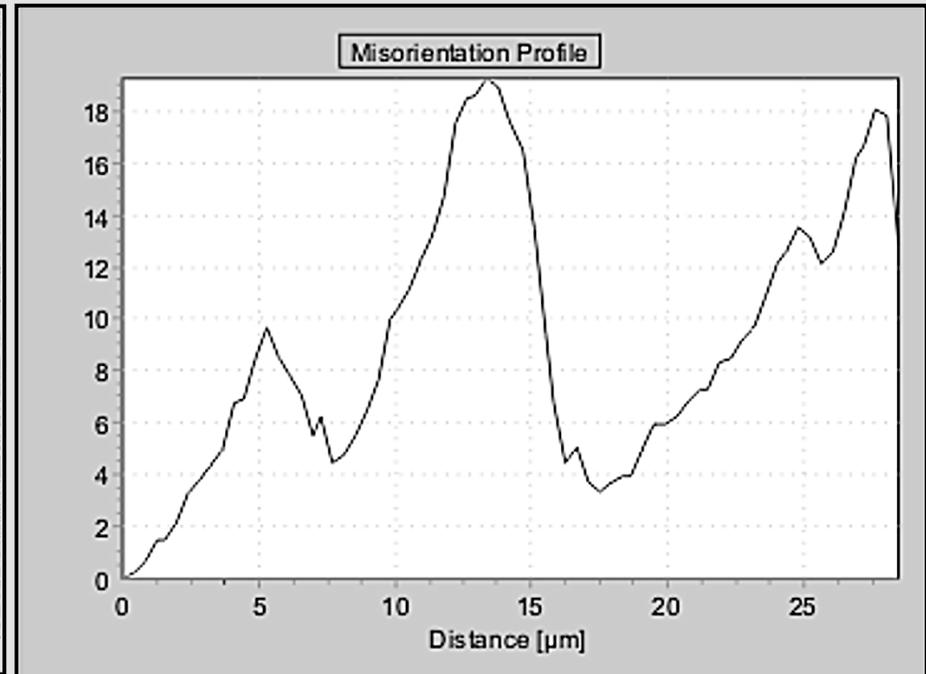
*GEG Test Sample C373*

*Misorientation axis map: Blue boundaries indicate the axis of rotation is the transverse (T) direction, red boundaries are rotated about the rolling (R) direction. Misorientation profile across grain in lower left hand region (black arrow) shows the degree of misorientation across the grain to the boundary.*

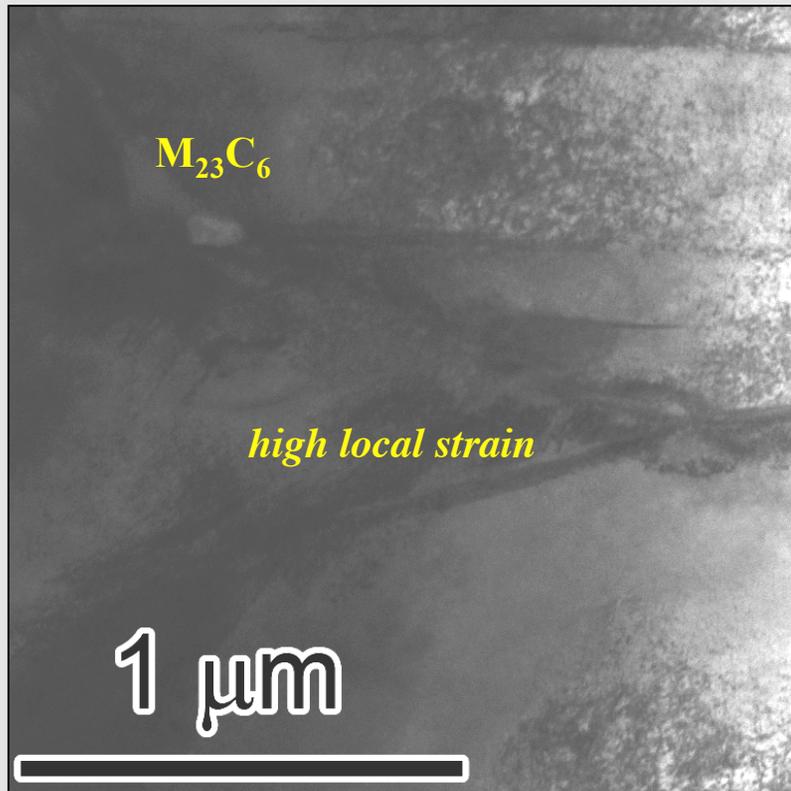
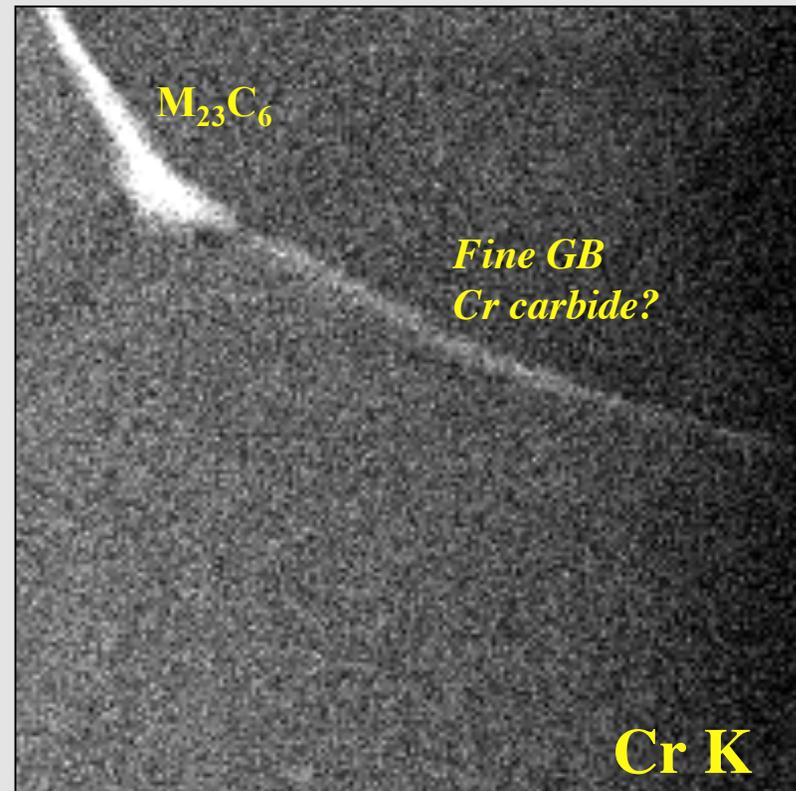
*GEG Test Sample C373*

*TEM images from FIB-TEM sample showing elongated grain boundary  $M_{23}C_6$  carbide and Cr enrichment along GB in EDS map; high local strain associated with grain boundaries and carbide interfaces, but no observations of cracks/voids at interfaces.*
