Grain Boundary Damage in Alloy 690 after One Dimensional Cold Rolling

Preliminary Observations

Matt Olszta, Dan Edwards and Steve Bruemmer
Pacific Northwest National Laboratory

2008 ICG-EAC

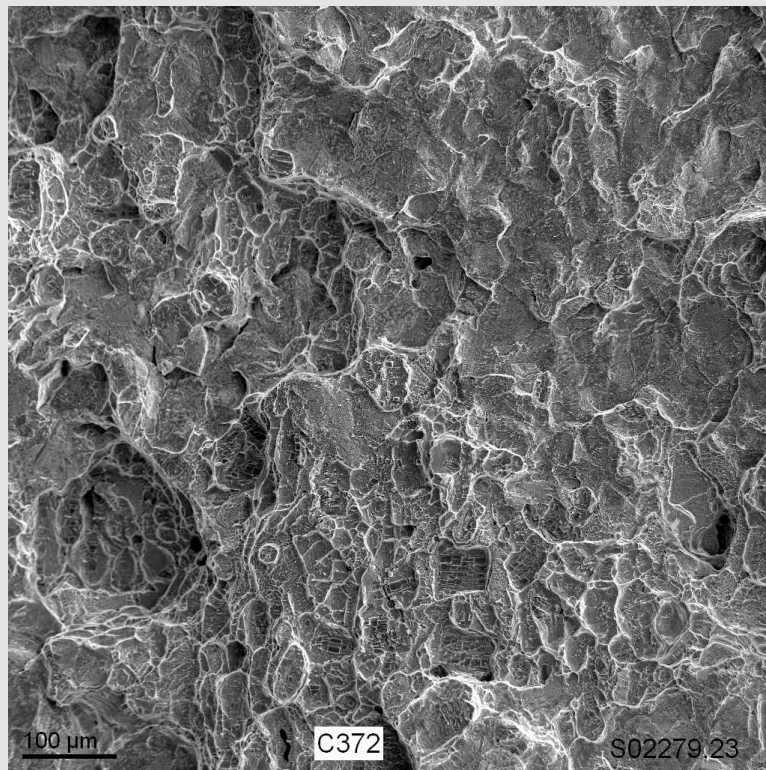
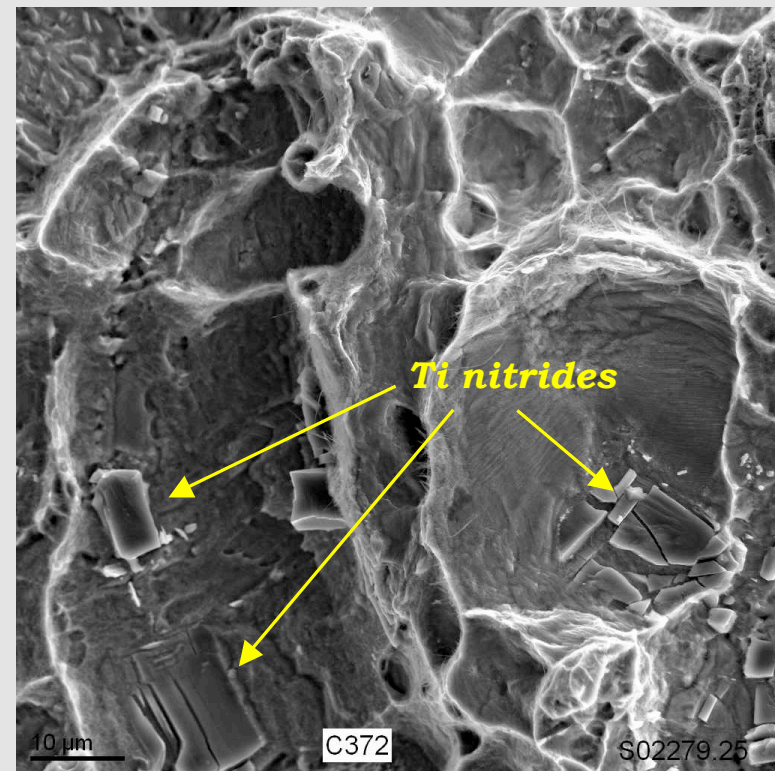
Mixed-mode fracture surface with IG (described as granulated) and TG regions, tearing regions often contain cracked Ti nitrides.

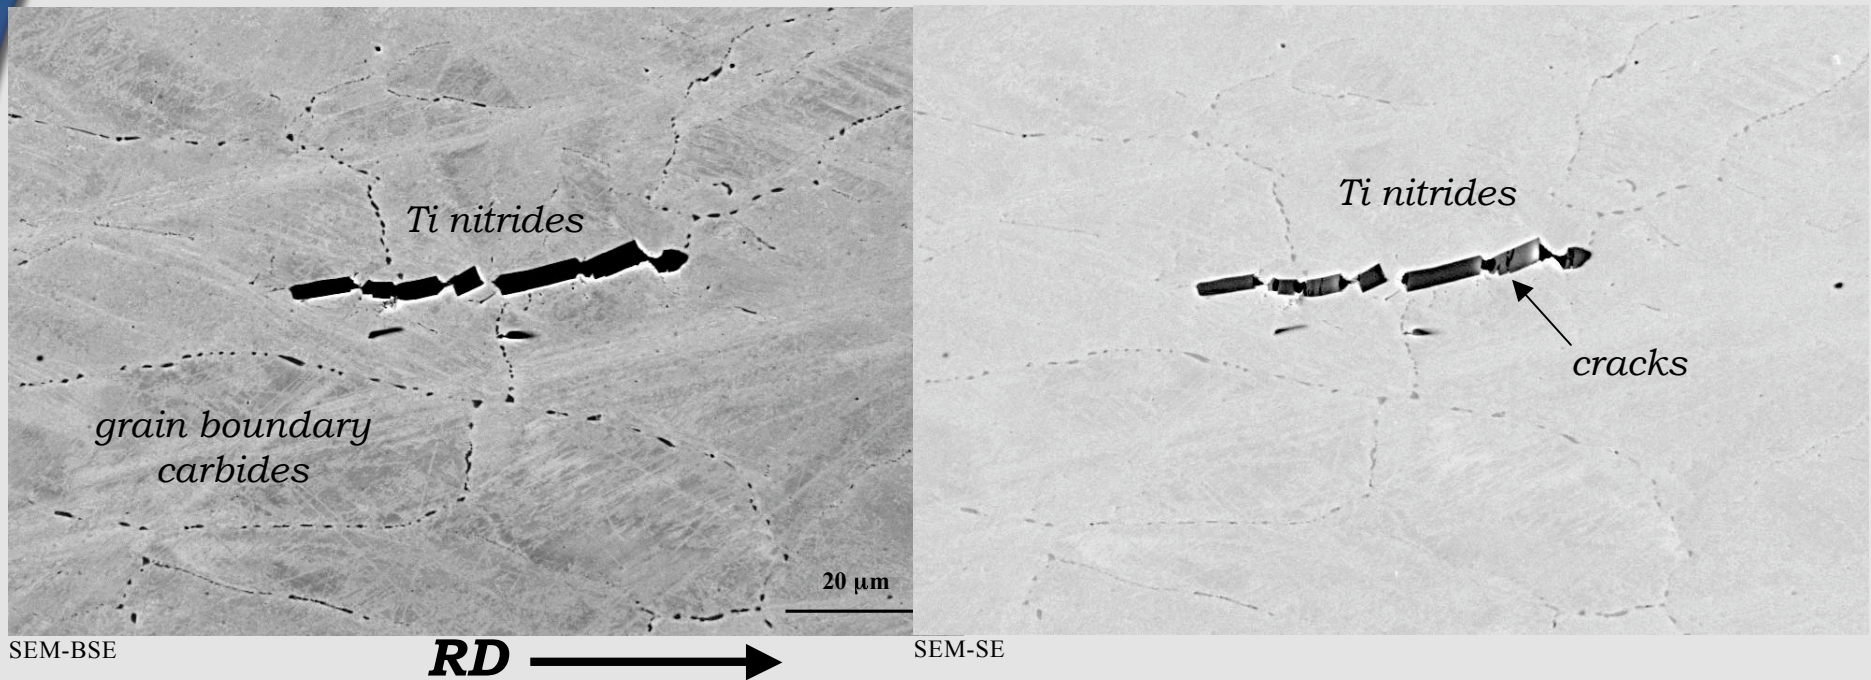
Metallographic examination of area far from fracture surface. Evidence for grain elongation along the rolling direction. High density of fine grain boundary Cr_{23}C_6 carbides with moderate density of large, cracked Ti nitrides.

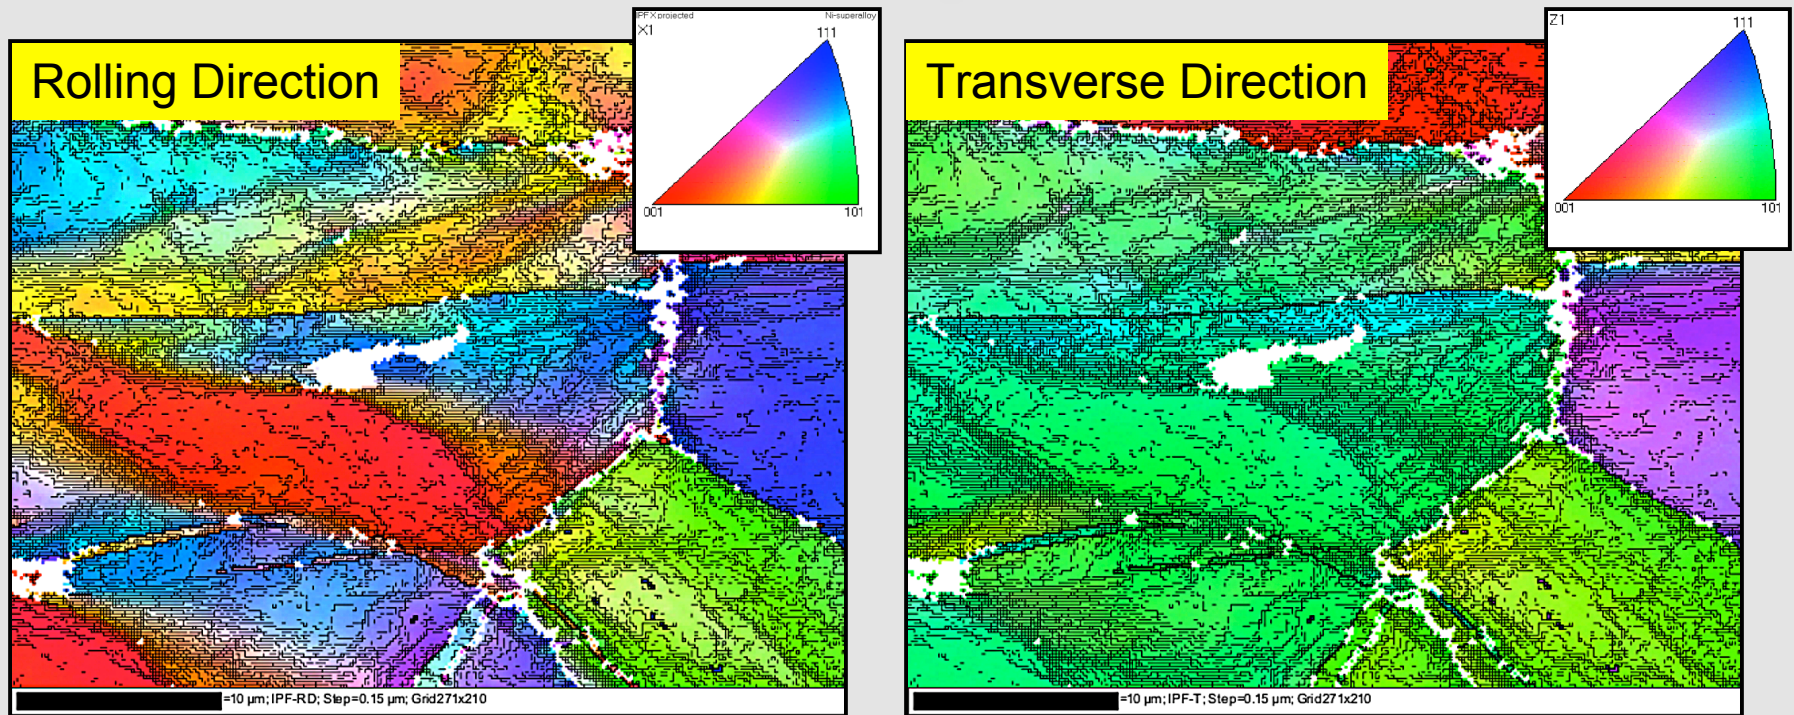
Comparison of inverse pole figure maps (RD versus TD): RD orientation map shows a greater degree of lattice misorientation than in the TD map. Boundaries are shown with regions of $>0.75^\circ$ misorientation. Difficulty indexing near matrix TiN or grain boundary $M_{23}C_6$ particles.

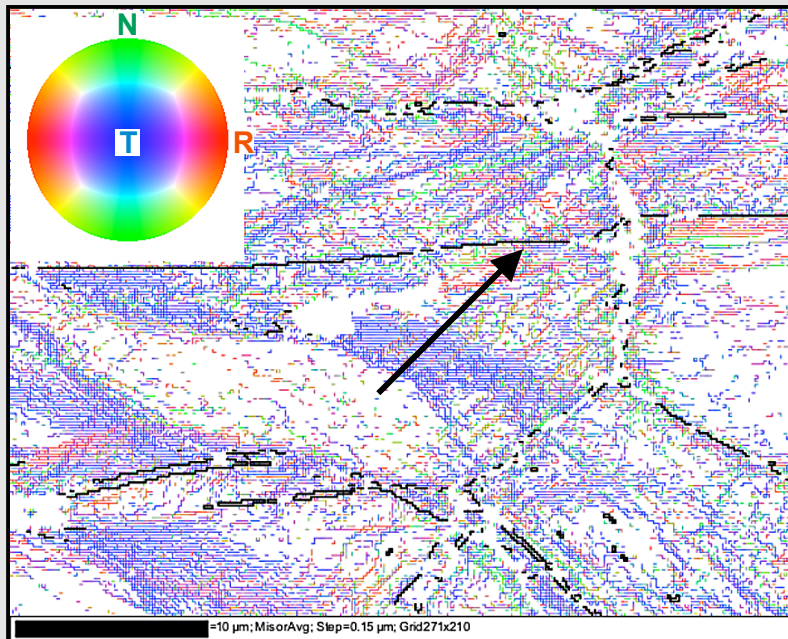
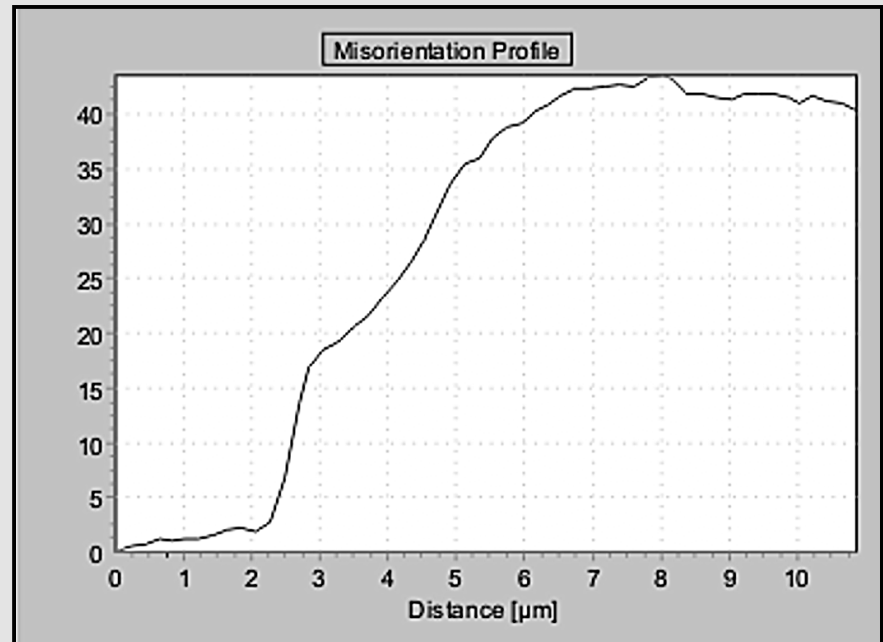
Misorientation axis map: *Blue* boundaries indicate the axis of rotation is the transverse (*T*) direction, *red* boundaries are rotated about the rolling (*R*) direction. Misorientation profile near TiN particle in the middle region (black arrow) shows the degree of misorientation across the grain to the boundary.

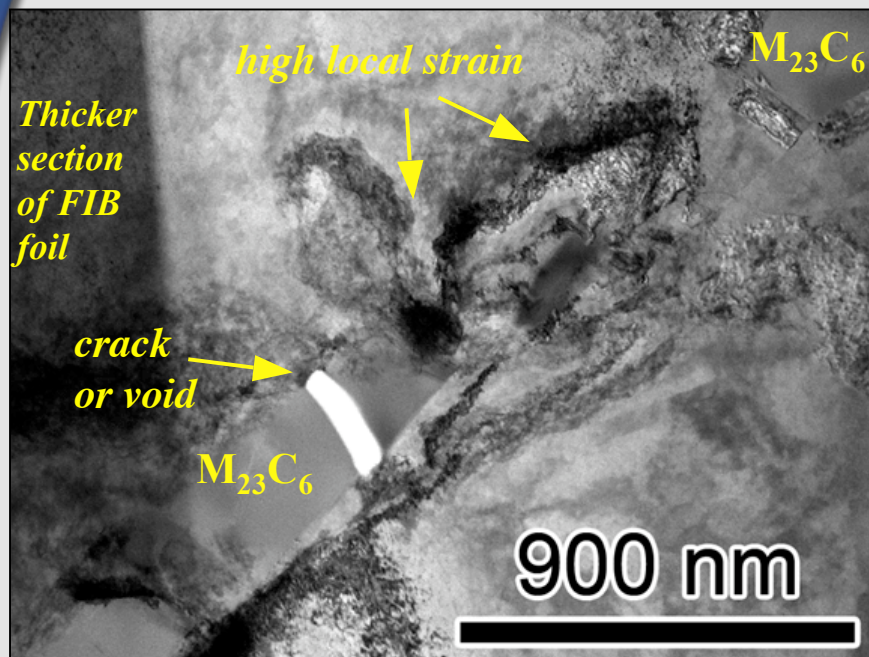
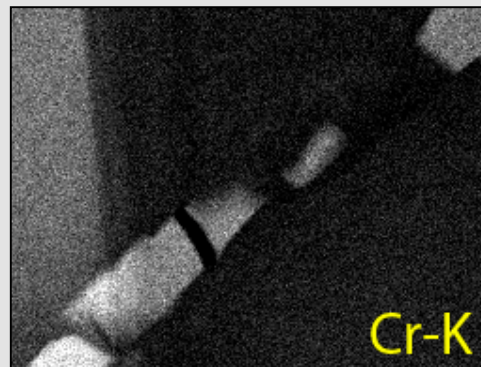
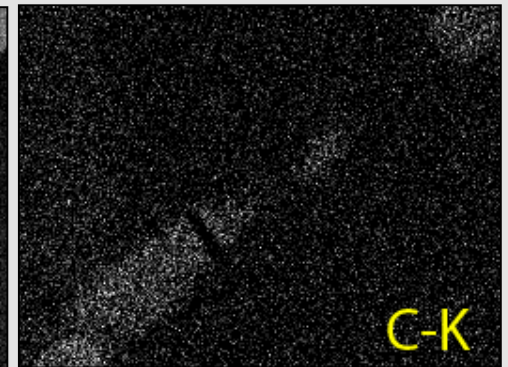
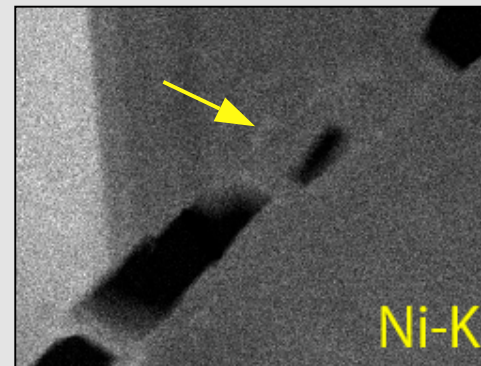
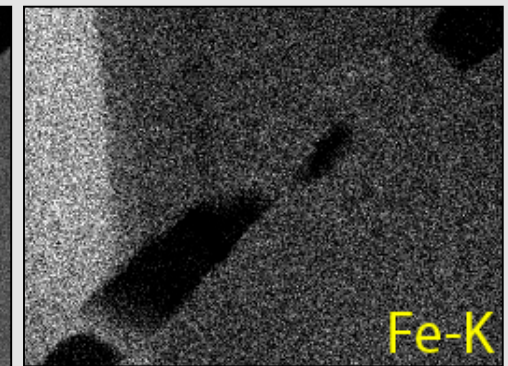
TEM image from third series of FIB samples; crack separating carbides, high local strain at all carbide interfaces. EDS maps illustrating GB Cr carbides and Cr depletion.

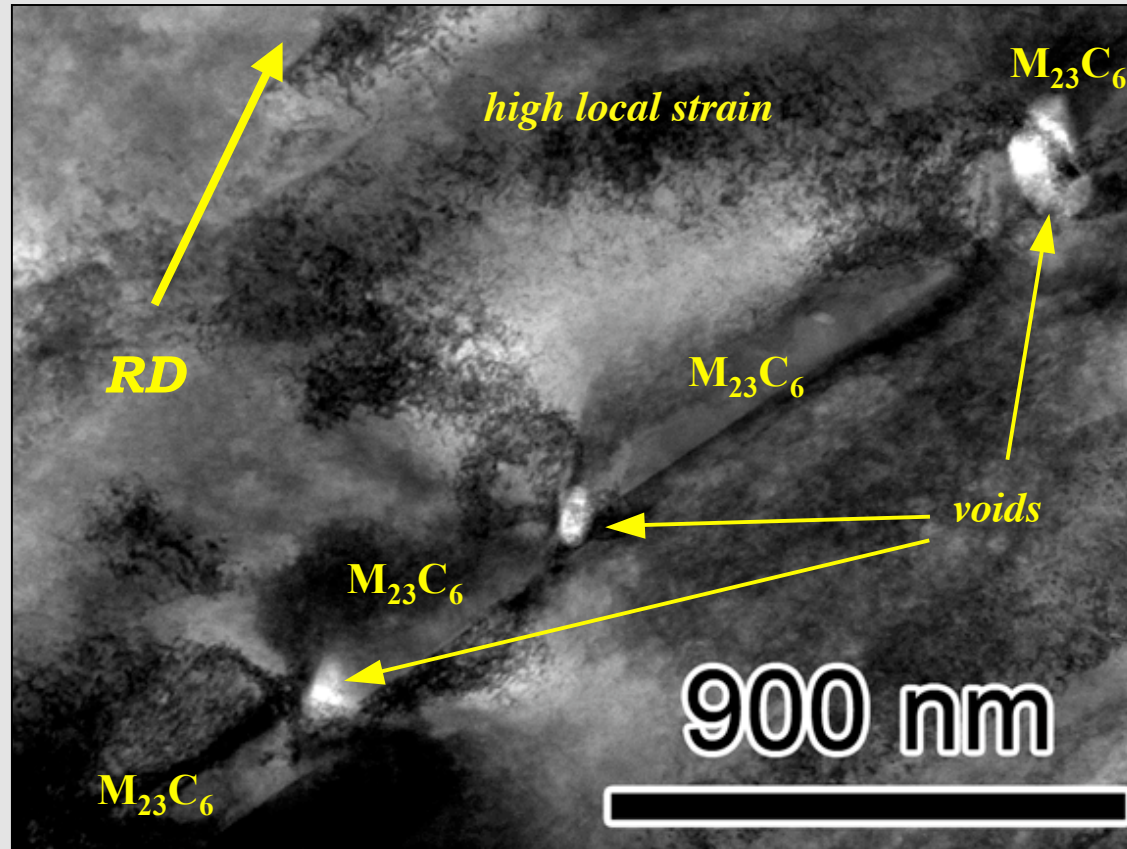
TEM image from third series of FIB samples (two orientations); voids separating carbides, high local strain at voids and at carbide interfaces.

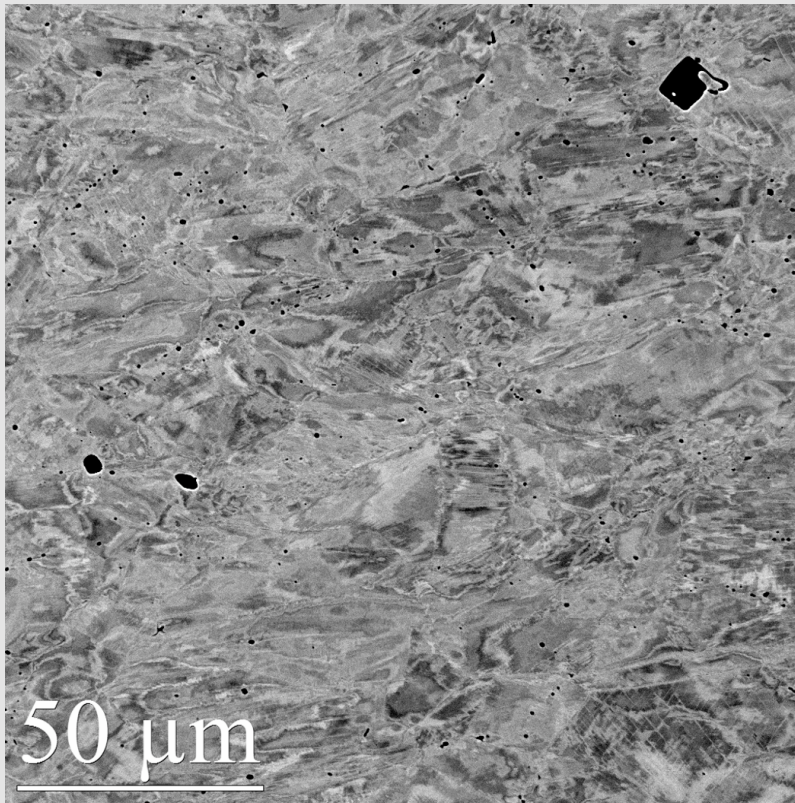
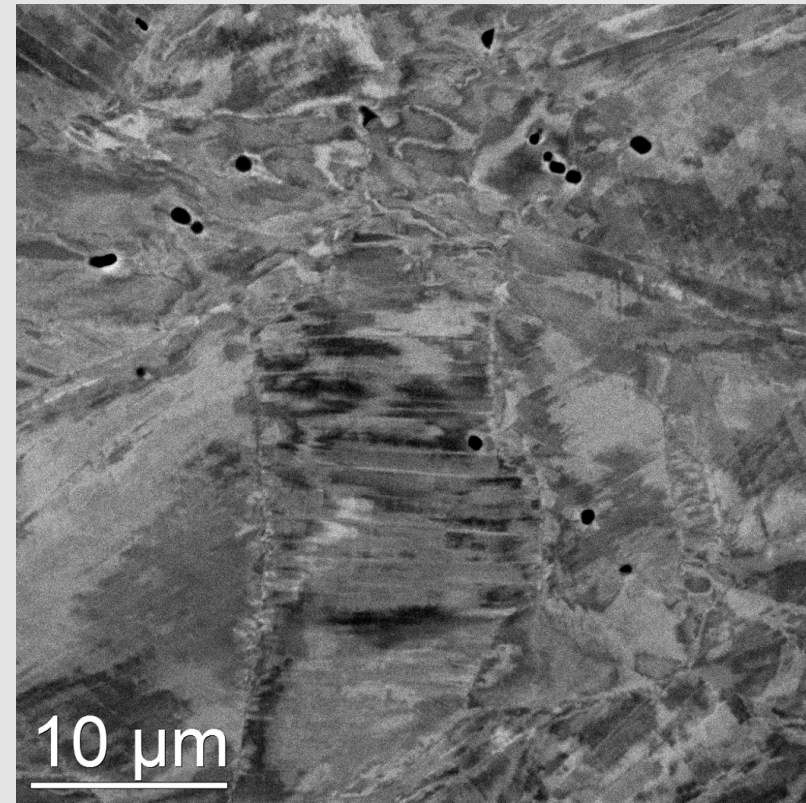
BSE-SEM images show a highly deformed grain structure with few visible carbides on the grain boundaries, but moderate density of large TiNi particles.

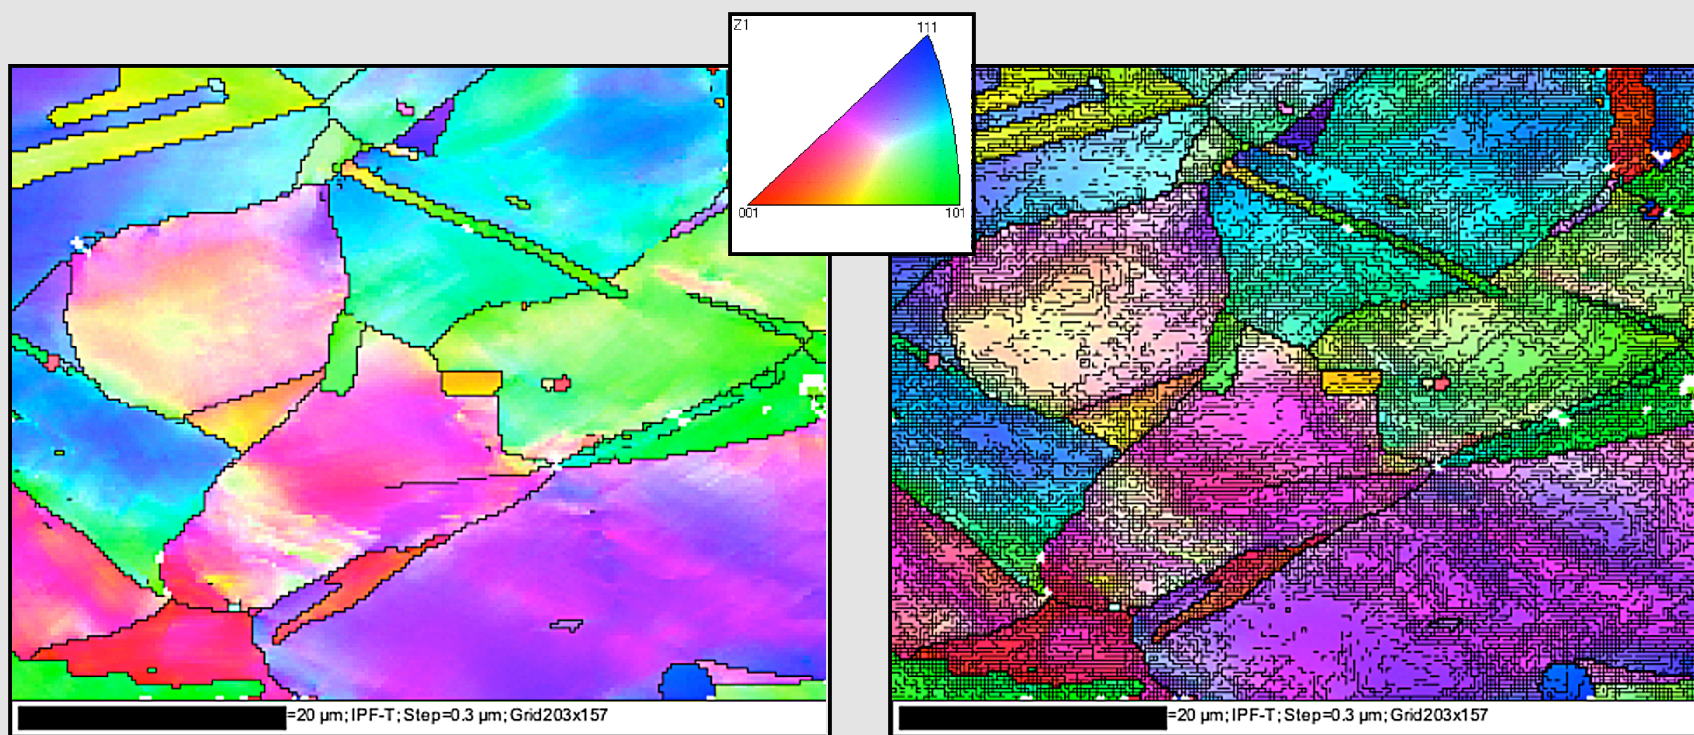
Inverse pole figure map (transverse direction): Non-uniform colors indicate lattice rotation across highly strained grains. Map shows boundaries with regions of greater than $>0.75^\circ$ misorientation.

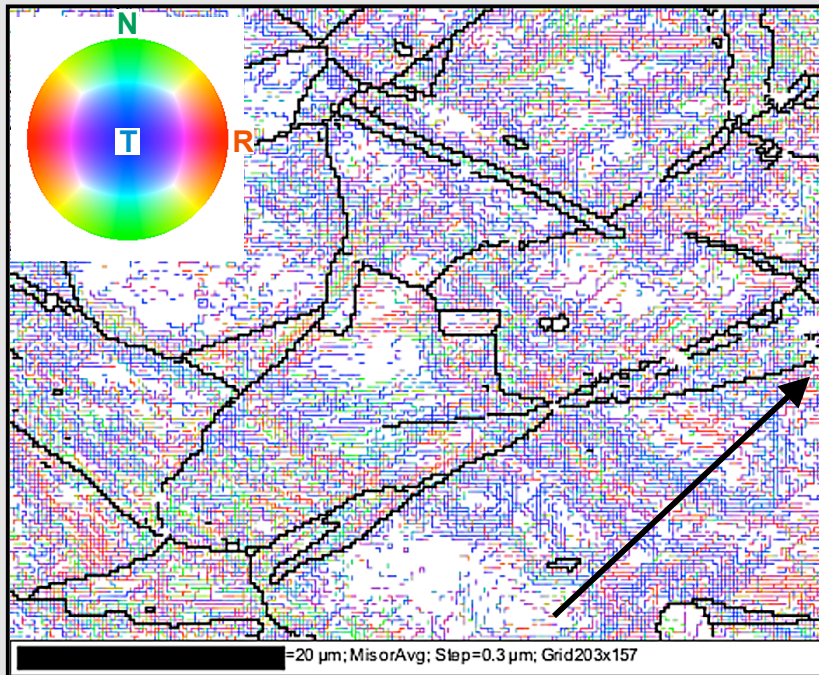
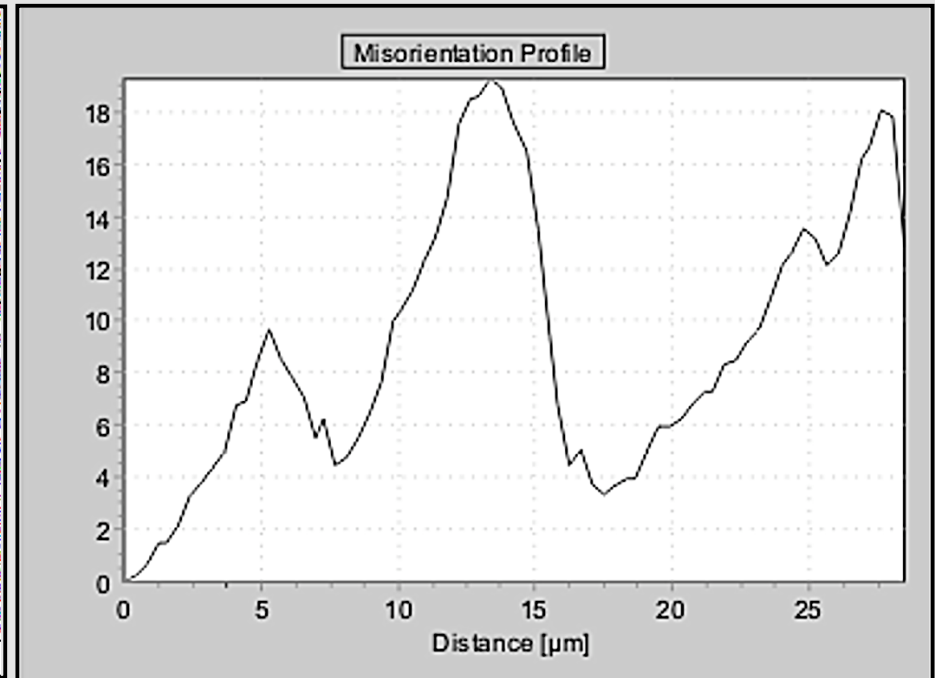
Misorientation axis map: *Blue* boundaries indicate the axis of rotation is the transverse (*T*) direction, *red* boundaries are rotated about the rolling (*R*) direction. Misorientation profile across grain in lower left hand region (black arrow) shows the degree of misorientation across the grain to the boundary.

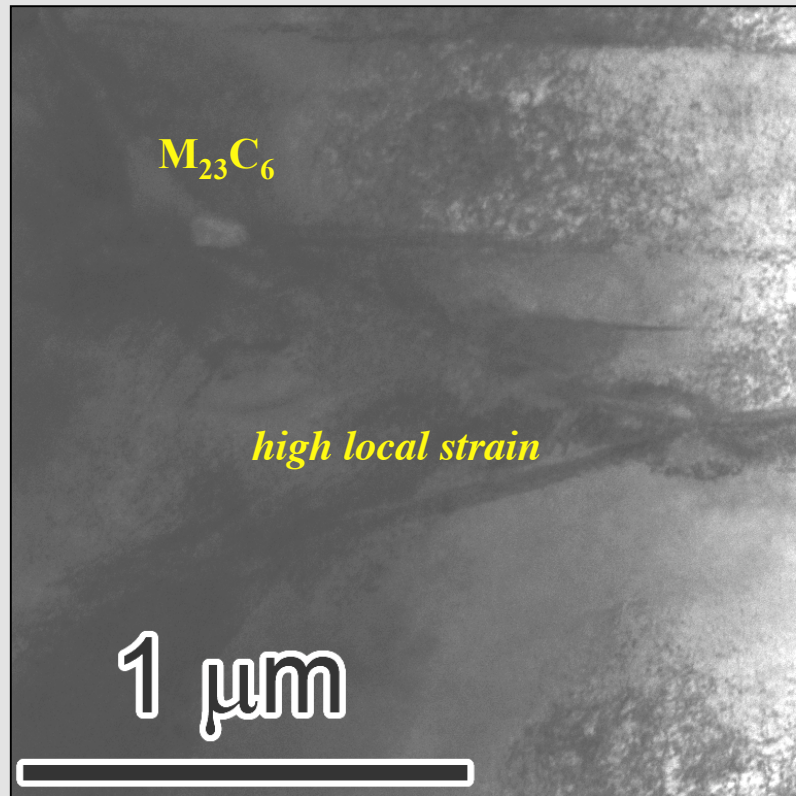
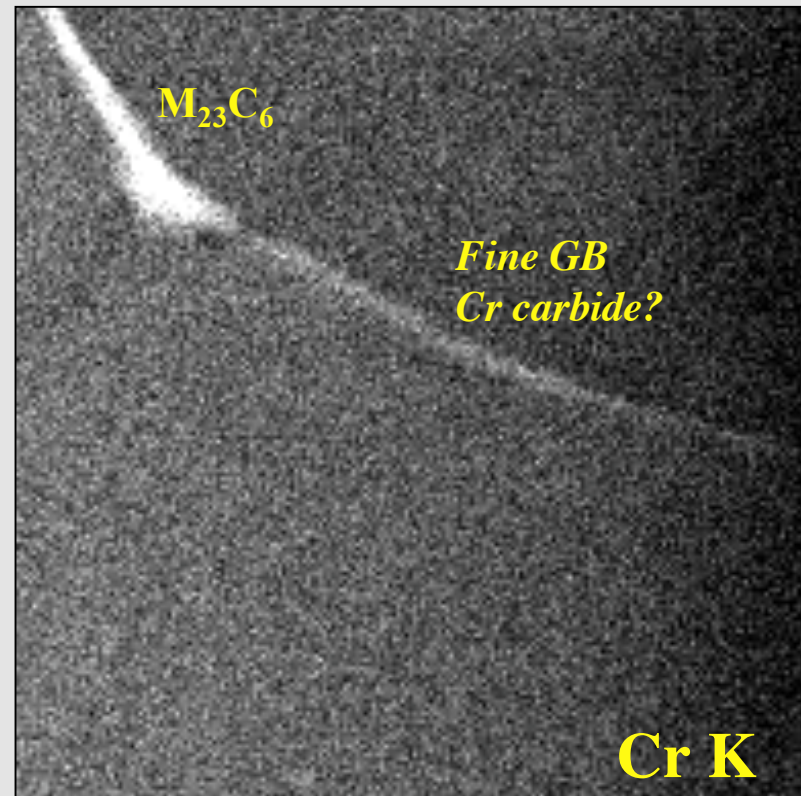
TEM images from FIB-TEM sample showing elongated grain boundary $M_{23}C_6$ carbide and Cr enrichment along GB in EDS map; high local strain associated with grain boundaries and carbide interfaces, but no observations of cracks/voids at interfaces.
