RE: REPONSE TO AN APPARENT VIOLATION IN INSPECTION REPORT
NUMBER 030-12975/2007-001; EA-08-041

Inspection Finding Considered for Escalated Enforcement

Inspection Findings Not Considered for Escalated Enforcement

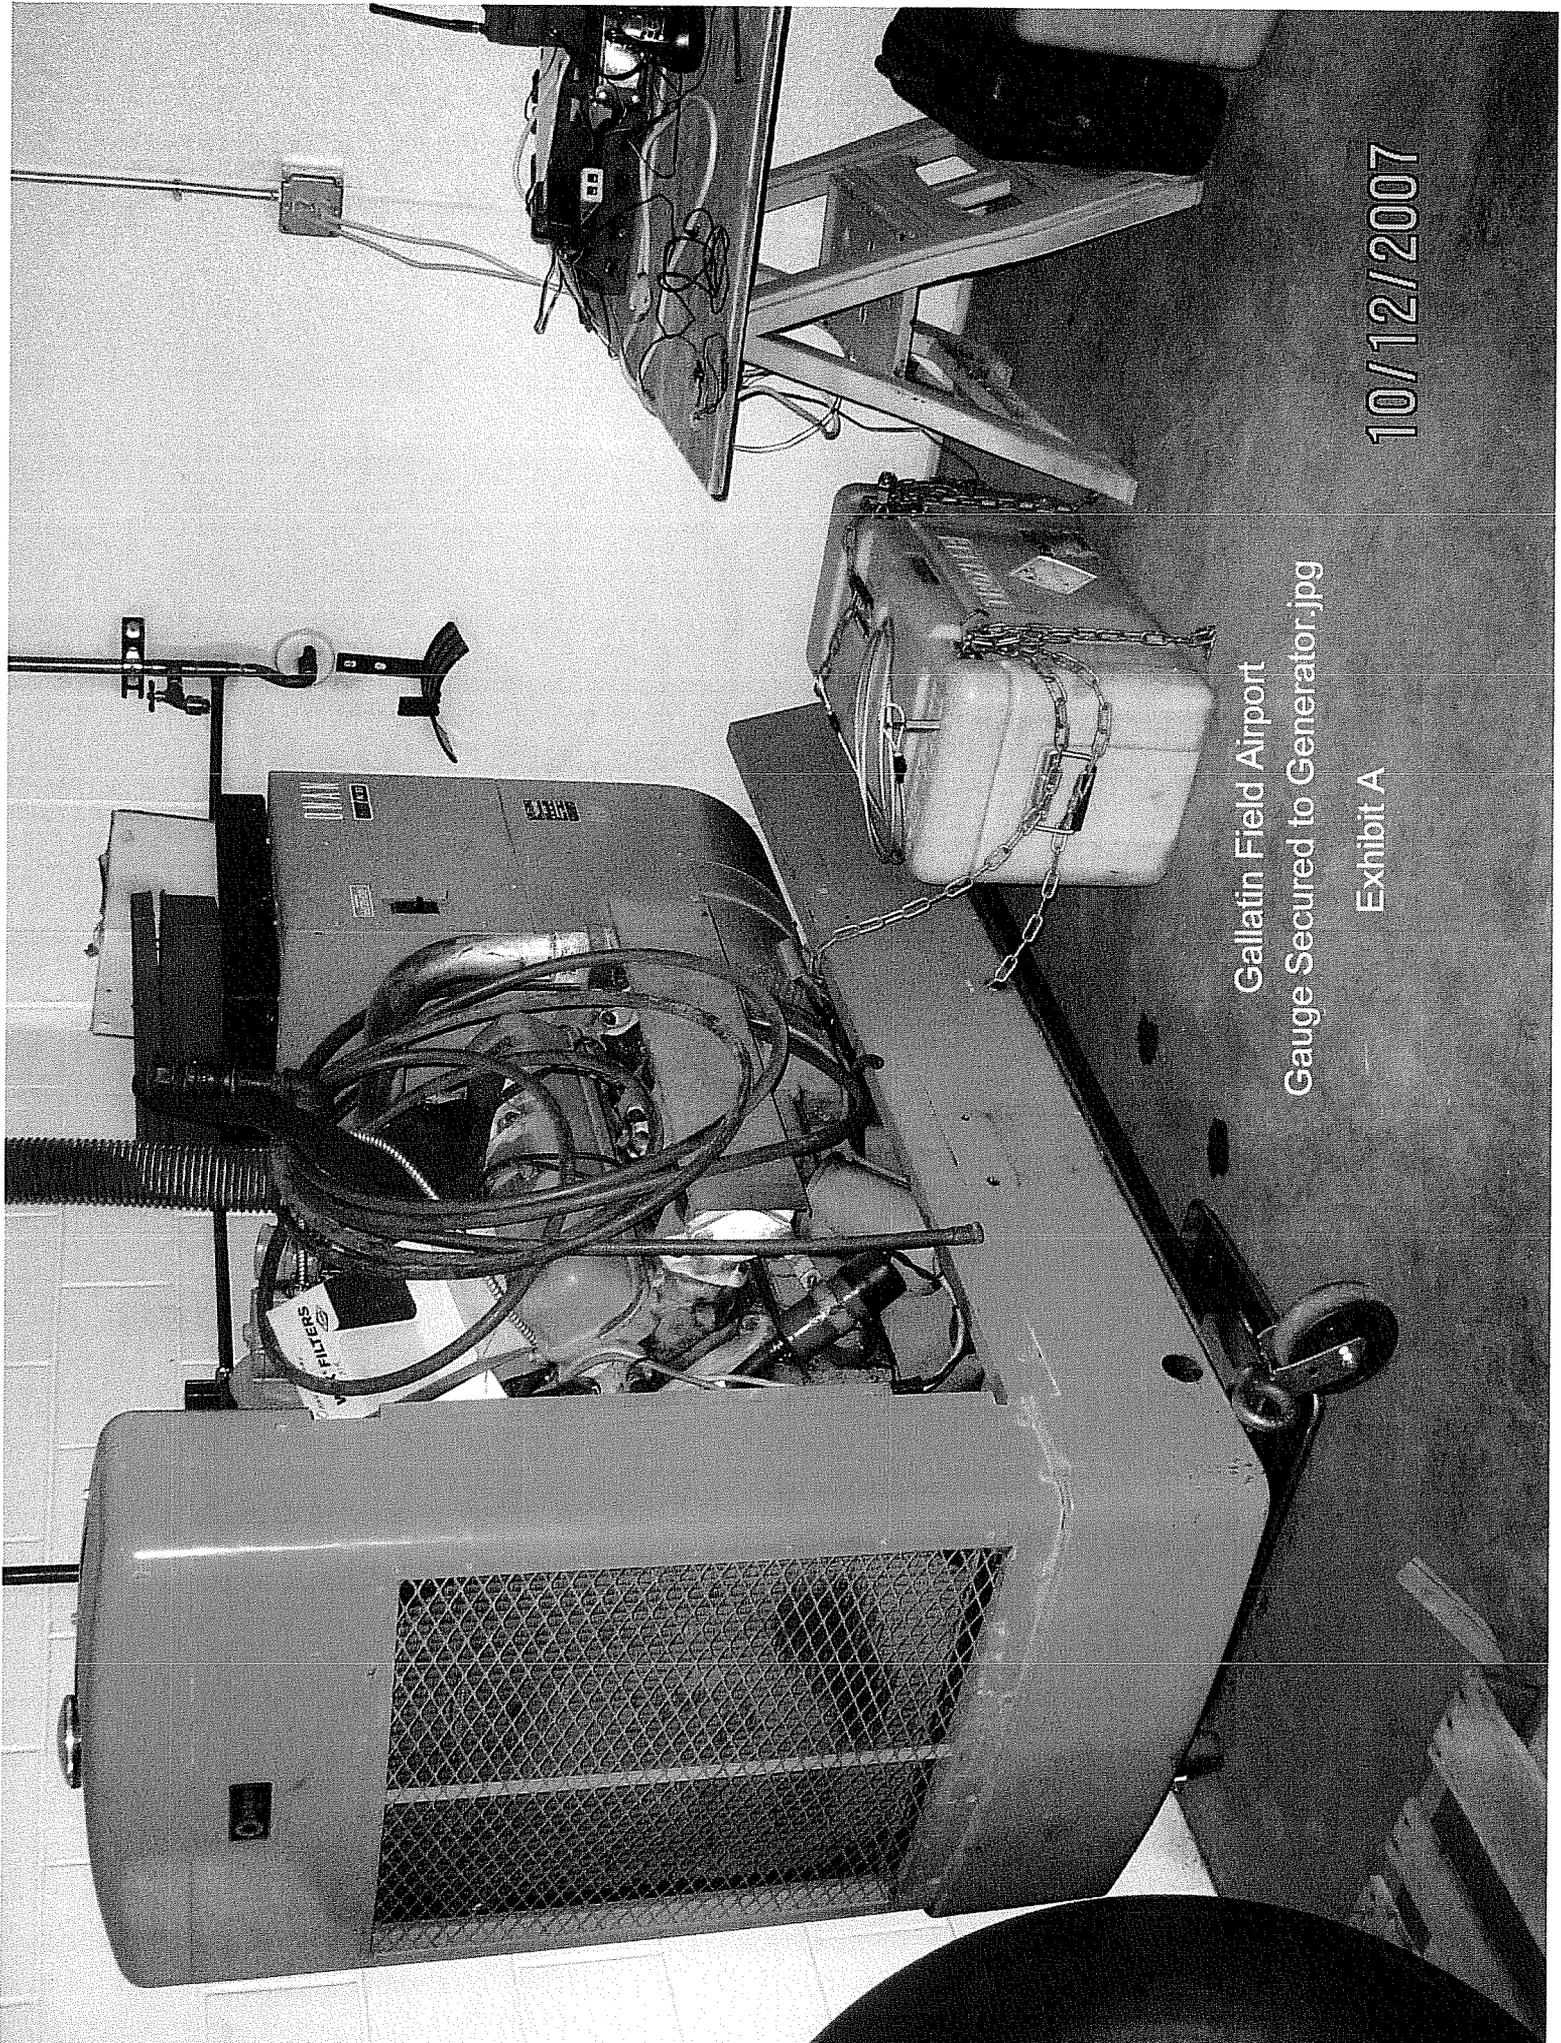
Exhibit A

Gallatin Field Airport
Gauge Secured to Generator.jpg

Employees of Morrison-Maierle, Inc. immediately secured the portable gauge to a fixed, immobile generator using a single chain and lock on hand and within 24 hours had secured the gauge with two independent locks to the fixed generator to become compliant with 10 CFR 30.34. Our immediate corrective actions were documented in the NRC Inspection Report 030-12975/2007-001 (See NRC Executive Summary, Enclosure 2, Corrective Actions; See attached photo Exhibit A). Individuals involved were interviewed and procedures reviewed so that future incidents would not occur. Additionally, all other authorized employees of Morrison-Maierle, Inc. were made aware of the violation and a review of procedures, with an emphasis on proper transportation and storage, was undertaken to prevent future violations.

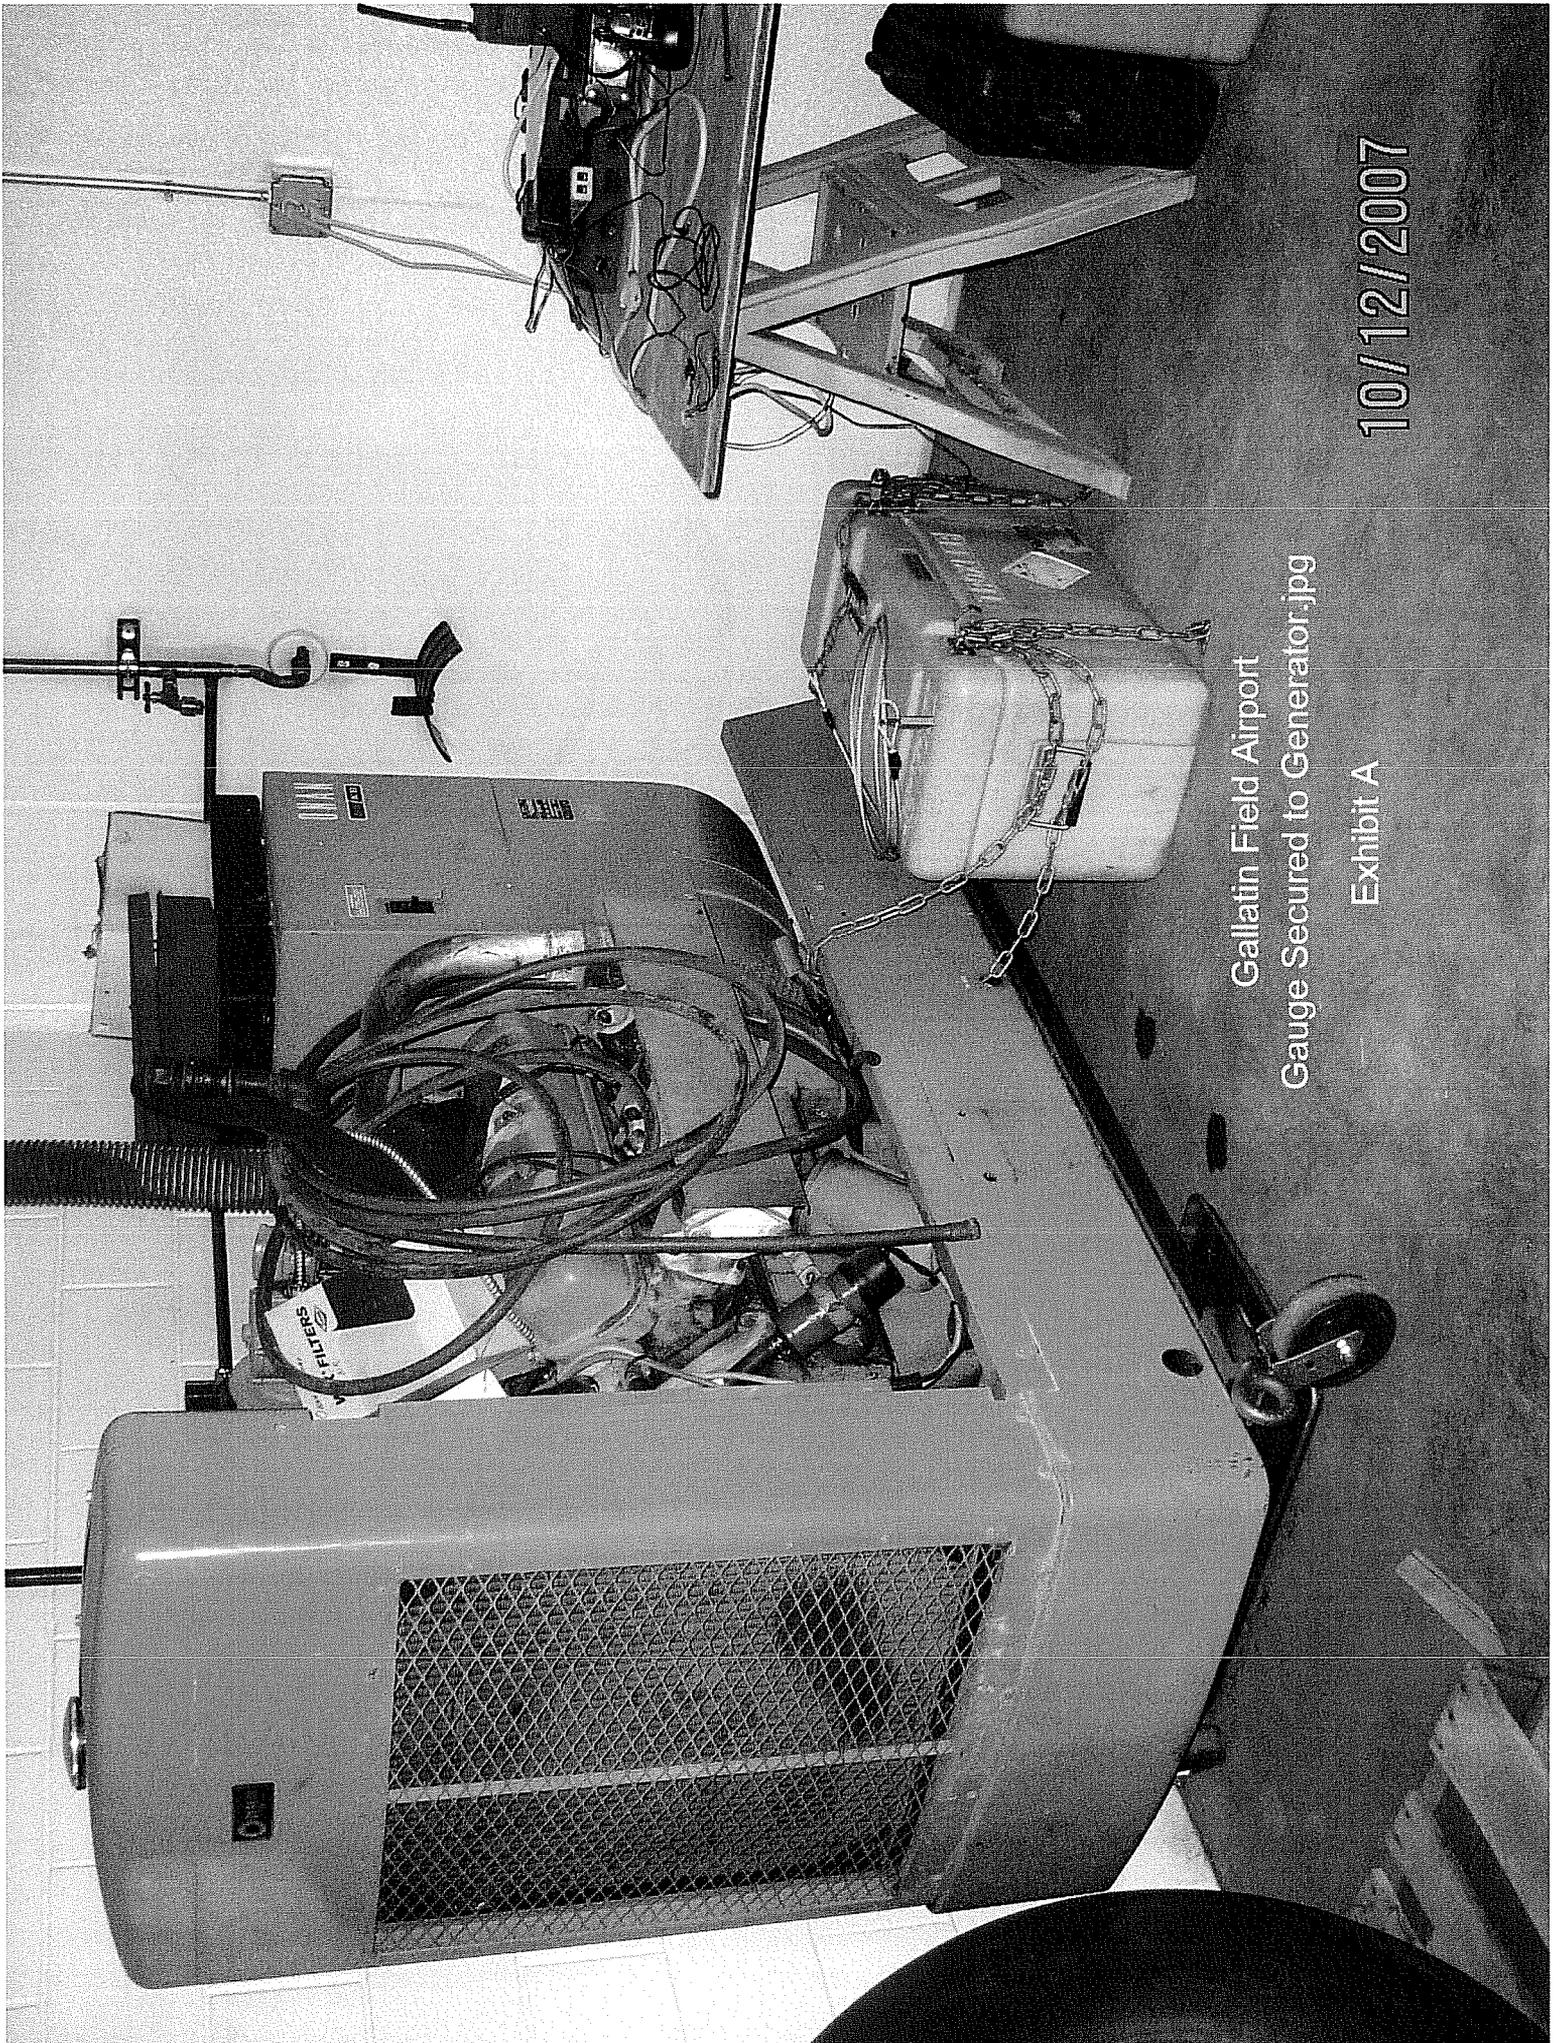
Exhibit A

Gallatin Field Airport
Gauge Secured to Generator.jpg
