South Texas Project Electric Generating Station P.O. Box 289 Wadsworth, Texas 77483

May 14, 2008  
NOC-AE-08002293  
File No.: G25  
10CFR50.55a

Response to Request for Additional Information:  
Request for Relief from ASME Boiler and Pressure Vessel Code,  
Section XI Requirements for the Essential Cooling Water System  
(Relief Request RR-ENG-2-49) (TAC No. MD7495)

**SOUTH TEXAS PROJECT  
UNIT 2  
REQUEST FOR RELIEF FROM ASME BOILER AND PRESSURE VESSEL CODE,  
SECTION XI REQUIREMENTS FOR THE ESSENTIAL COOLING WATER SYSTEM  
(RELIEF REQUEST RR-ENG-2-49)**

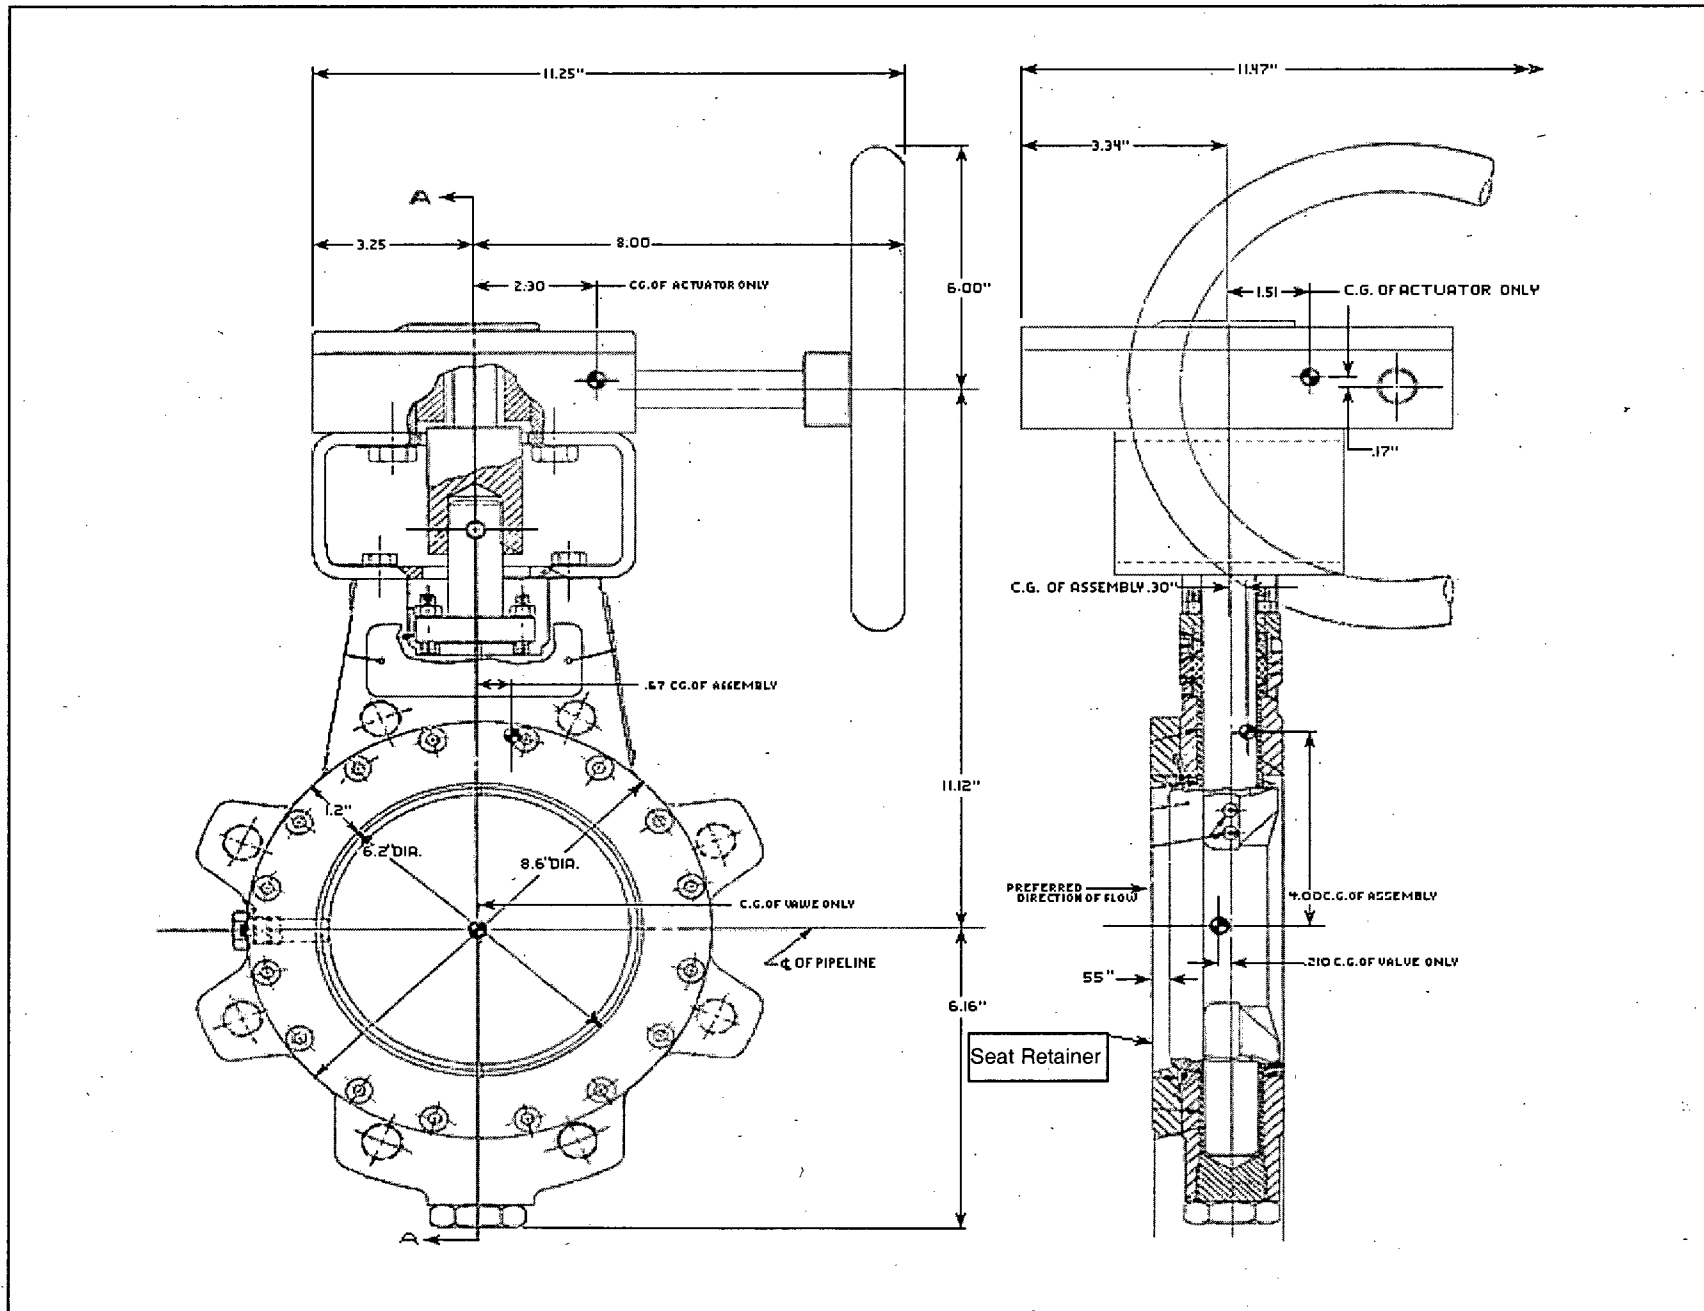
FIGURE 1: LINE DRAWING OF ROCKWELL VALVE

Figure 1 shows the configuration of the specific valve. Figure 2 is a typical representation of a valve showing how a seat retainer is installed. Figure 3 is a photograph of the actual valve showing its position relative to the attached ECW piping.

The dimensions of the parts illustrated in Figure 1 are as follows:

Outside diameter of seat retainer	= ~8.6"
Inside diameter of seat retainer	= ~5.9" to 6.2" (the ID is chamfered)
Thickness (radial) of seat retainer	= ~1.2" (the ID is chamfered)
Thickness (longitudinal) of seat retainer	= ~0.55"

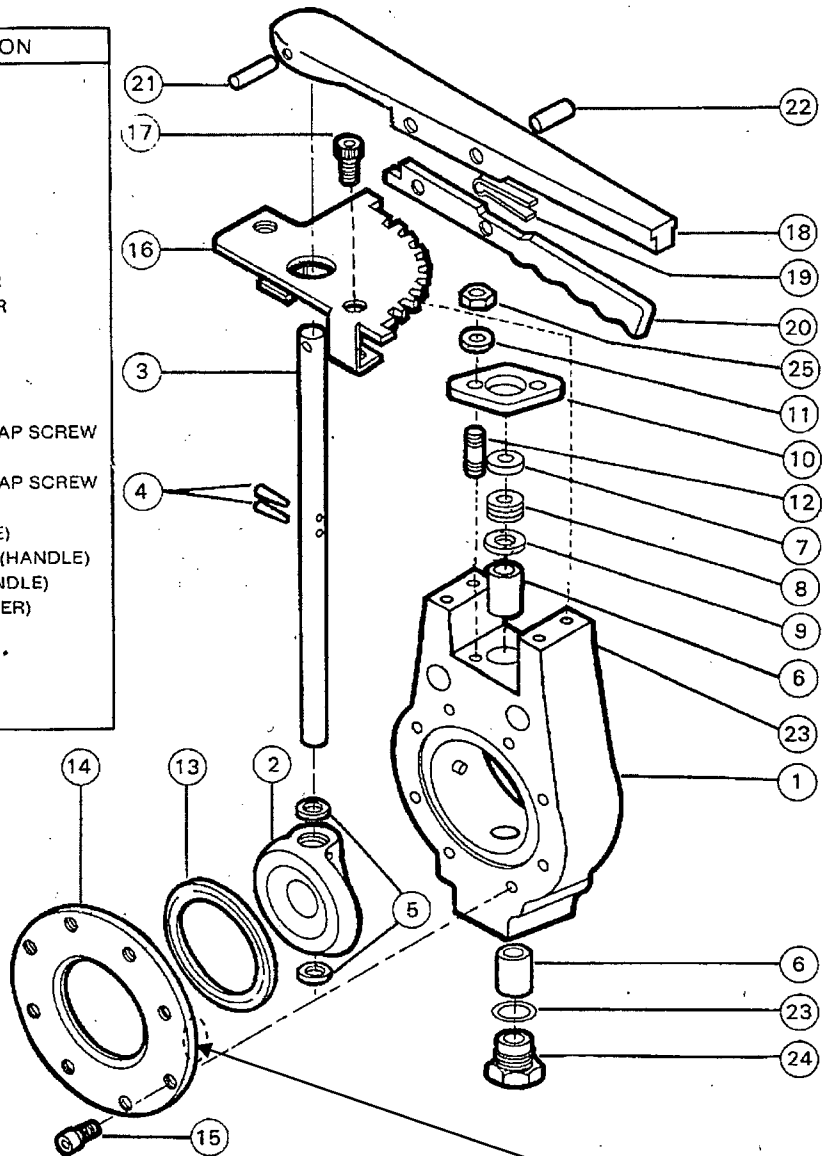
**FIGURE 2: EXPLODED DRAWING OF TYPICAL VALVE**

Approximate location  
 of dealloyed region

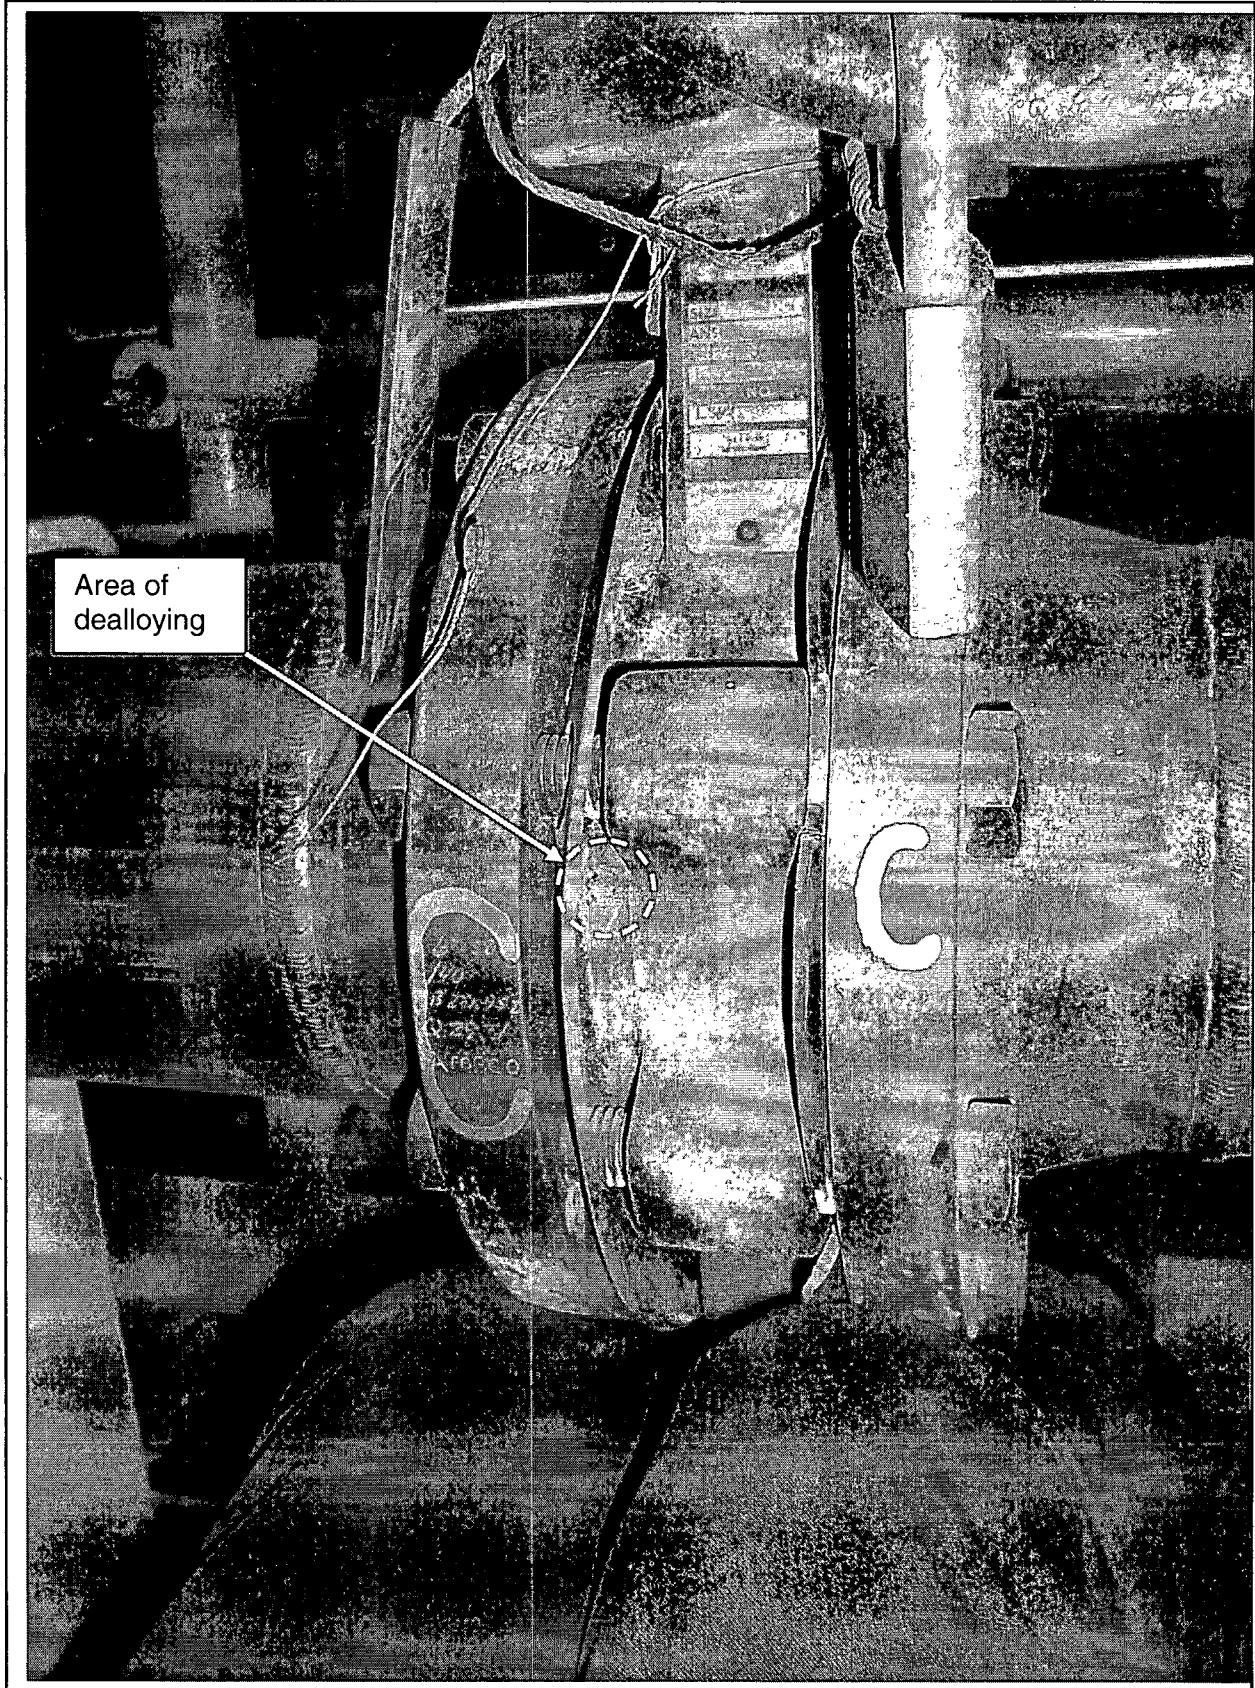
FIGURE 3: PHOTOGRAPH OF AFFECTED VALVE

1. In section 6.2.1 Scope of the subject relief request, the licensee stated that an indication of through-wall dealloying was identified on SBDG #23 cast aluminum-bronze ECW return flow balance throttle valve 2-EW-0204. The licensee also stated that the dealloying indication is a spot with residue buildup on the seat retainer.

- (c) From the photographs you provided in the e-mail, it appears that the materials of the components adjacent to the seat retainer are different from that of the seat retainer. Identify the adjacent components and its materials.

The adjacent components are a red rubber gasket, pipe flange (SB-271 CA-952 cast aluminum-bronze), and the valve body (SB 148 CA 954). The seat retainer material is also SB 148 CA 954. The difference in appearance between the seat retainer and the valve body may be due to machining of the seat retainer surface while the valve body is closer to its original as-cast appearance.

Normally, walkdowns of ECW piping are performed at intervals of six months. In the event a flawed area is discovered, augmented monthly inspections are performed to monitor the flaw to detect changes in the size of the discolored area or leakage rate. Inspectors look for: change from residue buildup to active dripping; new indication at a different area on the component; or, a substantial change (about 2x or more) in the area of the original indication. Structural integrity and the monitoring frequency are re-evaluated if monitoring identifies significant changes in the condition of the dealloyed area.
