RE: REPOSE TO AN APPARENT VIOLATION IN INSPECTION REPORT
NUMBER 030-12975/2007-001; EA-08-041

Inspection Finding Considered for Escalated Enforcement

Inspection Findings Not Considered for Escalated Enforcement

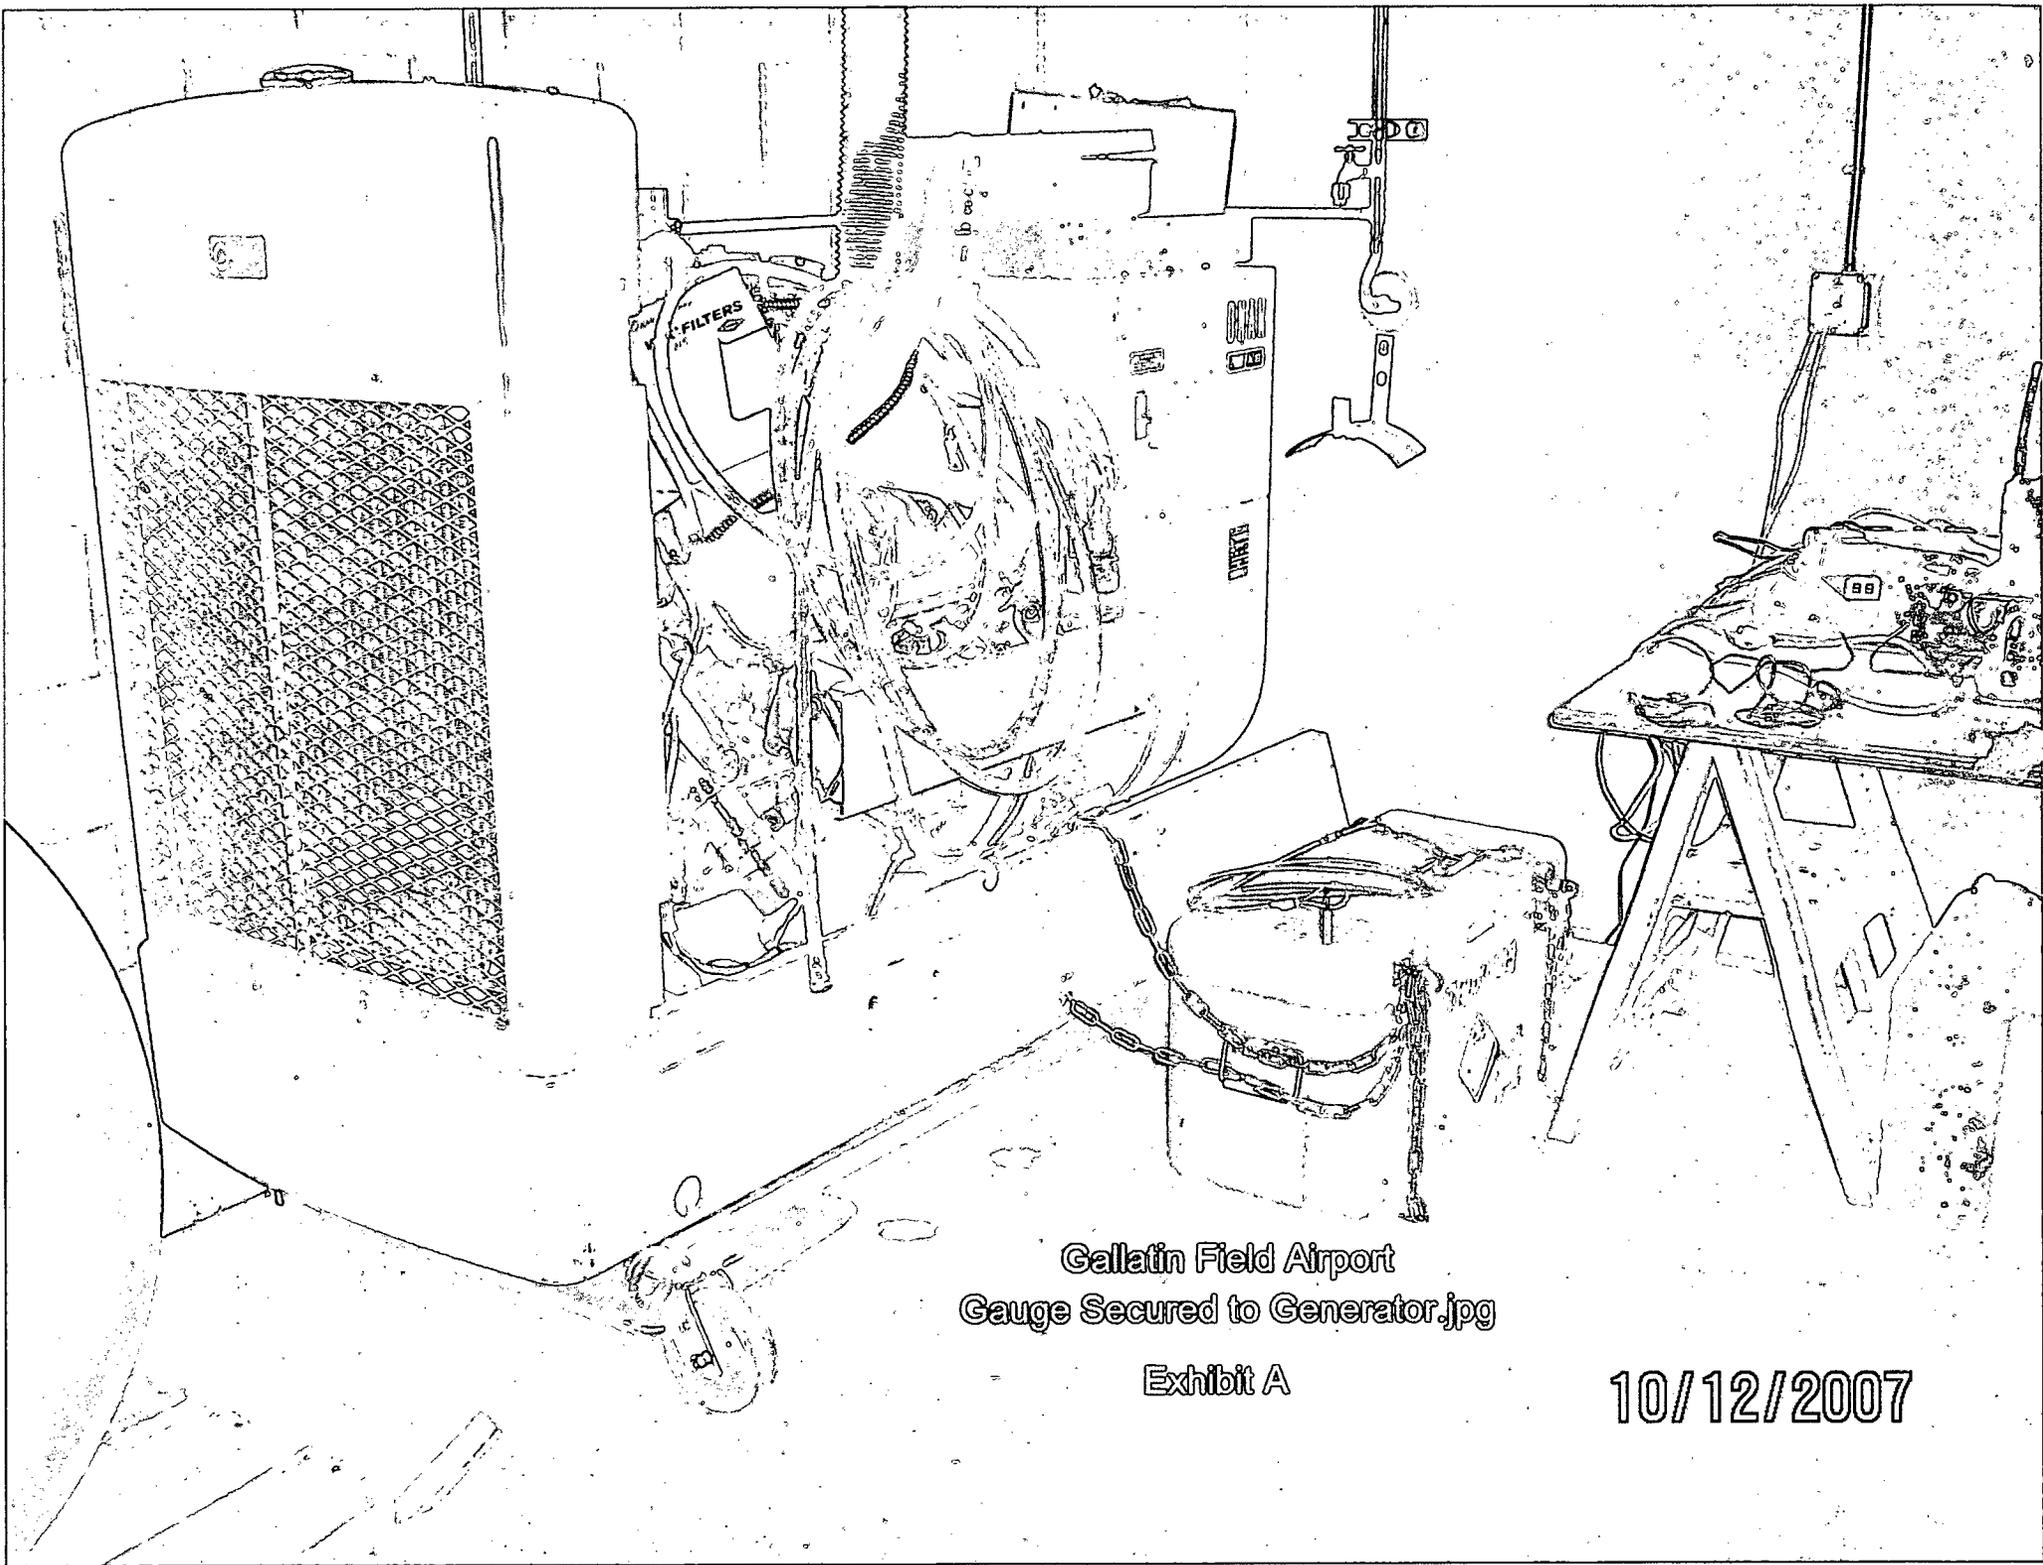
Exhibit A

“.. a portable gauge was stored at a temporary job site with no independent physical controls that form tangible barriers to prevent unauthorized removal of the gauge when not under the control and constant surveillance of the licensee. This was identified as an apparent violation of 10 CFR 30.34(i). (Section 2.2)”.

Callatin Field Airport
Gauge Secured to Generator.jpg

Employees of Morrison-Maierle, Inc. immediately secured the portable gauge to a fixed, immobile generator using a single chain and lock on hand and within 24 hours had secured the gauge with two independent locks to the fixed generator to become compliant with 10 CFR 30.34. Our immediate corrective actions were documented in the NRC Inspection Report 030-12975/2007-001 (See NRC Executive Summary, Enclosure 2, Corrective Actions; See attached photo Exhibit A). Individuals involved were interviewed and procedures reviewed so that future incidents would not occur. Additionally, all other authorized employees of Morrison-Maierle, Inc. were made aware of the violation and a review of procedures, with an emphasis on proper transportation and storage, was undertaken to prevent future violations.
