Issue date: April 28, 2003
Revision 1

SIL No. 642

CR105X auxiliary contact failure

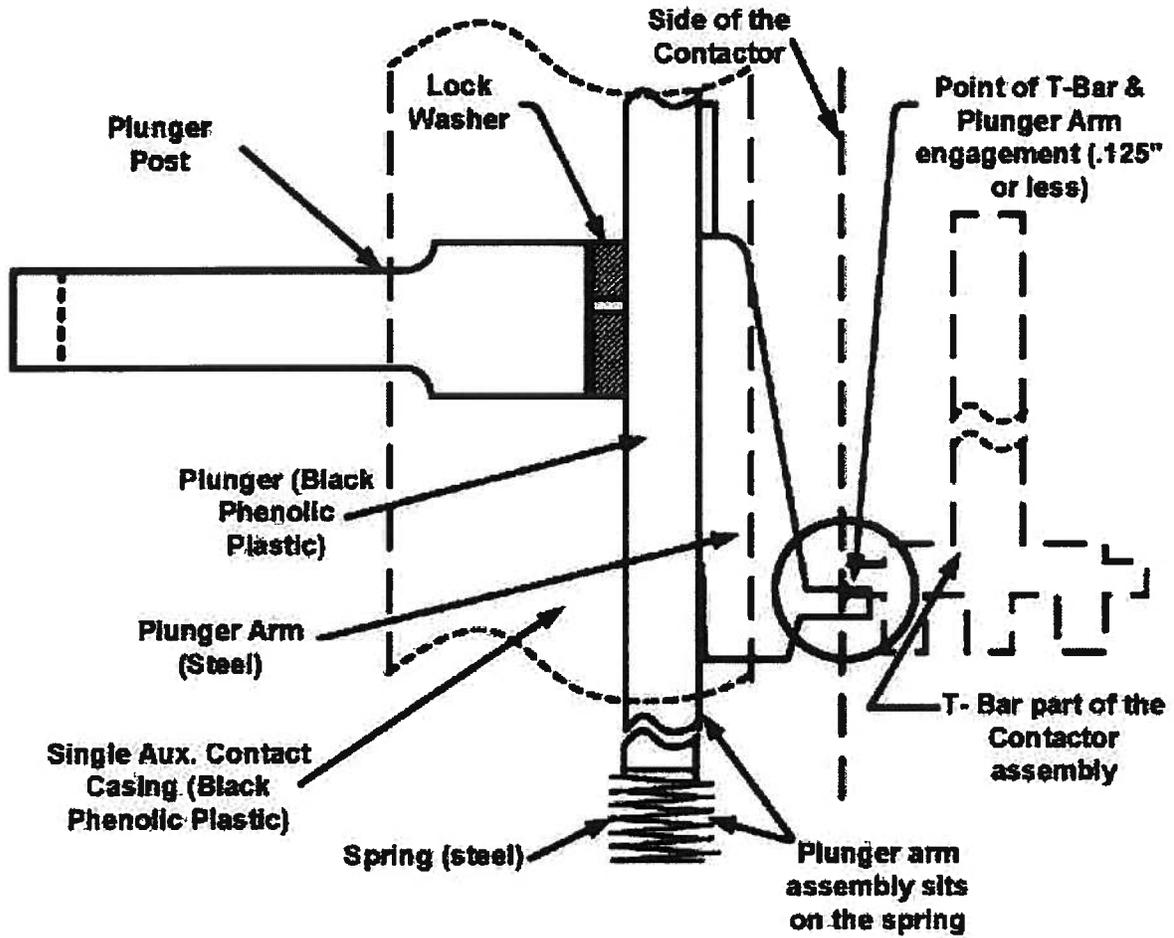
Figure 1

Recently at a BWR in the United States, a GE CR105X auxiliary contact failed to change state from the open to closed position. Plant troubleshooting revealed that the CR105X auxiliary contact was stuck in the open position. During repair, the auxiliary contact plunger arm was found disengaged from the T-Bar (see [Figure 1](#)), which caused the failure of the contact to change state. The cause of the disengaged plunger arm and loose plunger post was determined to be a missing #6 lock washer.

CR105X auxiliary contactors have been sold as either kits ([Figures 2 and 3](#)), or as part of an assembly. The CR105X auxiliary contacts sold as kits contain the #6 lock washer; however, the provided installation instructions did not contain guidance on where to install the #6 lock washer or the required torque to the plunger post. Assemblies shipped from the factory containing an auxiliary contact may not have the #6 lock washer installed. The plunger arm may disengage from the T-Bar causing the failure of the contact to change state if the plunger post is not properly torqued or if the #6 lock washer is not installed. There should be no gap between the steel plunger post and phenolic plunger (see [Figure 1](#)).

1. Visually verify that the #6 lock washer is installed between the plunger post and the plunger. There should be no gap between them.
2. If the #6 lock washer is missing, either install a new #6 lock washer or replace the auxiliary contact with a new one containing a #6 lock washer.
3. If the plunger arm is determined to be loose, tighten the plunger post to 4-7 in-lbs.
