***Pre-Decisional
Enforcement
Conference***

***NRC Region II
Atlanta, Georgia***

May 19, 2008

Global Nuclear Fuel - Americas

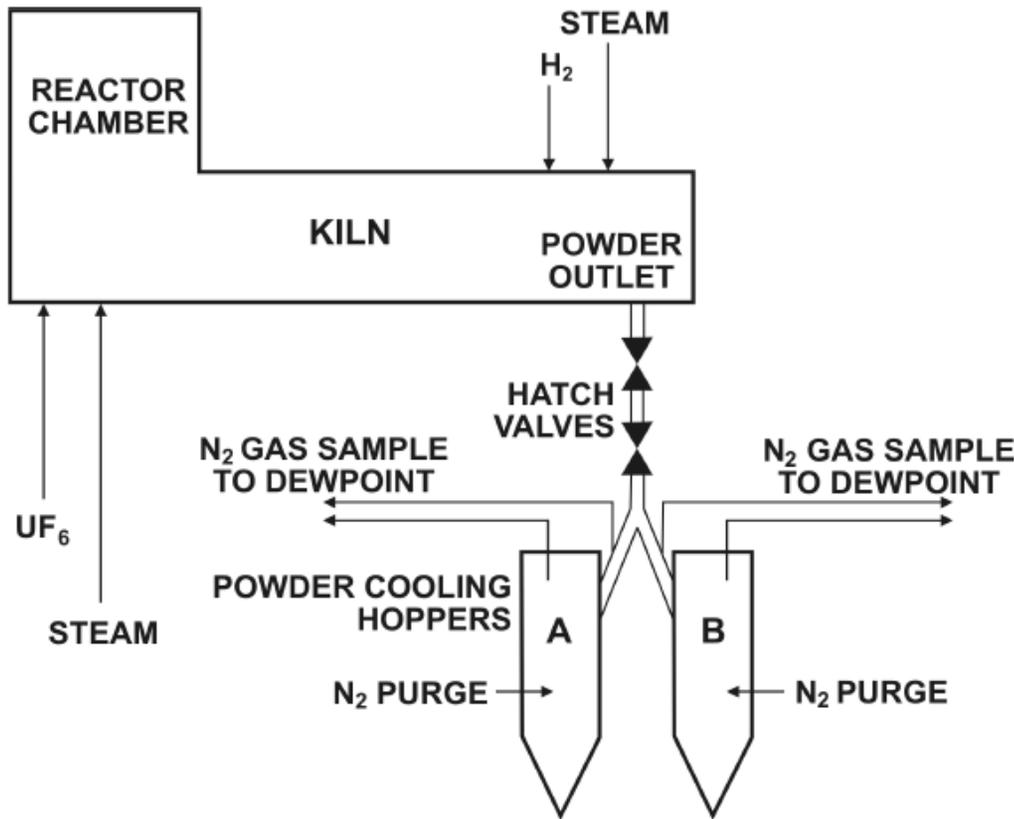
Figure 1

Conversion Reactor/Kiln and Cooling-Hopper Equipment Arrangement

During post-maintenance verification on the hatch valves, the operator identified that cycling the hatch valves resulted in elevated moisture levels. This discrepancy was reported to the Controls Engineer who confirmed the problem by observing two additional cycles. The Area Engineer directed that the system be secured in preparation for troubleshooting. Misalignment was discovered upon removing actuator.

Steam was only applied to the system during cycling of the hatch valves.

- Hatch valve maintenance cleanout requirements added (i.e., confirm hoppers empty)
- Added local leak check using nitrogen (before steam is introduced) to test hatch valves after installation or maintenance
- DCP operating procedures revised to ensure proper cleanout of adjoining equipment prior to maintenance
- Additional guidance and training provided for maintenance or repairs on Items Relied On For Safety (IROFS)
- Added audible interlock alarm signals to DCP control room
